BMP NUMBER: JR016

MEMORANDUM

Name (if known): Governors Land

Located behind 3001 Travis Close

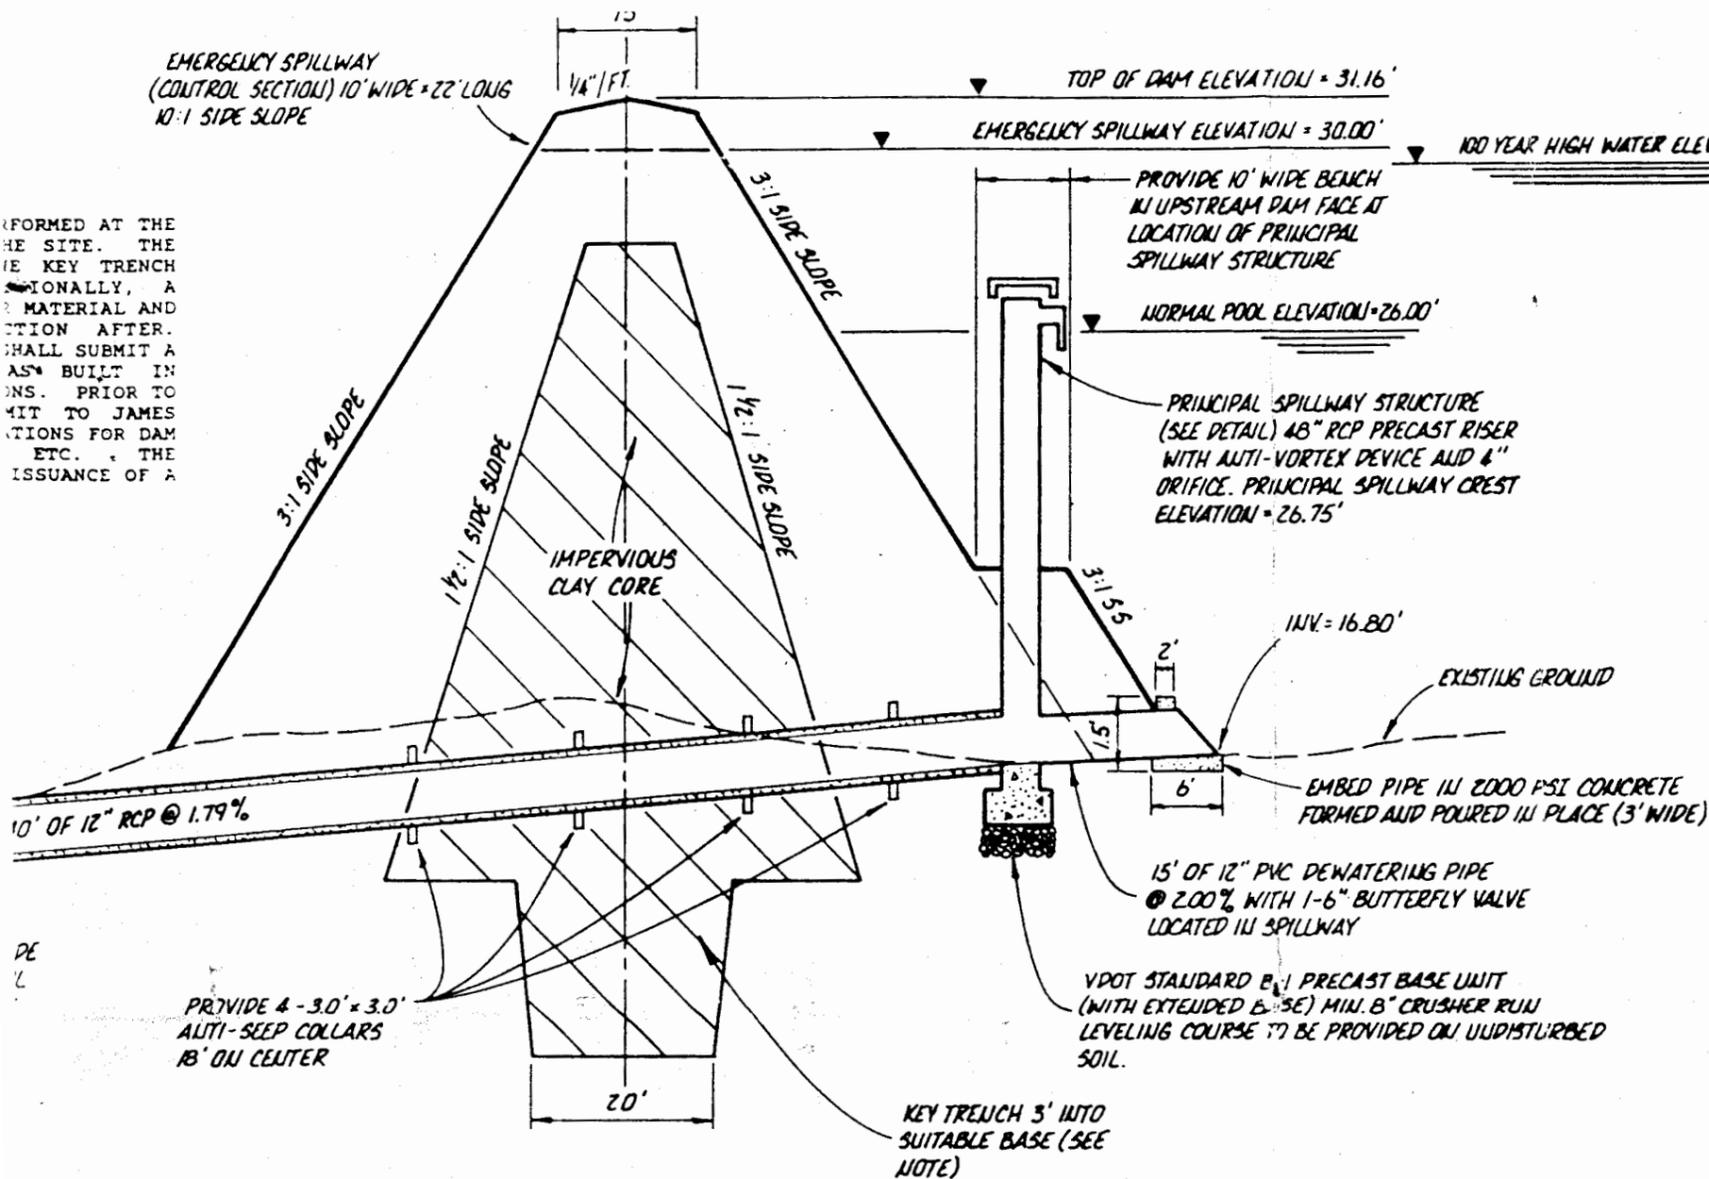
**DAM CROSS SECTION B-B
 9TH HOLE POND**

1. In accordance with notes on Sheet 6 and on Section B-B of Sheet 10 of the approved plan, construction certification was required for the BMP. This note stated that "... after construction, the geotechnical consultant shall submit a report demonstrating that the dam was built in accordance with their report recommendations." None was provided. Although not provided, a post-construction geotechnical analyses of the dam embankment was performed. The portion of the post-construction geotechnical report for Travis Pond appears to satisfy any outstanding construction certification requirements for the facility.
