BMP NUMBER: JR025

Stormwater Management / BMP Facilities
Record Drawing and Construction Certification Forms

Project Name: GOVERNOR'S LAND - PHASE I
Structure/BMP Name: DRY DETENTION POND #2
Project Location: ROUTE 5
BMP Location: END OF PRIVATE DRIVE AT END OF WEST ISLAND ROAD
County Plan No.: S - 7 - 90

Brief Description of Stormwater Management/BMP Facility: EARTHEN EMBANKMENT
APPROXIMATELY 10 FEET HIGH WITH CONCRETE PIER STRUCTURE
AND ANTI-VORTEX COLLAR

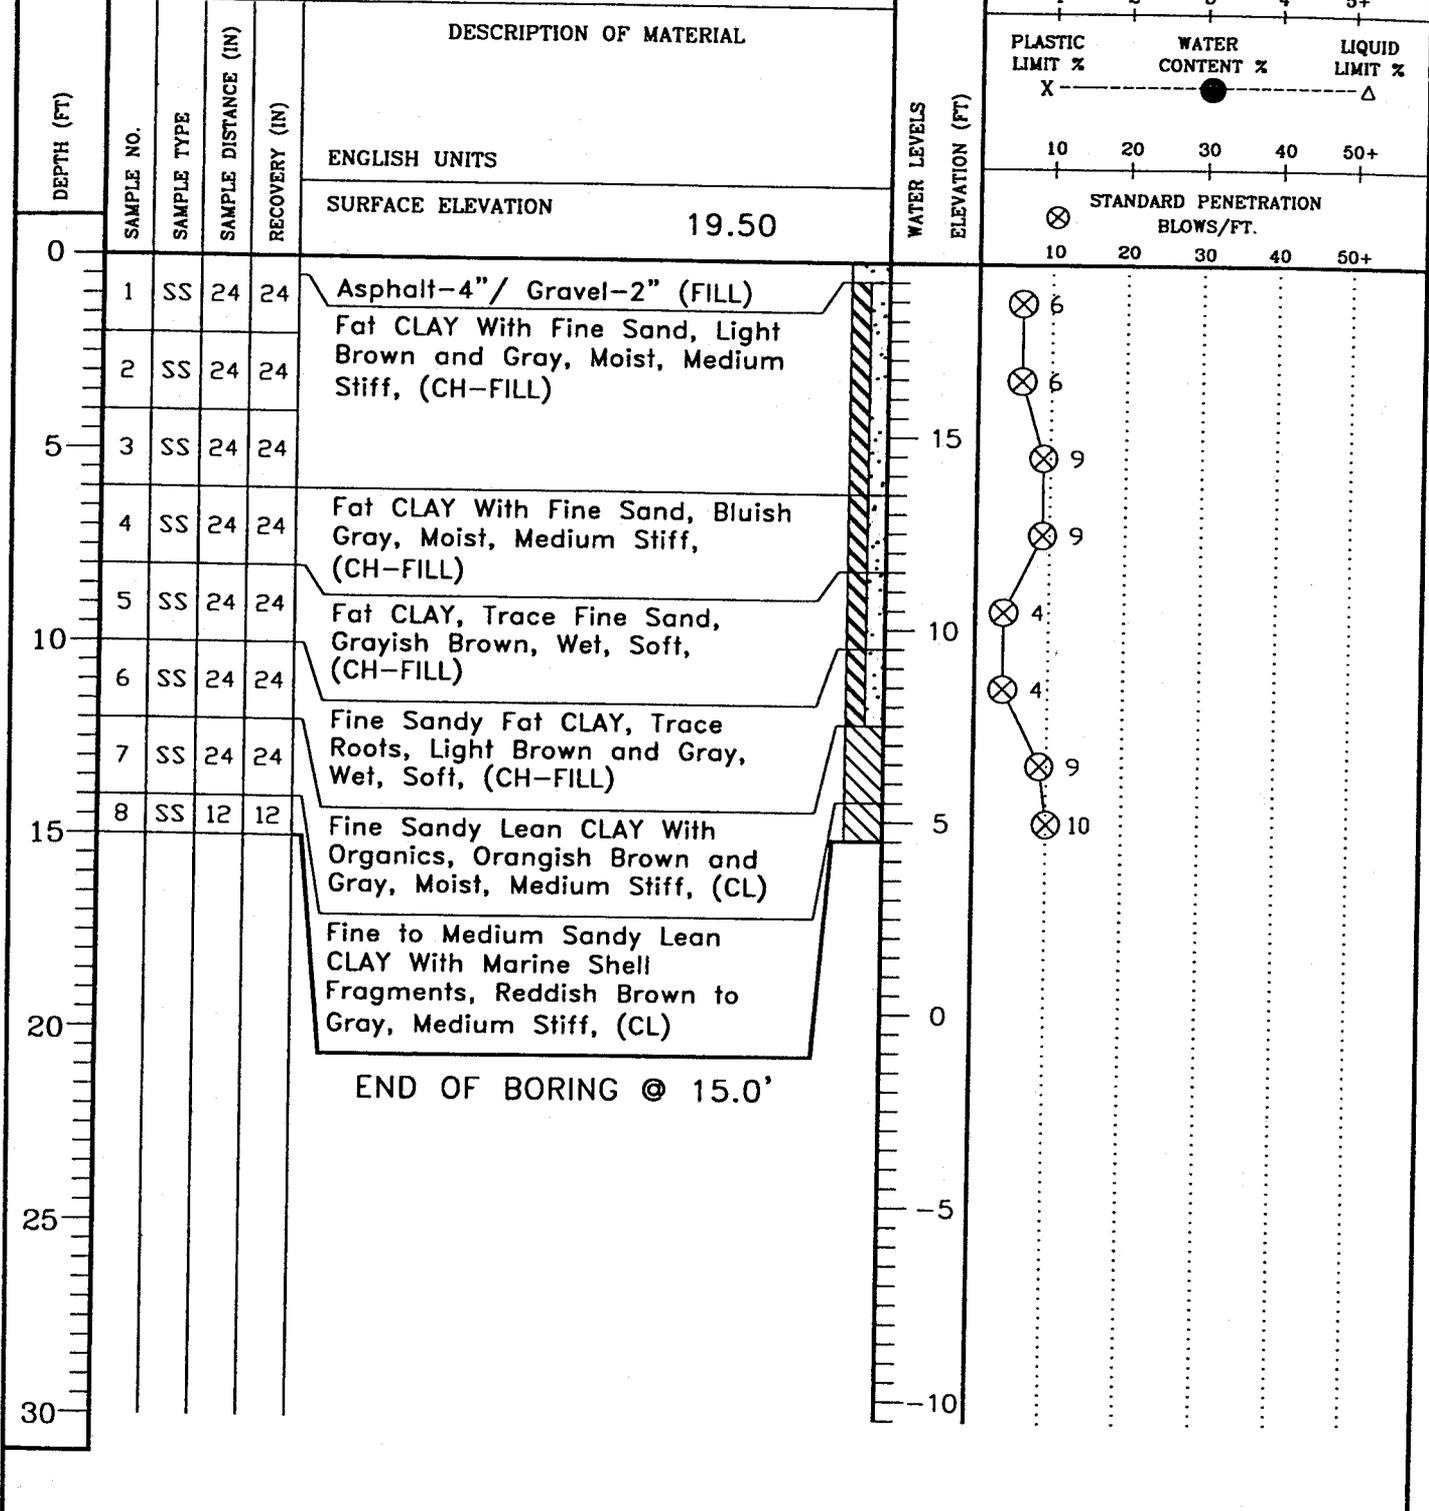
CLIENT DOMINION LAND MANAGEMENT CO.	JOB # 6221	BORING # B-2	SHEET 1 OF 1	
PROJECT NAME GOVERNOR'S LAND DAMS (EMBANKMENT EVAL.)	ARCHITECT-ENGINEER AES, INC.

Significant moisture was not observed within the dam fill material. Groundwater was encountered in boring B-2 at a depth of about 23 feet below top of the dam surface. The presence of water at this depth does not present a problem with the stability of the dam.

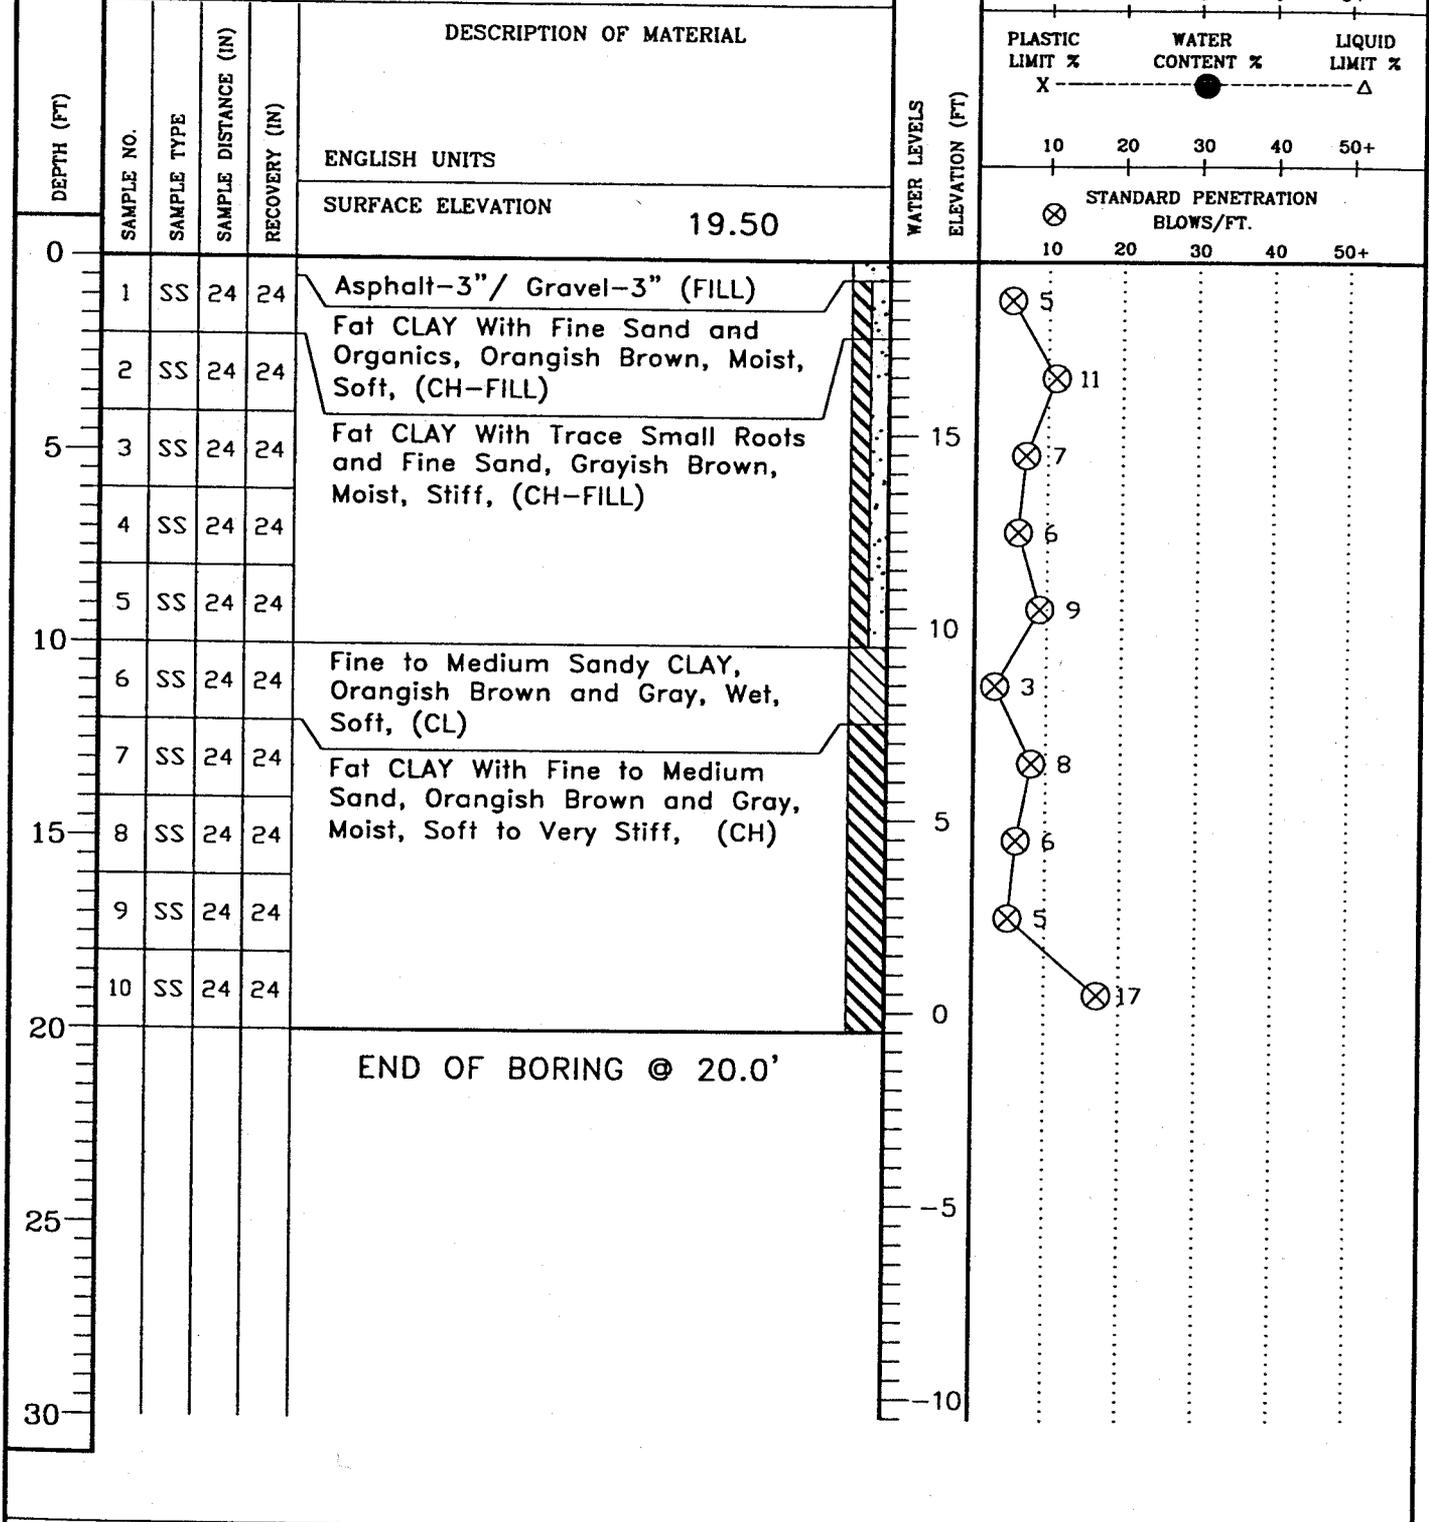
CLIENT DOMINION LAND MANAGEMENT CO.	JOB # 6221	BORING # B-3	SHEET 1 OF 1	ECS LTD
PROJECT NAME GOVERNOR'S LAND DAMS (EMBANKMENT EVAL.)	ARCHITECT-ENGINEER AES, INC.

Significant moisture was not observed within the dam fill material. Groundwater, however, was encountered in boring B-3 at a depth of about 24 feet below top of the dam surface. The presence of water at this depth does not present a problem with regard to the stability of the dam.
