**BMP NUMBER:** MC041

PRELIMINARY SPILLWAY REPAIR PROJECT	
DESIGNED	DRAWN
SCALE	DATE
PROJECT NO.	
DRAWING NO.

# LAKE LORING - SPILLWAY REPAIR

### Lower Lake Loring – Preliminary Spillway Repair Estimate

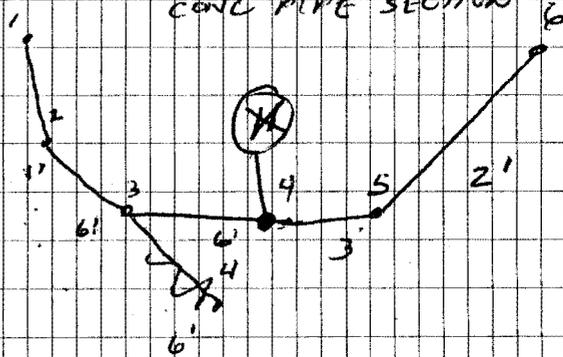
X-SECTION 1

LOOKING DS

END NON BROKEN CONCL PIPE SECTION

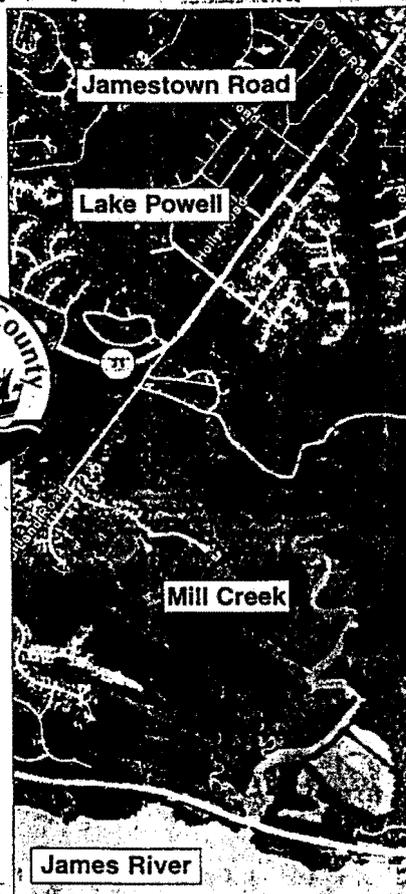
Tidal water is flowing up Mill Creek into Lake Powell, potentially creating different guidelines for reformation of the lake.
