BMP NUMBER: PC025

Powhatan Crossing

**AS-BUILT
EXISTING POND
POWHATAN CROSSING
SECTION IV**

Powhatan Crossing Sec 3/4 Wet Pond PC 025
RE: Construction-Related Items for BMP

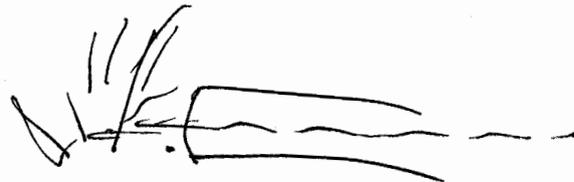
<u>Position</u>	<u>AB</u>
ES	50.28	49.7
Riser Crest	49.60	49.19
WP	46	<u>44.60</u>

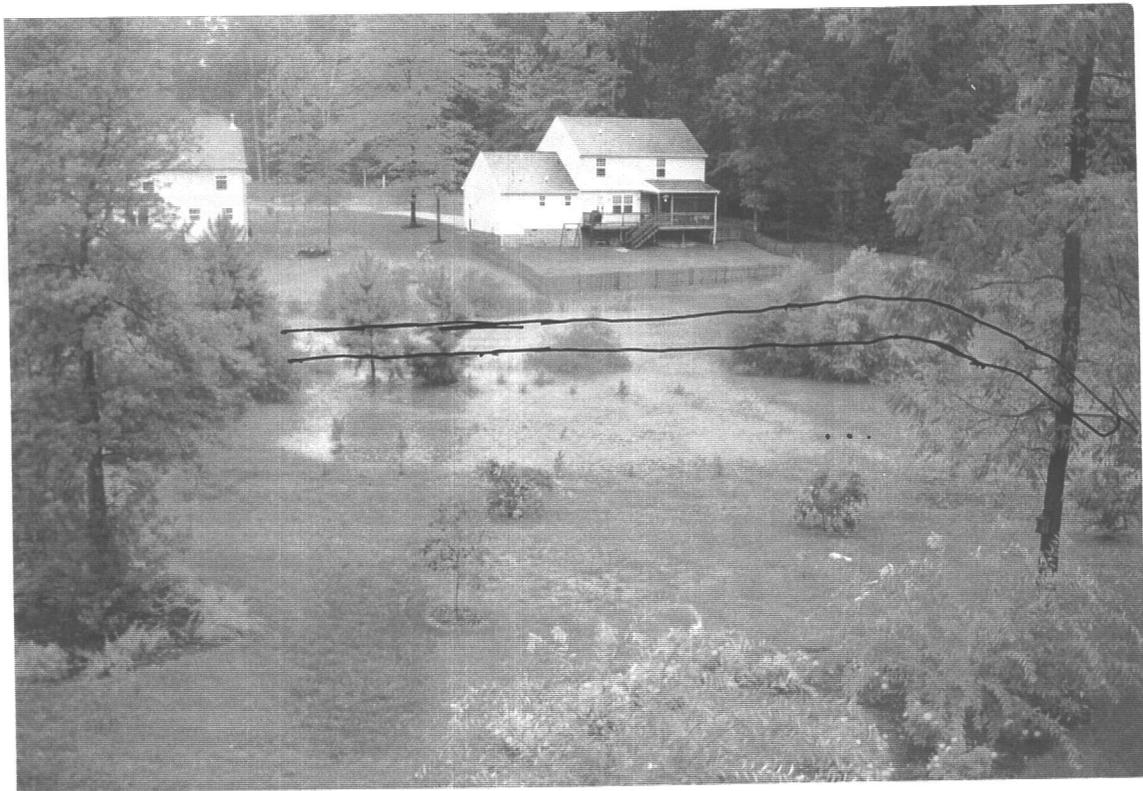
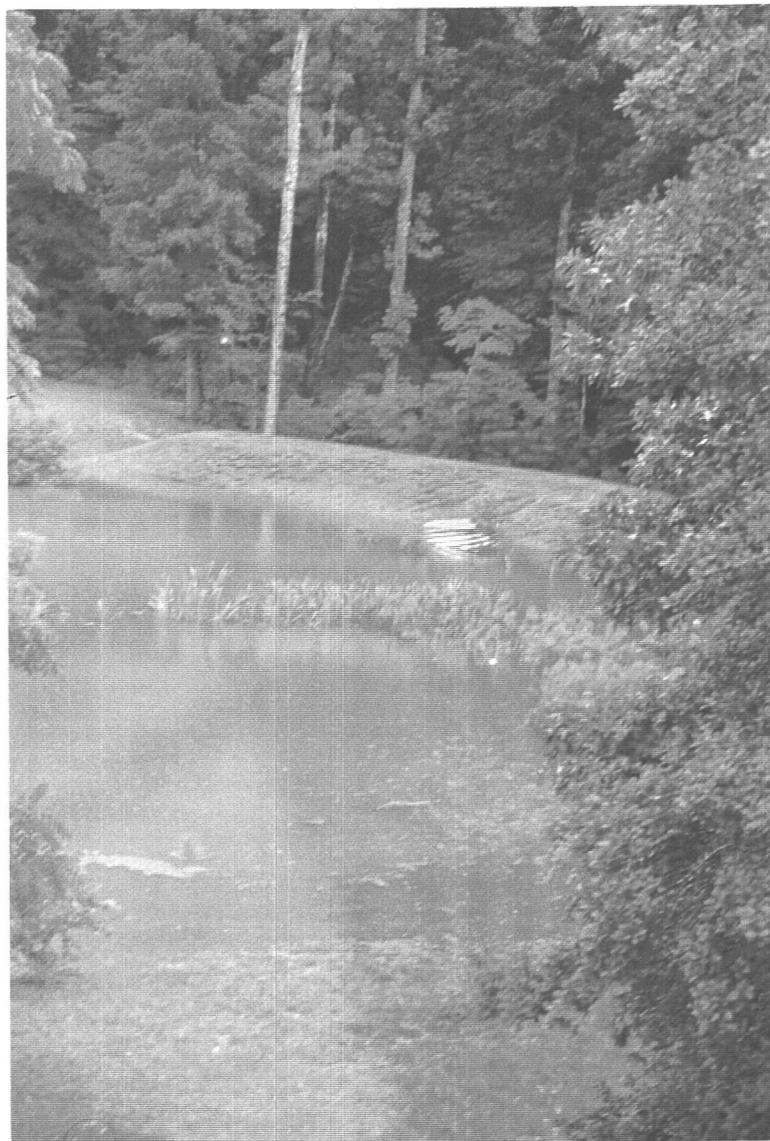
Received from
Jesse Hampton
08/01/01

Personal Photos
Date Unknown
