**BMP NUMBER: PC130**

Longhill Gate Homeowners Association

Upper wet pond located on the north side of the main entrance road; Combined folder with PC033

# LONGHILL GATE SITE ASSESSMENT

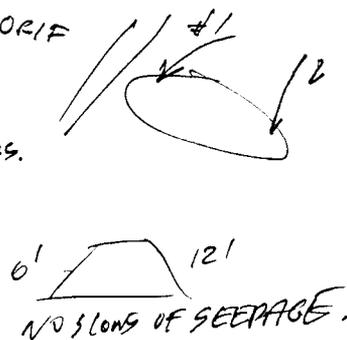
SMALL BASIN @ SITE ENTRANCE (30x10)  
 VEG & SEDIMENT CLEARED NEEDS CLEARED  
 24" IN; 30" OUT

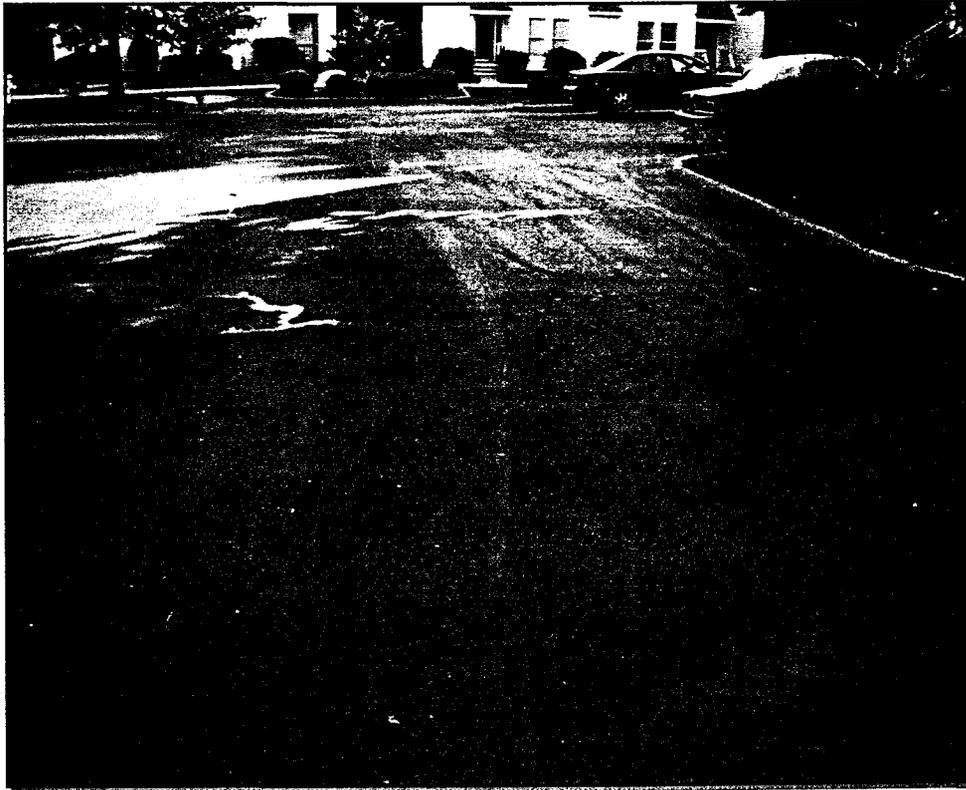
Areas of subgrade failure characterized by irregular cracking will sometimes weep trapped moisture contained in underlying aggregate or subgrade soils. Referencing Photo 3, the area located in the *Tower Hill* section represents the trapped moisture weeping from the subgrade, and also beneath the asphalt surface. Although the pavement has not completely failed in the area, future pavement failure can be expected, as the trapped moisture is weakening subgrade.

**Photo 3 – Tower Hill**  
Evidence of trapped moisture weeping through cracks in the asphalt surface.

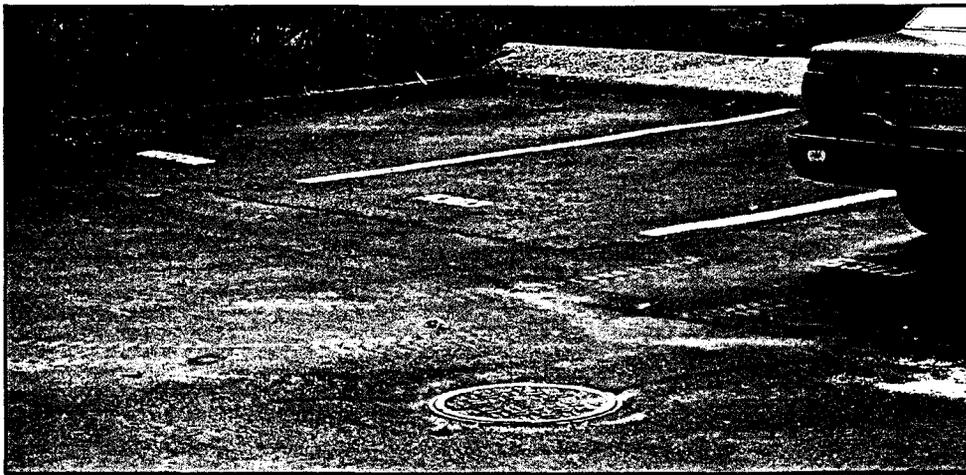
**Photo 4 –  
Sloane Square**  
Typical addition of asphalt surface to promote positive drainage.

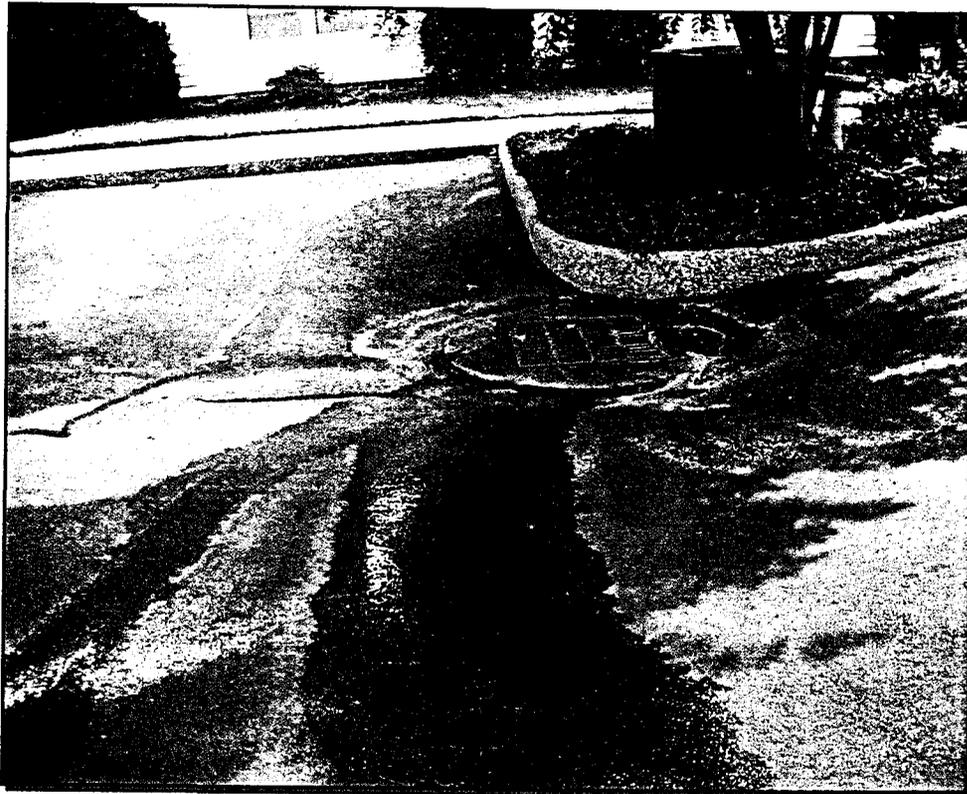
In the original examination of the site, several locations where the asphalt surface is slightly lower than the top of a storm sewer inlet were noted. (See Photo 5) The apparent cause has been that the surrounding pavement has worn and shrunk over time, and the underlying subgrade material beneath the asphalt surface has compacted. However, the storm sewer inlet, which apparently was placed on undisturbed subsoil, has not moved. Again, this condition is not a serious problem; very minor depressions can be corrected with multiple applications of a dense asphalt sealer in the depressed area around the storm sewer inlet will yield good results. To date, several additional applications of this type of repair are still warranted around storm sewer structures throughout the development.

**Photo 5 –  
Highgate Green**  
Storm sewer top is higher than asphalt surface. Note inability of water to reach inlet to drain properly.

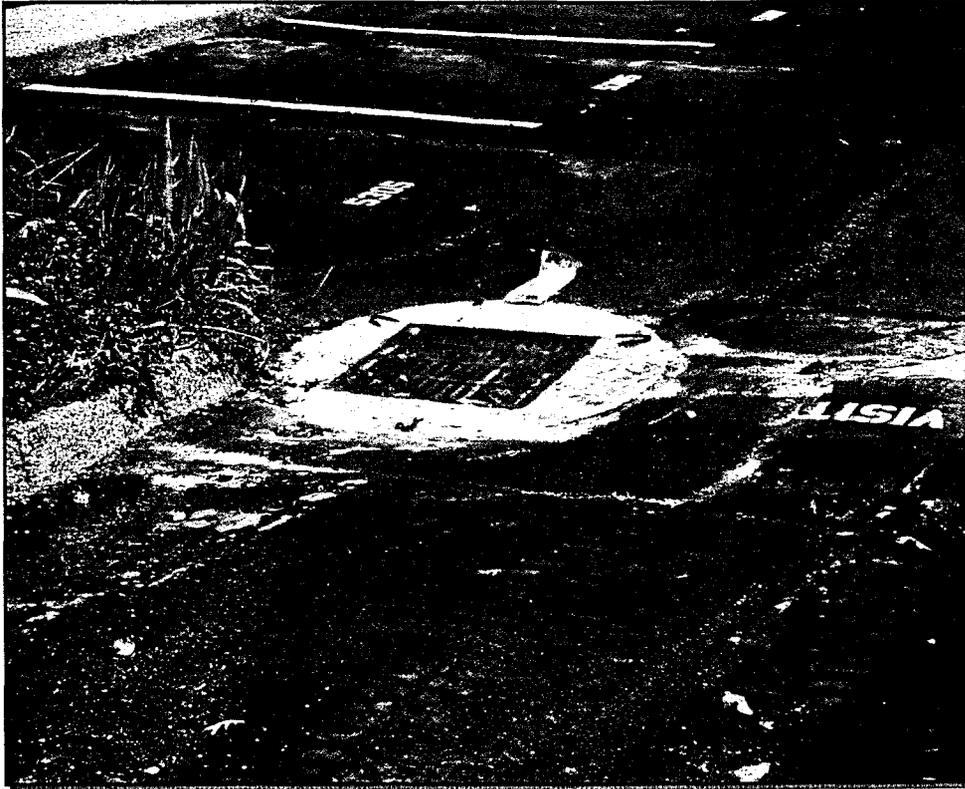
**Photo 6 –  
Sloane Square**  
Note irregular asphalt surface around storm drain structure. Photo taken 9/15/00. No apparent signs of failure other than irregular asphalt surface.

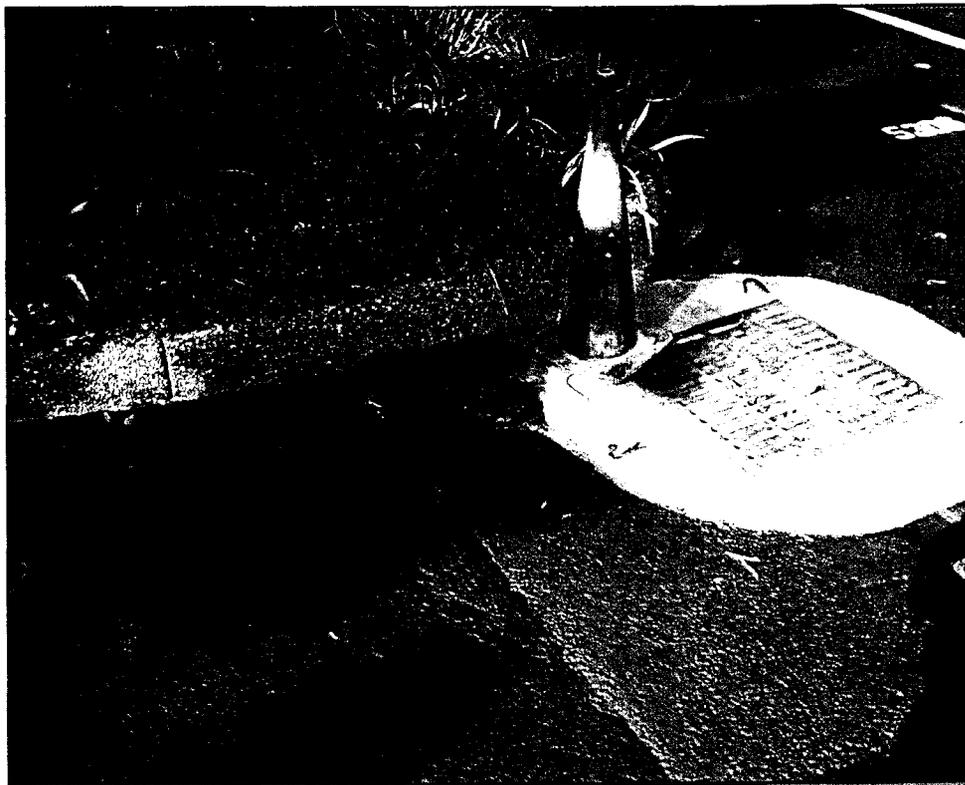
There are a few locations where the pavement surface is very irregular along the perimeter of storm sewer inlets. (See Photo 6) AES concludes that substandard workmanship is responsible for these situations. The condition in *Sloane Square* is serious and most likely the result of a lengthy period of subgrade related failure associated with the drainage structure. The above-mentioned photo was taken on September 15, 2000 and at that time no obvious subgrade failure had occurred. However, AES was contacted in October and informed that a “sinkhole” had formed adjacent to this structure. (See Photo 7).

**Photo 7 –  
Sloane Square**  
Subgrade failure. Note sinkhole by storm drain structure. Photo taken 10/03/00.

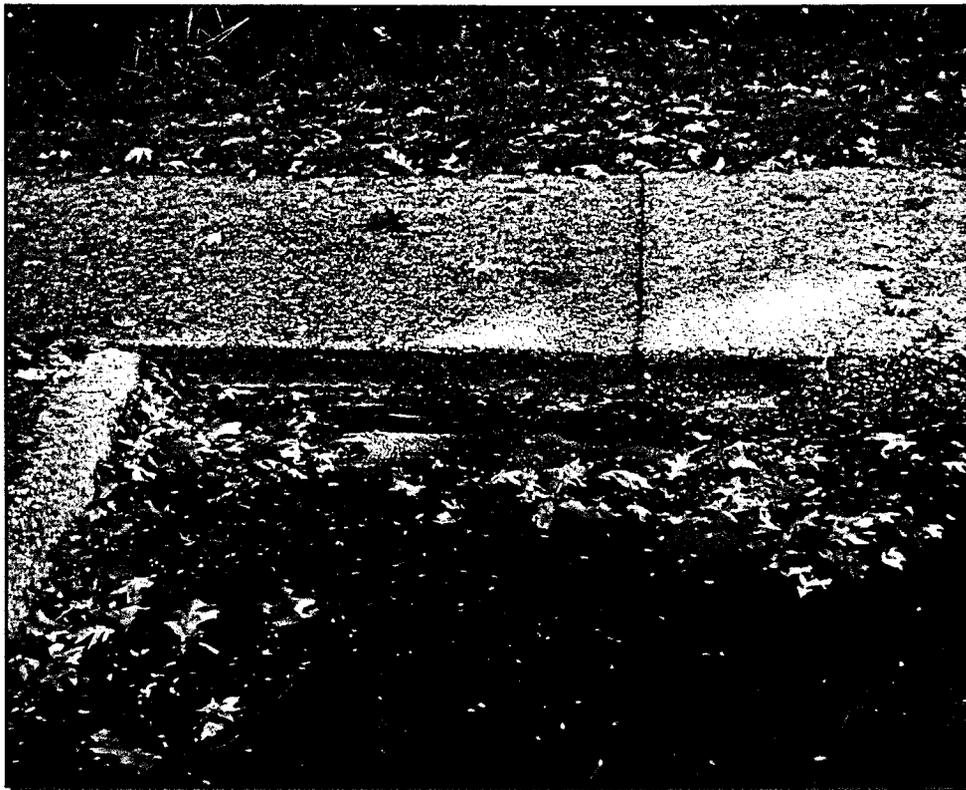
The curbing and sidewalks in *Longhill Gate* are rated to be in fair to good condition. Since AES report dated February 1997, it appears some of the damaged concrete sidewalks and curb sections have been repaired or replaced. AES believes the original poor condition of the curbs and sidewalks is due, in some degree, to substandard workmanship, as this is still evidence in some areas. (See Photo 8)

**Photo 8 – Tower Hill**  
Note voids in the bottom of the sidewalk, which demonstrate poor construction workmanship.

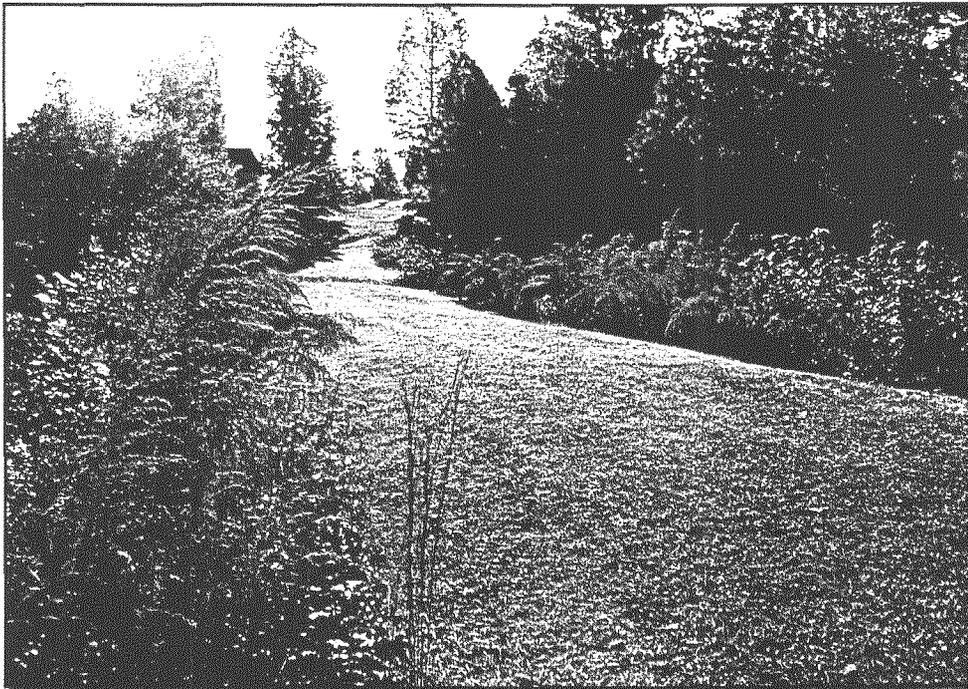
During the original site visit to the *Longhill Gate* site, AES staff recognized the need for routine maintenance of the ditches, drainage systems and the dam embankment. Drainage ditches were clogged with leaves and debris, storm sewer inlets covered with leaves, and the dam embankment slopes covered with a large amount of young trees and underbrush. (See Photo 9)

**Photo 9 –  
Dam Embankment**  
Note heavy shrub and underbrush growth on the upstream and downstream sides of the dam embankment.

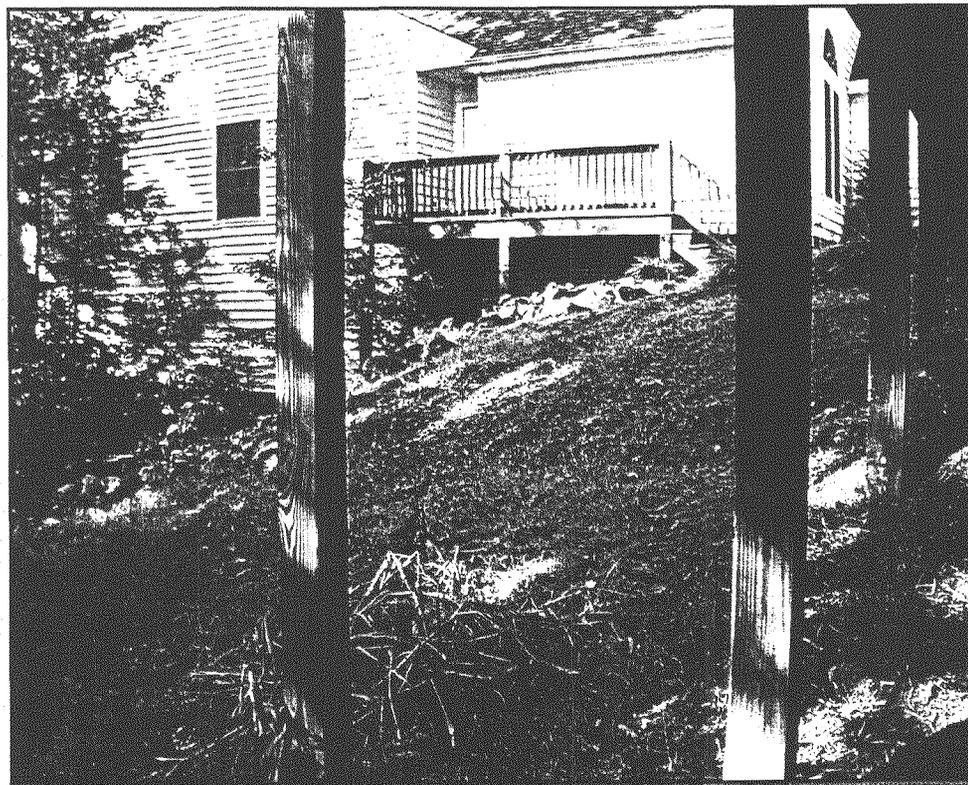
Also noted was a recently repaired bank at the upstream side of this outfall. (See Photo 12) It is assumed that the repair was made to stabilize the slope in this area. It is unclear whether the repair of this slope included the installation of filter fabric under the rip-rap. This area should be monitored to ensure that soil beneath the rip-rap does not migrate from the repaired areas.

**Photo 12 –  
Chiswick Park**  
Newly repaired slope. Earthen slope should be observed to ensure proper construction methods.

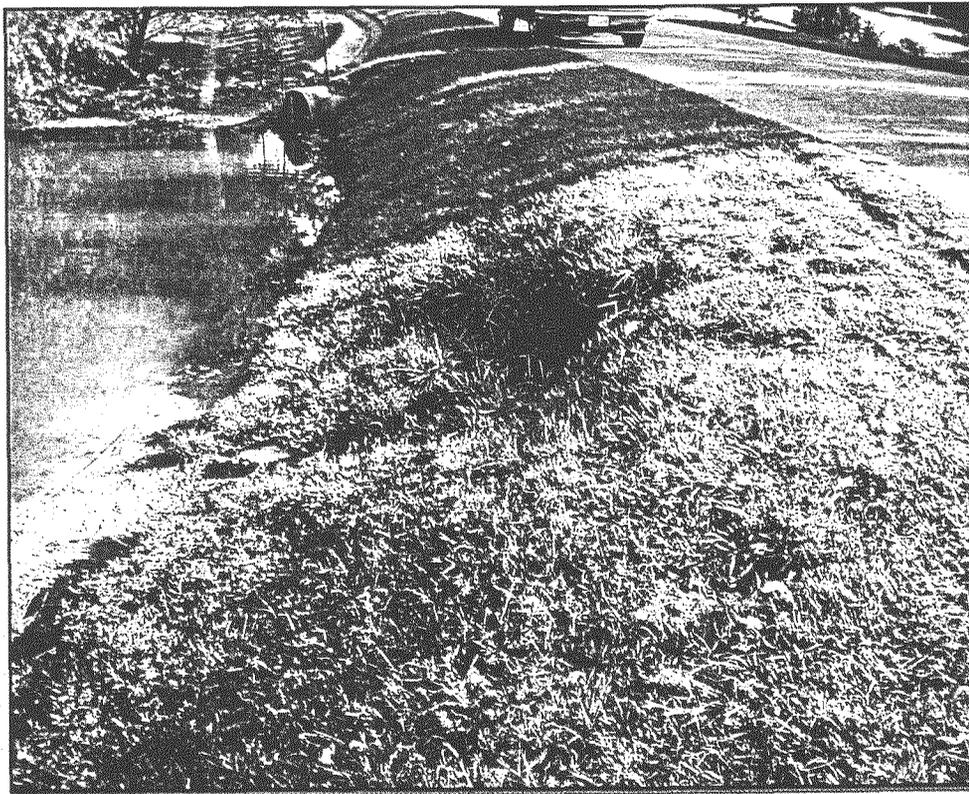
**Photo 13 – Longhill Gate Entrance Road Causeway**

Another area of concern was found along the entrance road between the *Tower Hill* and *Sloane Square* sections of *Longhill Gate*. (See Photo 13) As can be observed by the photo, the surface is eroding away most likely due to large volumes of runoff flowing over the roadway's shoulder. It appears the grass shoulders being higher than the roadway surface cause the problem; once at the low point of the roadway, the storm runoff accumulates, overtopping the shoulder. The result is an eroded channel to the adjacent pond. AES recommends that forming a concrete channel approximately 9-inches in depth along the current eroded channel centerline repair this channel. This should provide an adequate solution and alleviate any further erosion problems. In the previous assessment, AES recommended that the road shoulders be graded to be slightly lower than the surface of the adjacent roadway. We still recommend the solution as the long-term repair.

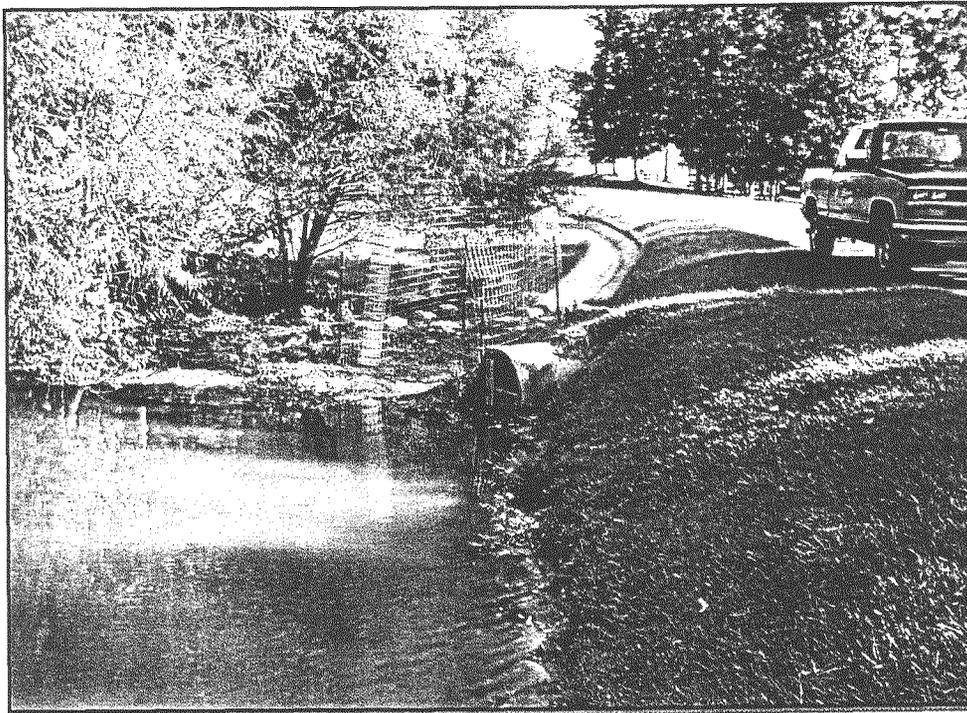
**Photo 14 – Longhill Gate Entrance Road Causeway**

Just to the left of *Longhill Gate* (entrance road), a small pond is found. Dewatered by a culvert under *Longhill Gate*, an obstruction to the inlet of the culvert pipe was noted (See Photo 14). As this obstruction prevents the culvert functioning efficiently, AES recommends that this item be removed.

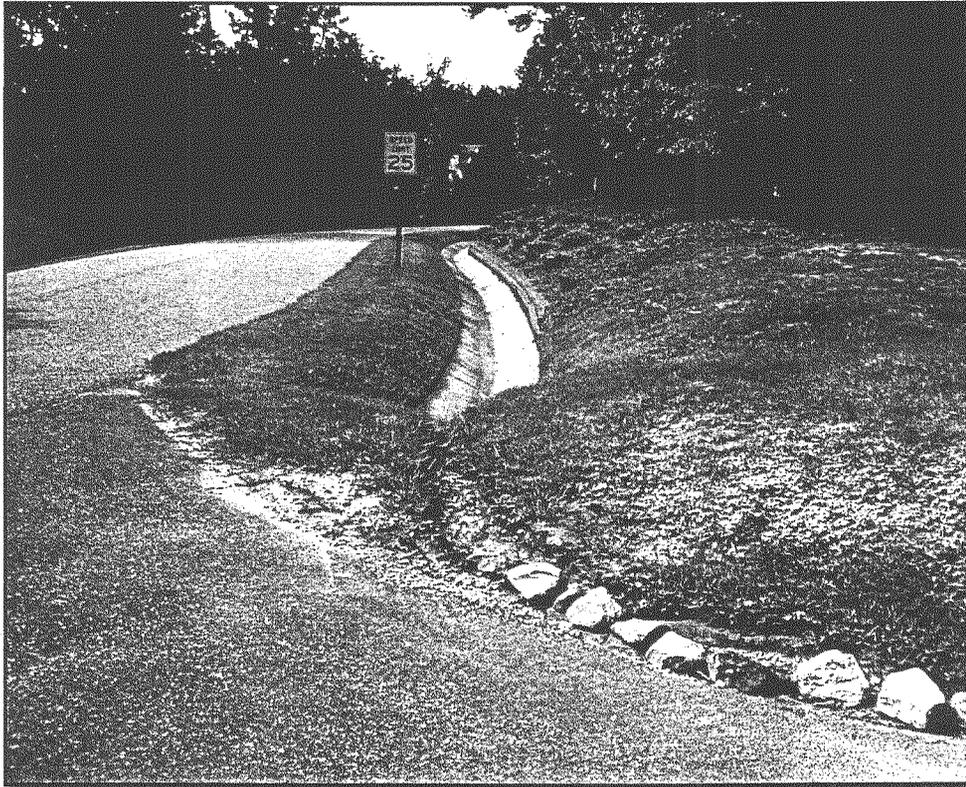
Other area of concern includes *Baron's Court*. A drainage pipe in a parking island appears to be inadequate. Sediment-bearing runoff deposits sediment in the corner of the parking lot because the runoff is unable to quickly flow from this point, thus allowing material to settle out on the uphill side of the pipe. During the winter, it is very likely for this area to pond water, allowing it to freeze, creating a pedestrian hazard. (See Photo 17) A low spot can be evidenced at the downstream side of the island by the standing water. (See Photo 18) AES recommends that a paved gutter be constructed through the parking island to allow the drainage to flow through the island and prevent any obstruction of the sediment-laden stormwater, or the accumulation of runoff.

**Photo 15 – Baron’s Court**  
Note erosion of drainage ditch, rock lining does not provide adequate protection.

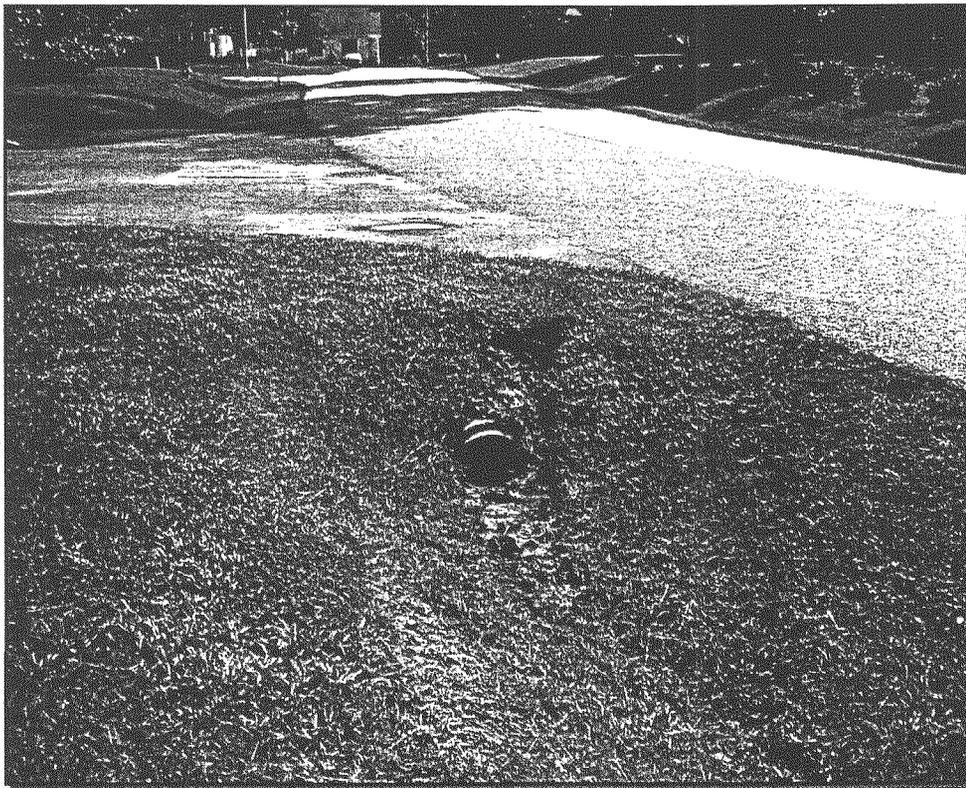
**Photo 16 – Hatton Cross**  
Moderate erosion above cross-culvert can be alleviated by earthwork, reseeding the area and proper

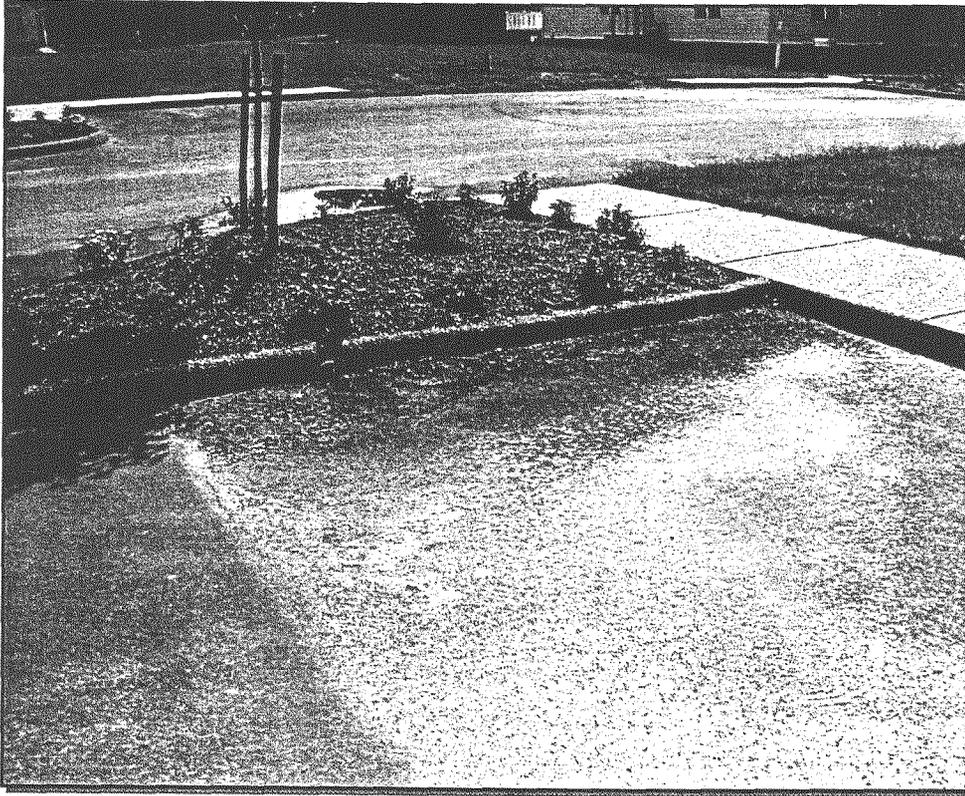
**Photo 17 – Baron’s Court**

Drainage impediment. Note collection of sediment due to inadequate drainage pipe in landscape island.

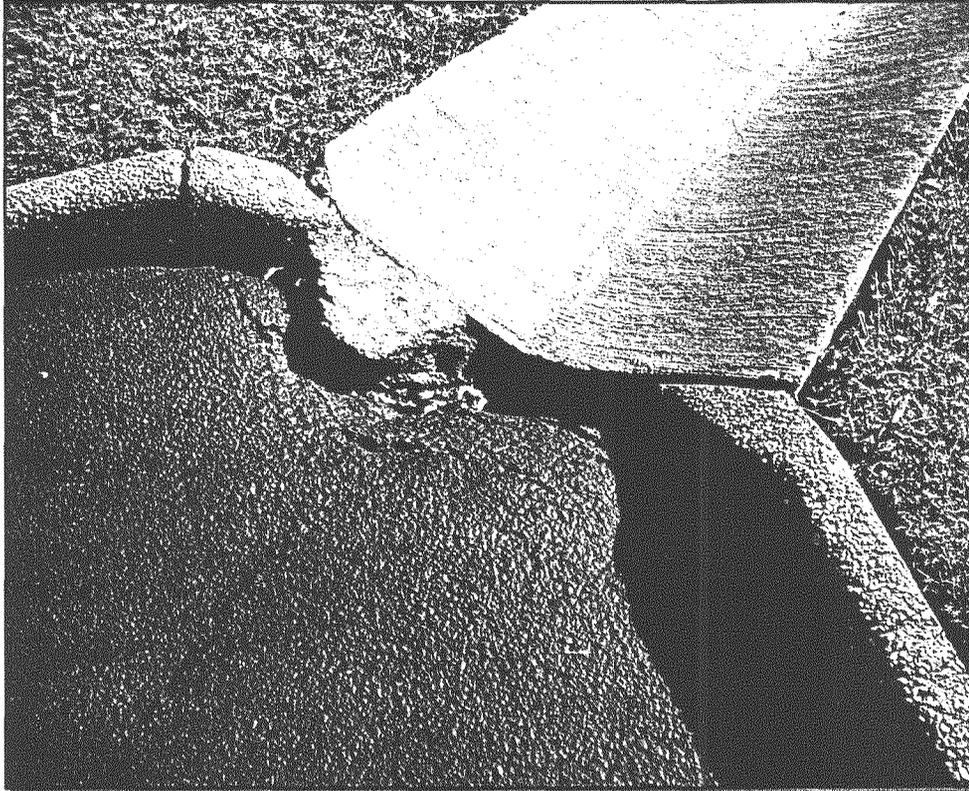
**Photo 19 – Tower Hill**

A pedestrian hazard was noted in the Tower Hill section (see Photo 19), this should be alleviated by a smooth transition of asphalt to the concrete swale. This will prevent the undermining of the drainage way as well.

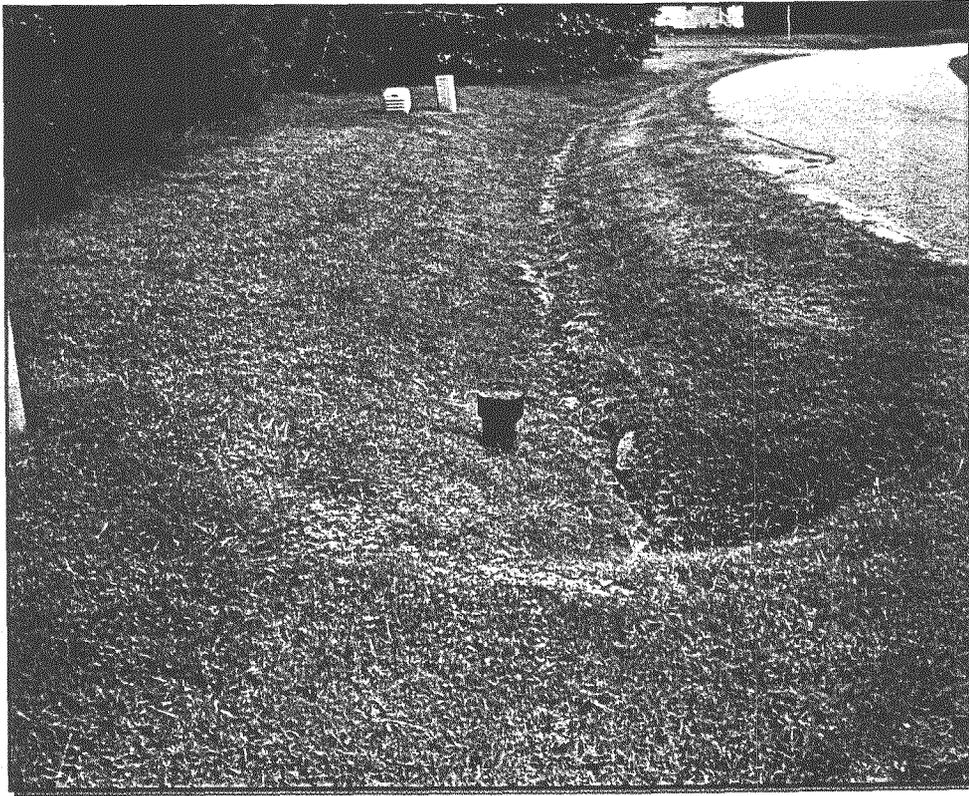
**Photo 20 – Baron’s Court**  
Utility valve box above grade, should be adjusted to be flush with slope.

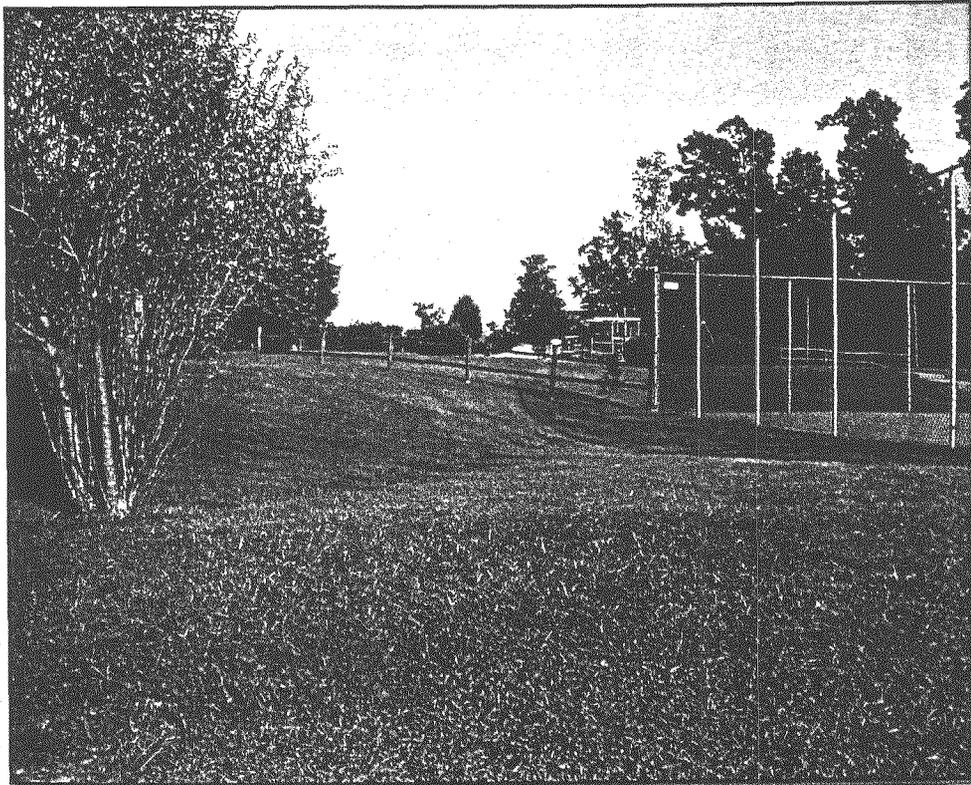
**Photo 21 – Recreation Area**  
Standing water between the tennis courts and pool. Swa should be regraded to provide positive drainage and seeded.

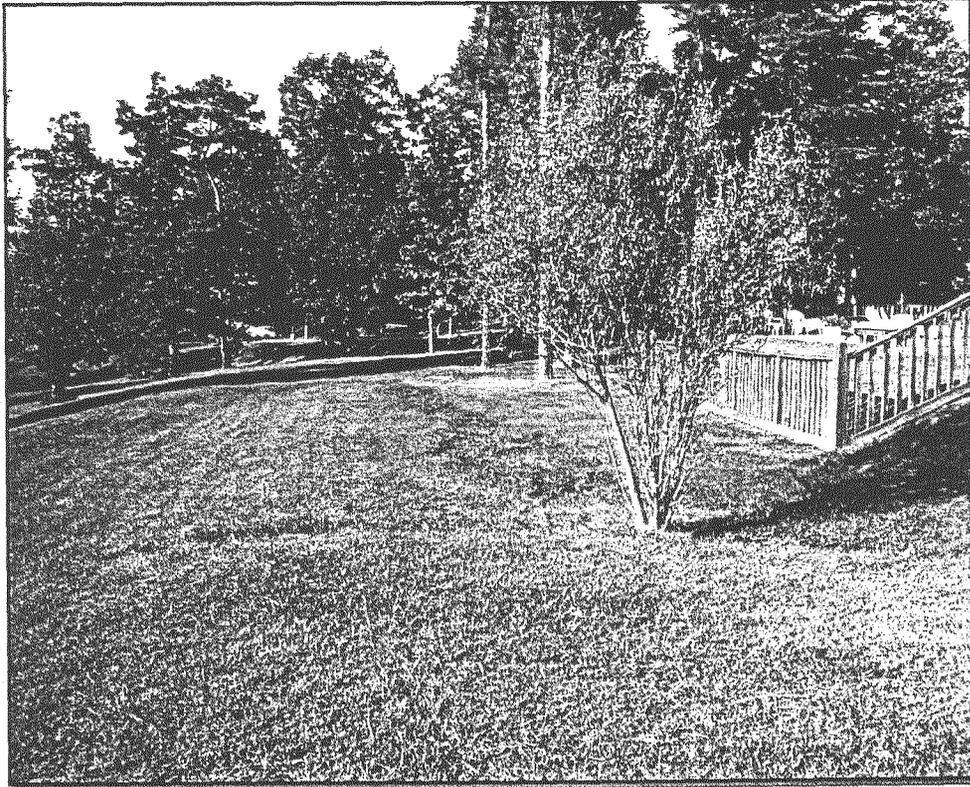
**Photo 22 – Recreation Area**

Another area of concern is located nearby between the pool and the pond. (See Photo 22) This area should also be repaired in a similar manner as the above-mentioned area.

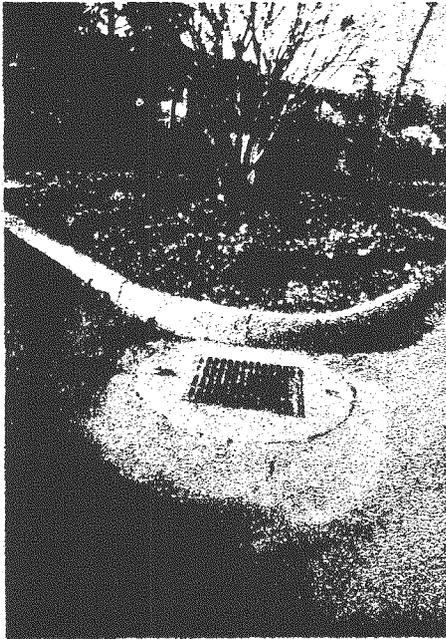
**Photo 5 - Highgate Greer**  
Surrounding asphalt surface slightly lower than deck of storm inlet. Note evidence standing water adjacent to storm water inlet.

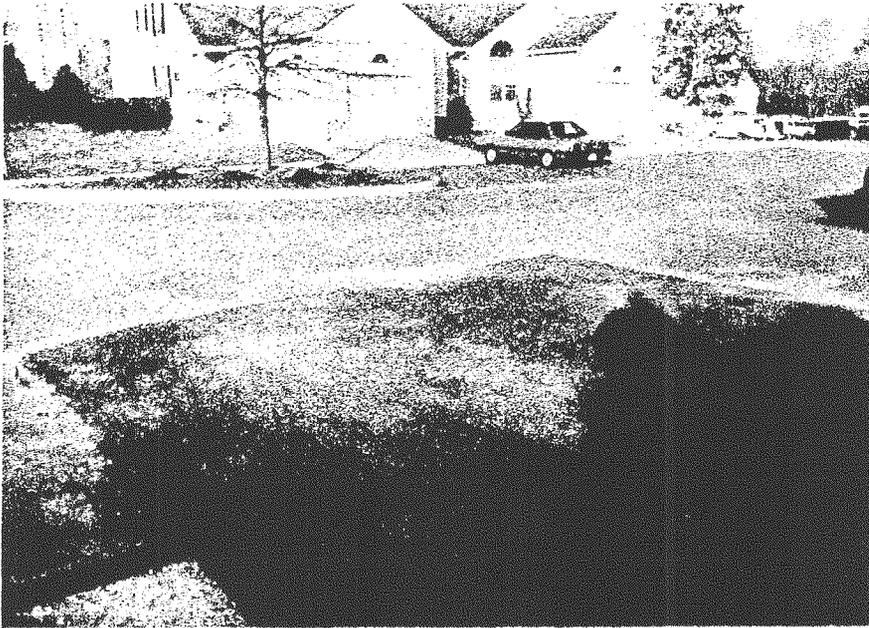
**Photo 3 - Chiswick Park**  
Additional asphalt layer placed to improve surface flow. Utility access cover should be adjusted to be flush with surrounding surface.

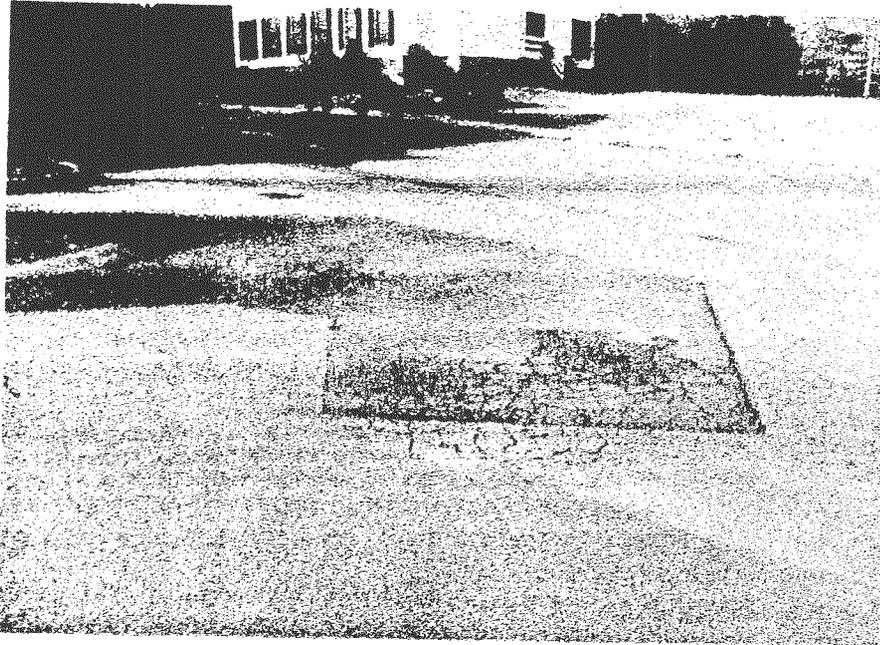
**Photo 1 - Tower Hill**  
Subgrade failure. Note "alligator" texture of asphalt surface. This area has been repaired several times.

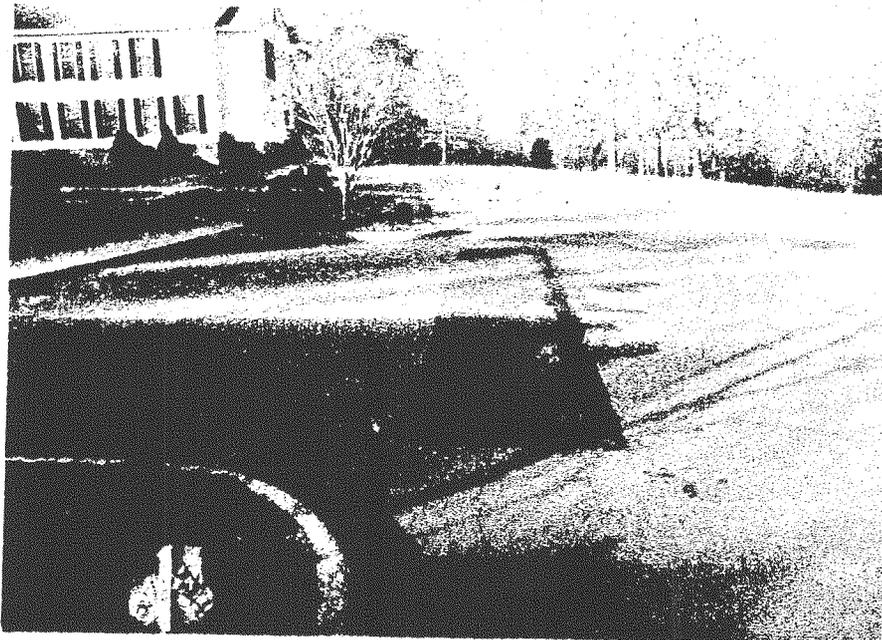
**Photo 2 - Tower Hill**  
Normal surface wear and utility repair. Accumulated underground moisture weeps from joints and cracks.

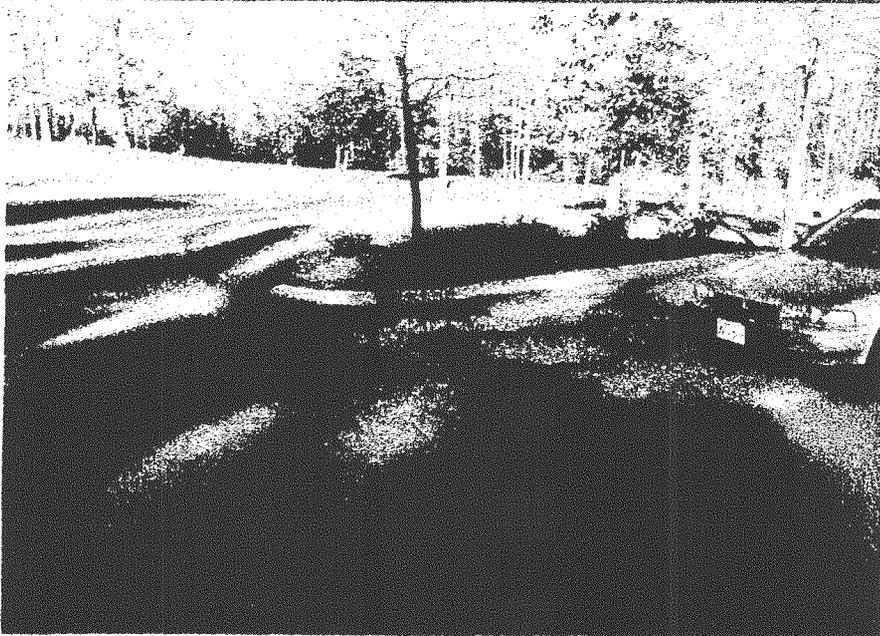
**Photo 7 - Tower Hill**  
Surface flow impeded by high turf at edge of asphalt surface.  
Grassy area should be re-graded to enhance surface flow.

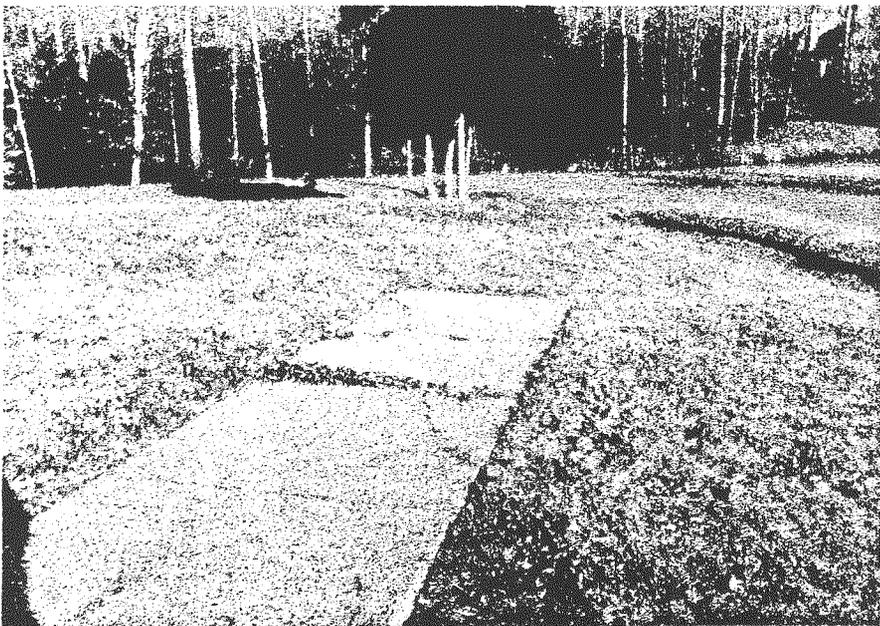
**Photo 8**  
Typical example of broken sidewalk.

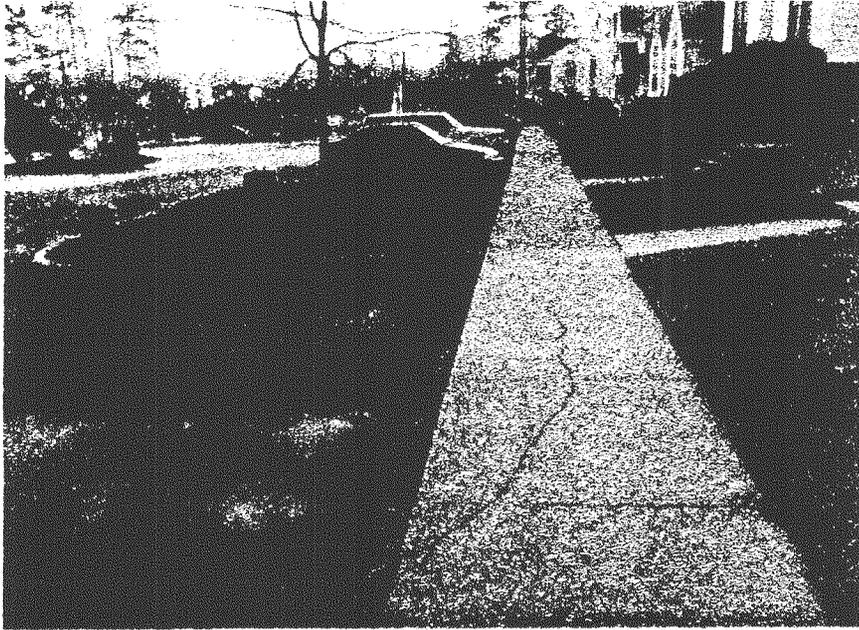
**Photo 9 - Tower Hill**  
Typical example of cracked and broken sidewalks and curbing.

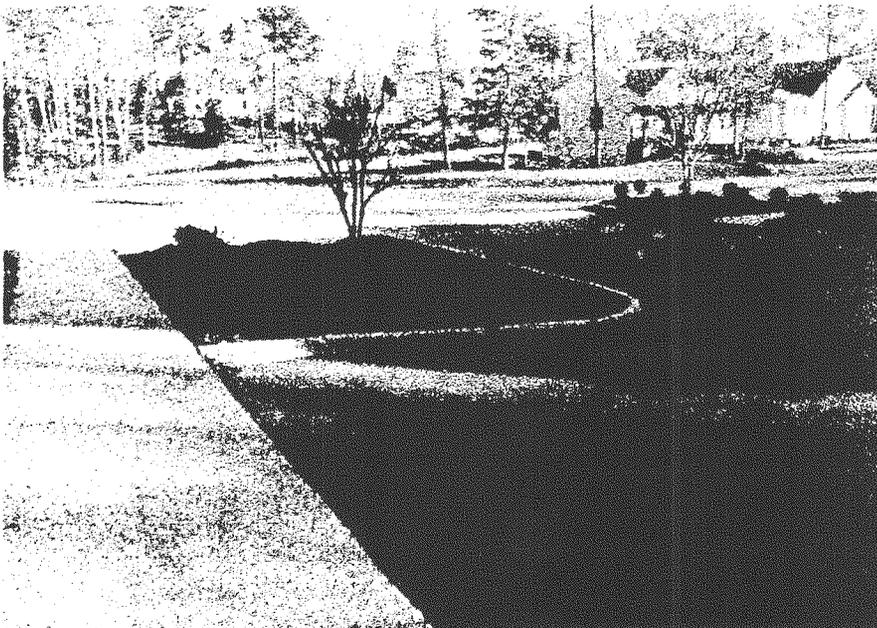
**Photo 10 - Tower Hill**  
Typical example of broken and cracked curbs. Curb is skewed and is recommended for repair.

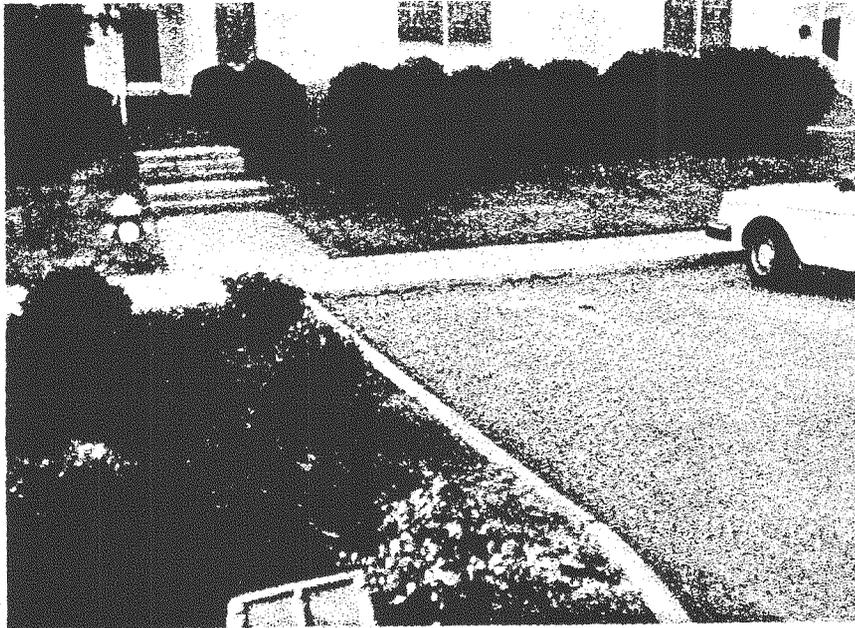
**Photo 11 - Tower Hill**  
Evidence of substandard workmanship. Note voids in concrete at line with asphalt surface.
