**Stormwater Management/BMP Facilities
Record Drawing/Construction Certification
*Review Tracking Form***

County Plan No.: 5-30-97
 Project Name: STONEHOUSE SEC 4A Leather Leaf ~~Basin B~~
 Stormwater Management Facility: BASIN B DRY DET 9815 LEXINGTON LEX
 Phase: I II III

RECORD DRAWING
 OF
BASIN B
SECTION IVA
AT STONEHOUSE

Re: Stonehouse Section 4A Leather Leaf, Basin B
Dry Pond near 9815 Turning Leaf
County BMP ID Code: WC 038

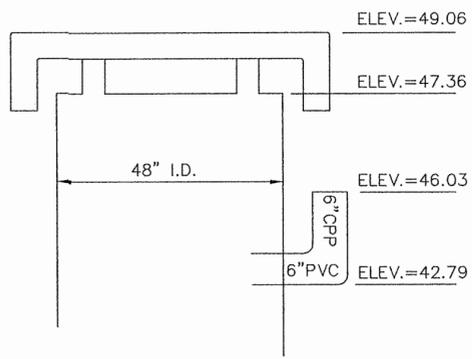
RISER STRUCTURE DETAIL
(N.T.S.)

RISER STRUCTURE
 RIM=49.06
 TOP RISER=47.36 (0-46.90)
 DEWATERING RIM=46.03, INV=42.79 (0-42.5)
 TOP RISER=47.36
 INV IN=38.63 (4\"/>

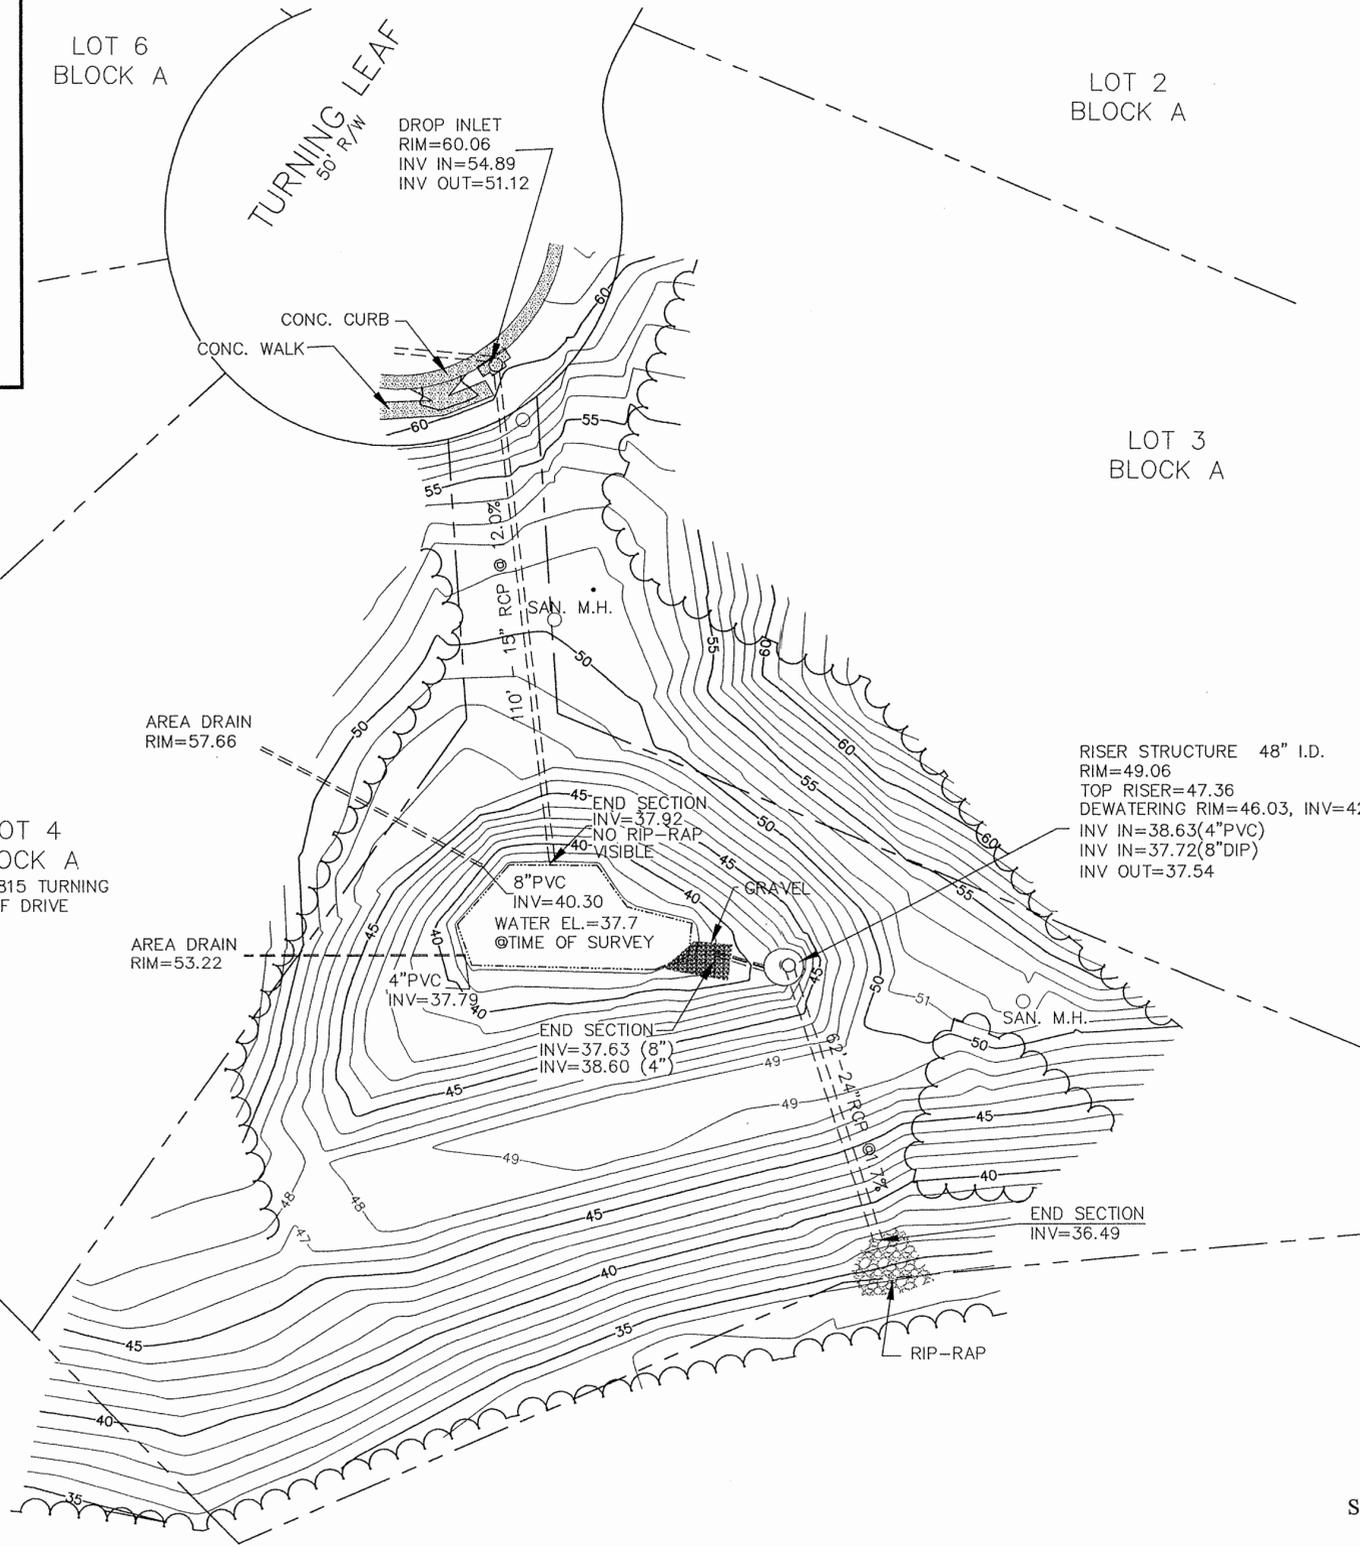
RECORD DRAWING
OF
BASIN B
SECTION IVA
AT STONEHOUSE

Need Spot E/Ls
 Contours
 not right
 TW=12' and 20'

Show the following additional information on the record drawing: size of riser; size of the higher level (dewatering) orifice; crest elevation/dimensions for the emergency spillway; outlet protection at the end of the 15-inch storm drain which inflows to the basin (ie. Structure 1-56); and show the street address on Lot 4 as 9815 Turning Leaf.
