September 5, 2008

**Re: Site Assessment and Conceptual Plan
 Kristiansand Tributary Project, James City County, Virginia
 WEG Project #3935**

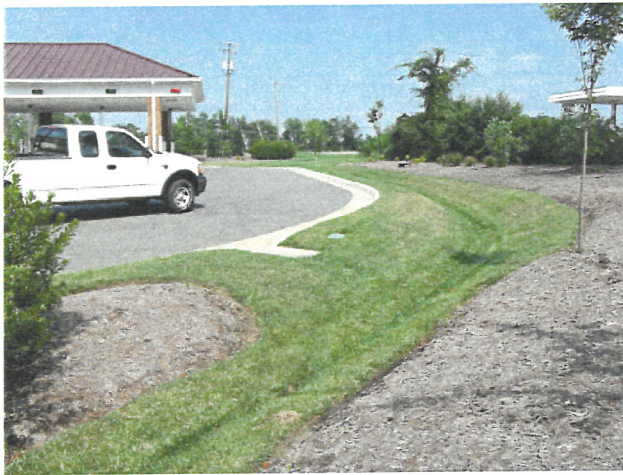
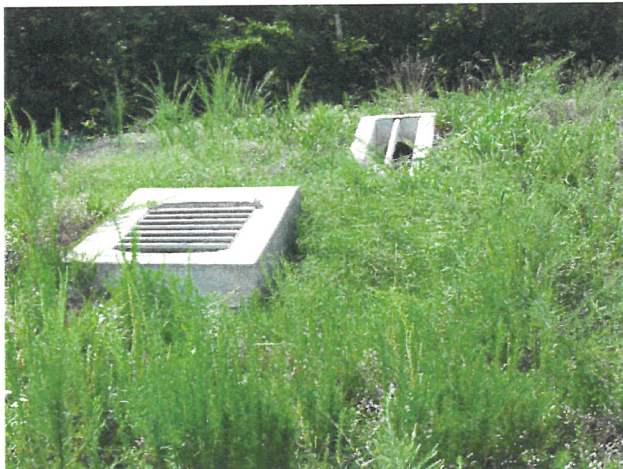
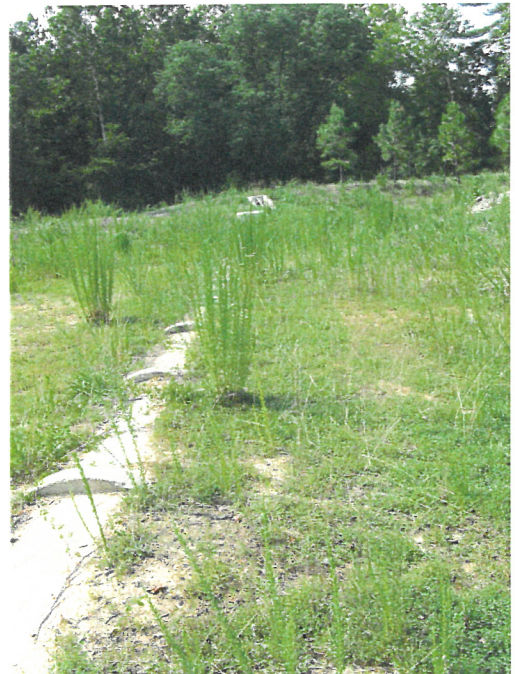
Identifier:	Kristiansand - 9
Location:	Behind BayLands Federal Credit Union west of Rt. 60
<p><u>Existing Conditions:</u></p> <p>Grassed swales convey runoff from bank into detention basin. An existing pipeline is exposed across the facility.</p>	
<p><u>Potential Improvements:</u></p> <p>Improve grassed swales to better promote infiltration. Improvements may include soil amendments and/or installation of check dams. Convert detention basin into a shallow marsh facility. Further review of existing pipeline needed to determine any design implications it may introduce, such as limited wet pool areas.</p>

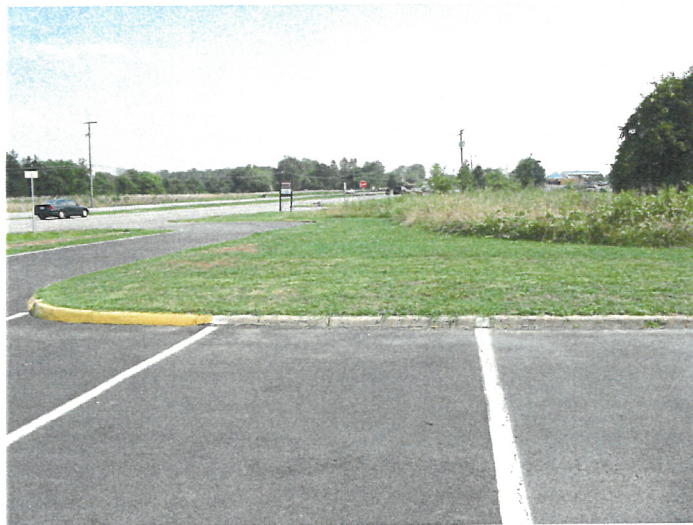
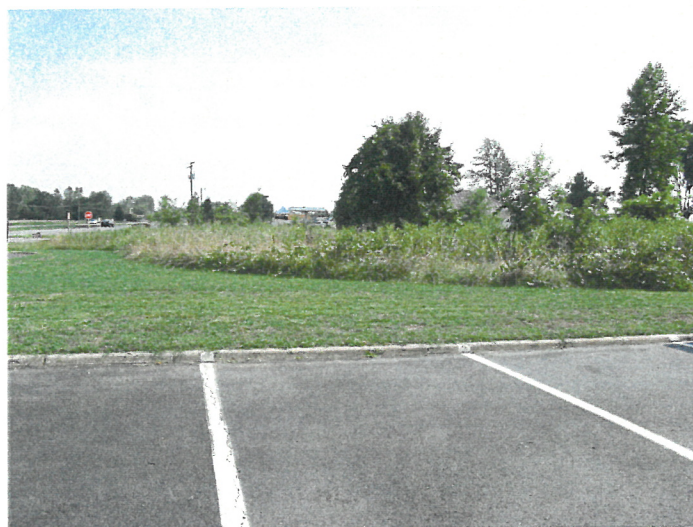
Identifier:	Kristiansand - 11
Location:	Econo Lodge (southeast of parking lot near entrance)
<u>Existing Conditions:</u> Open space adjacent to parking lot. Curb and gutter along parking lot edge.	
<u>Potential Improvements:</u> Install curb cuts and offline bioretention filter within adjacent open area.

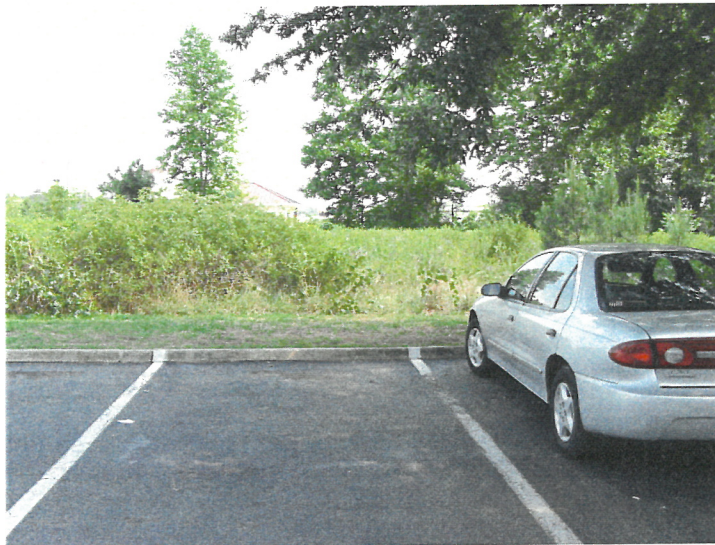
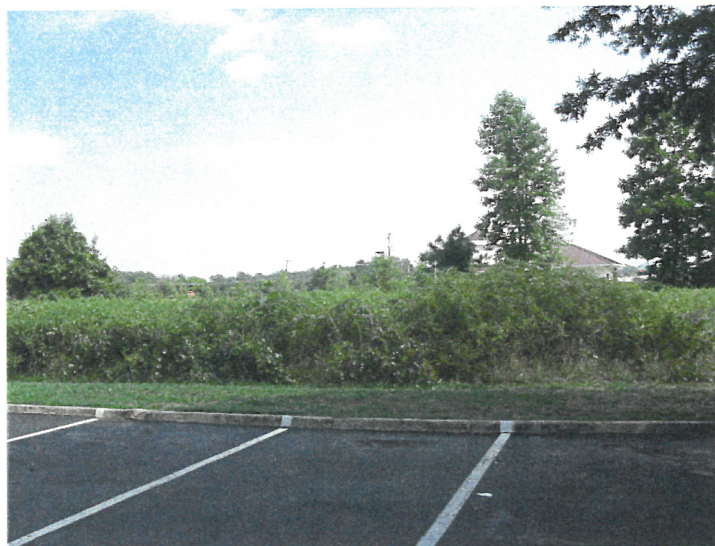
Identifier:	Kristiansand - 12
Location:	Econo Lodge (along southern edge of parking lot)
<u>Existing Conditions:</u>	Open space/brush adjacent to parking lot, curb and gutter along parking lot edge.
<u>Potential Improvements:</u>	Install curb cuts and offline bioretention filter within adjacent open area.

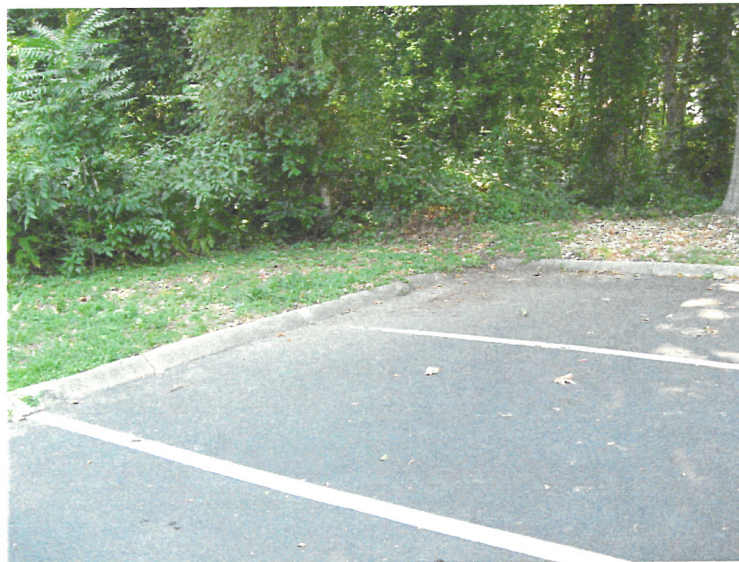
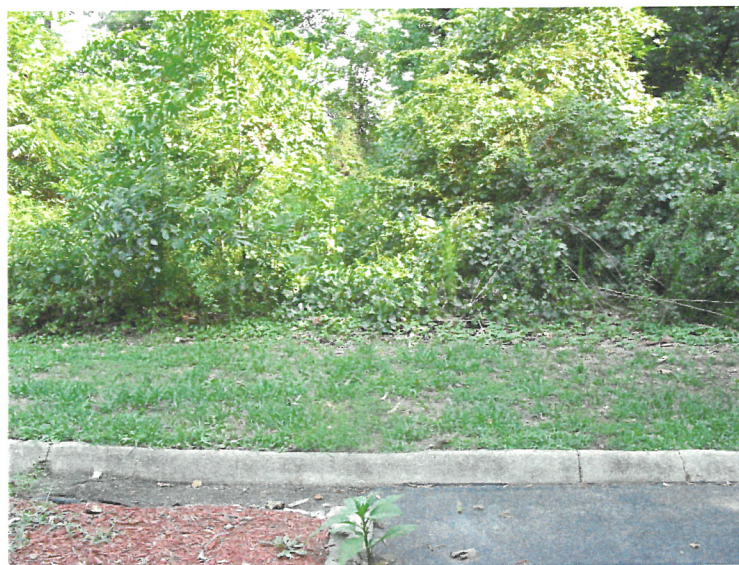
Identifier:	Kristiansand - 13
Location:	Econo Lodge (southwest corner of parking lot near dumpster)
<u>Existing Conditions:</u>	
Open space/brush adjacent to parking lot, curb and gutter along parking lot edge.	
<u>Potential Improvements:</u>	
Install curb cuts and offline bioretention filter within adjacent open area.

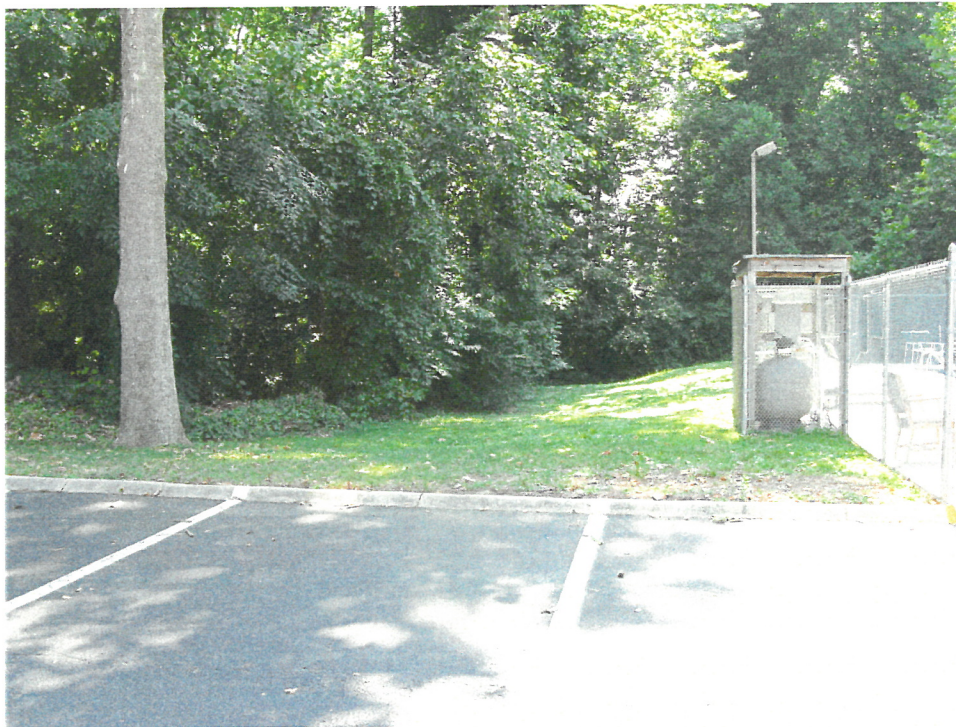
Identifier:	Kristiansand - 14
Location:	Econo Lodge (western edge of parking lot near swimming pool)
<u>Existing Conditions:</u> Open space adjacent to parking lot. Curb and gutter along parking lot edge.	
<u>Potential Improvements:</u> Install curb cuts and offline bioretention filter within adjacent open area.

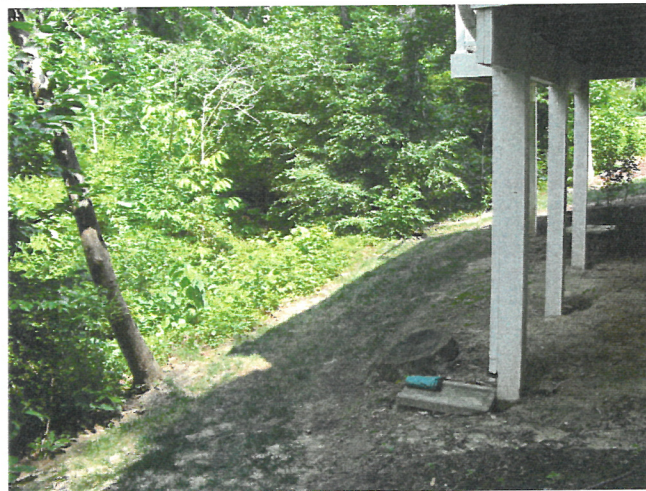
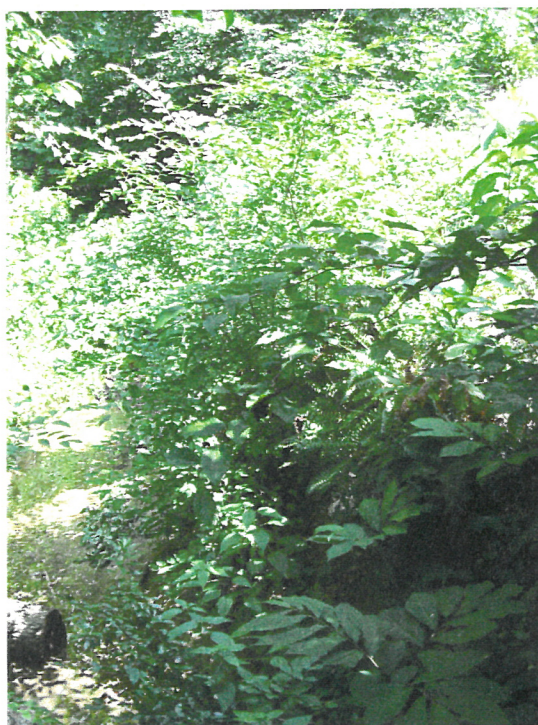
Identifier:	Kristiansand – 15
Location:	Behind lot northeast of Winterberry Drive cul-de-sac
<u>Existing Conditions:</u>	Stream channel close to existing deck, with bank erosion occurring.
<u>Potential Improvements:</u>	Stabilize stream bank along property line, in particular the outside bend at the northeast corner of the parcel.

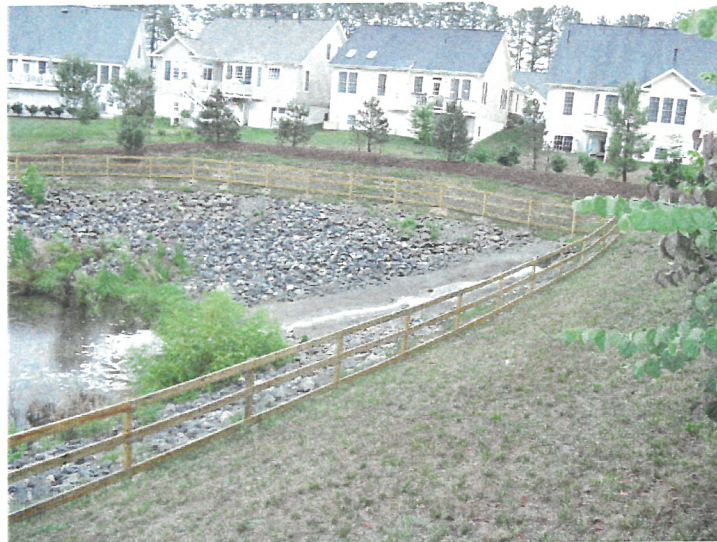
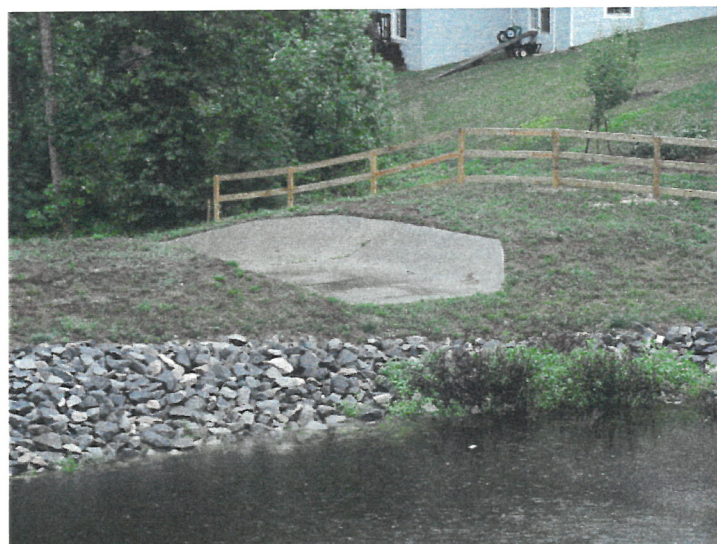
Identifier:	Kristiansand - 16
Location:	At end of Pinebrook Rd, north of Winterberry Ct
<u>Existing Conditions:</u>	Existing retention pond with majority of side slopes lined with riprap.
<u>Potential Improvements:</u>	Replace riprap slopes with natural buffer enhancement and aquatic bench. May also consider extending natural buffer zone beyond perimeter fence rather than maintained turf pending authorization from Colonial Heritage. At a minimum, consider the use of additional joint planting throughout riprap if replacement is not feasible. Further review of outlet structure design may also identify potential optimization for enhanced water quality treatment and/or channel protection.

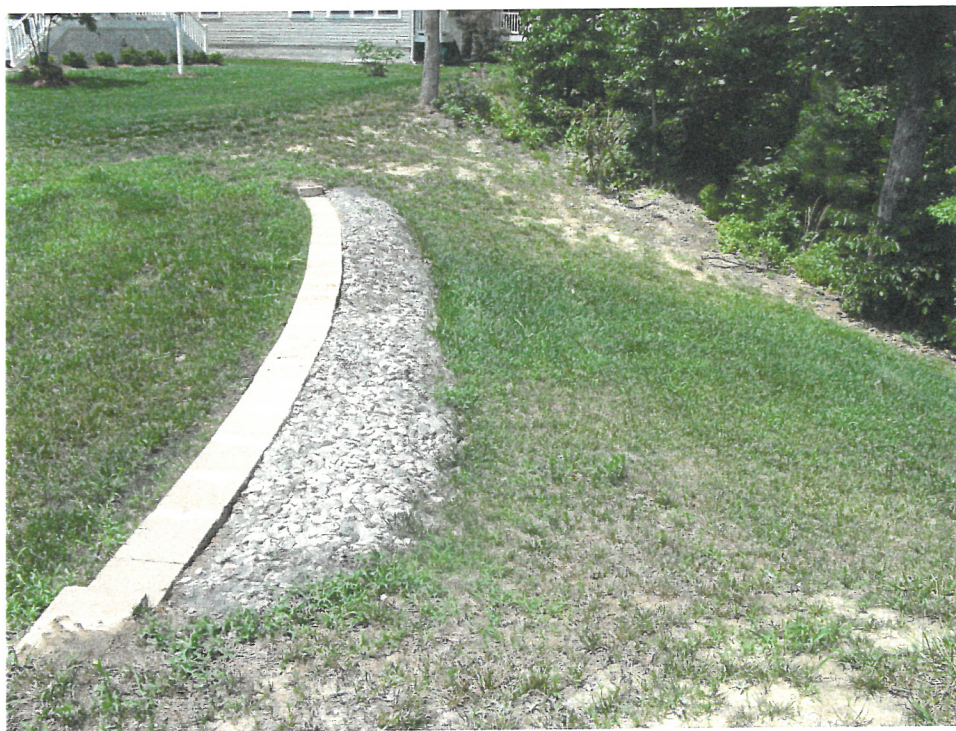
Identifier:	Kristiansand - 17
Location:	Behind houses north of Pinebrook Rd and east of Levingston Ln
<u>Existing Conditions:</u>	
Concrete level spreader and filter strip which appears to be functioning well. Some barren areas near treeline.	
<u>Potential Improvements:</u>	
Install bioretention filter upslope of level spreader. Repair bare spots. Consider the use of natural buffer enhancement downslope rather than just maintained turf.

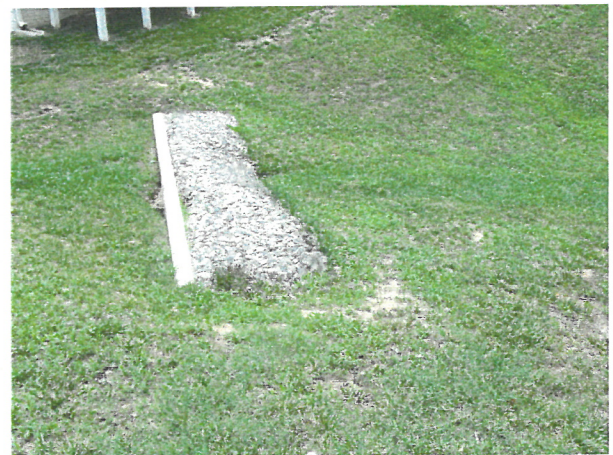
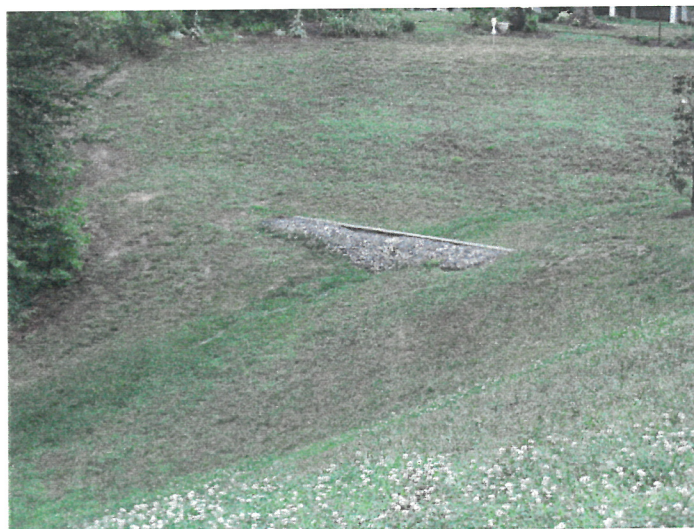
Identifier:	Kristiansand - 18
Location:	North of Pinebrook Rd, between Newport Forest and Livingston Lon
<p><u>Existing Conditions:</u></p> <p>Concrete level spreader and filter strip which appear to be functioning moderately well, but downslope area is relatively steep with some rills forming. May be too steep/channelized for proper function of filter strip.</p>	
<p><u>Potential Improvements:</u></p> <p>Construct bioretention filter upslope of level spreader. Recommend removing level spreader and provide stable conveyance down slope, especially if erosion problems begin to occur. At a minimum, ensure ends of level spreader are fully tied into slopes, repair rills, and consider the use of natural buffer enhancement downslope.</p>

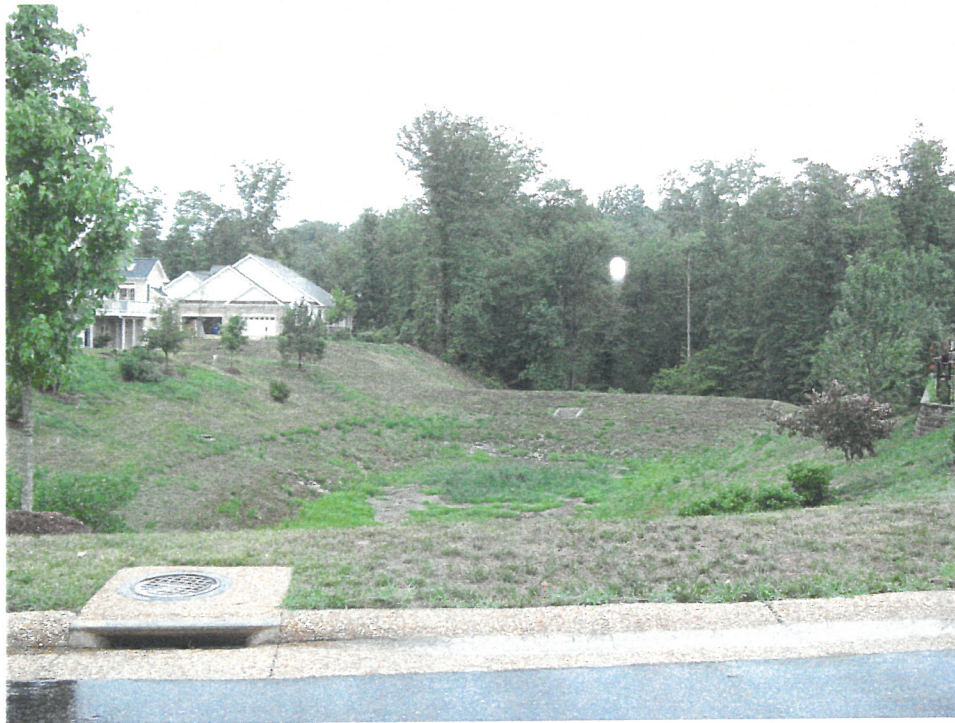
Identifier:	Kristiansand - 19
Location:	West of Pinebrook Rd, between Sandford Arms and Newport Forest
<u>Existing Conditions:</u>	Existing dry detention basin.
<u>Potential Improvements:</u>	Convert basin to an enhanced shallow marsh facility. Provide additional upland buffer plantings around buffer perimeter.

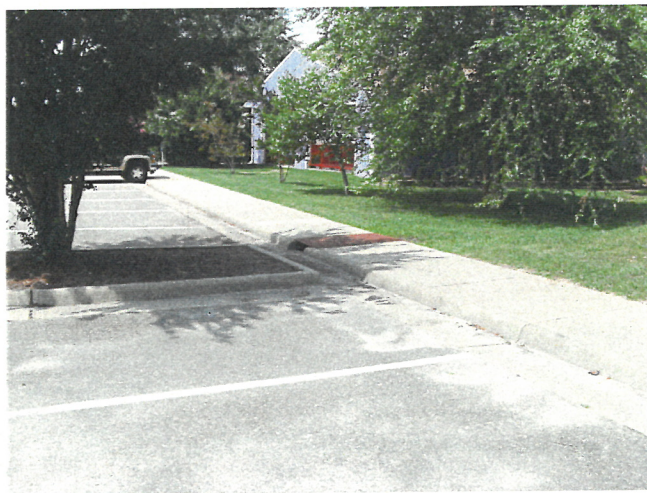
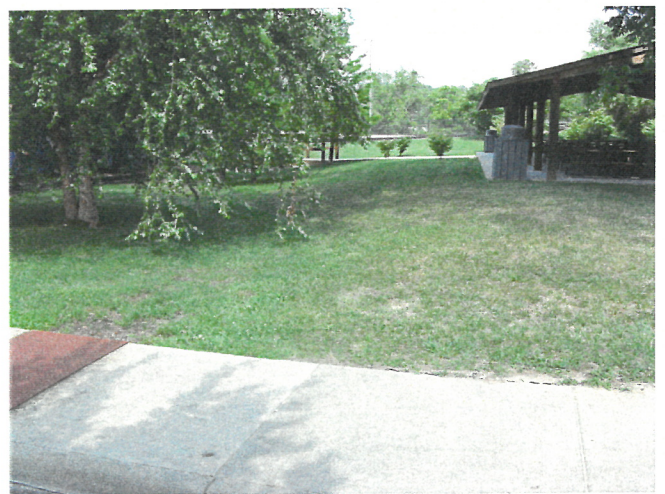
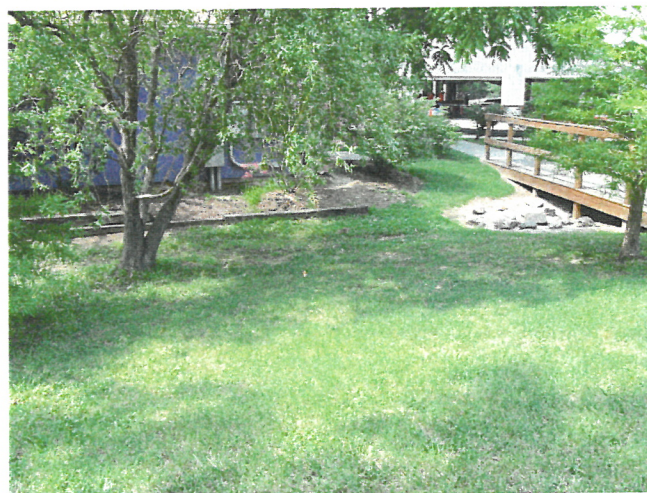
Identifier:	Kristiansand - 1
Location:	Go-Karts Plus (southern end of parking lot)
<u>Existing Conditions:</u>	Existing curb cut from parking lot into grassed swale.
<u>Potential Improvements:</u>	Install bioretention filter or engineered swale. May be difficult to daylight underdrains.

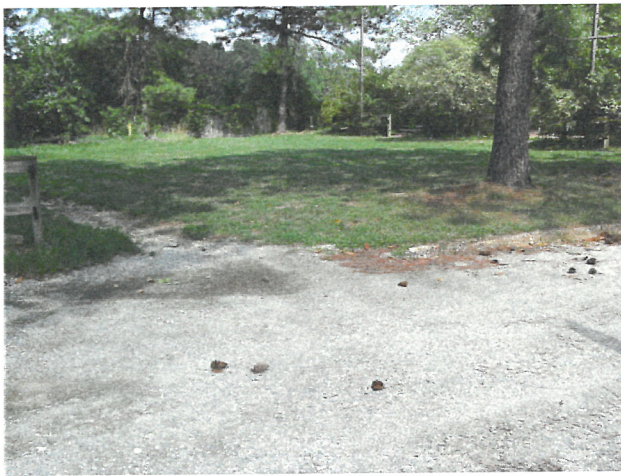
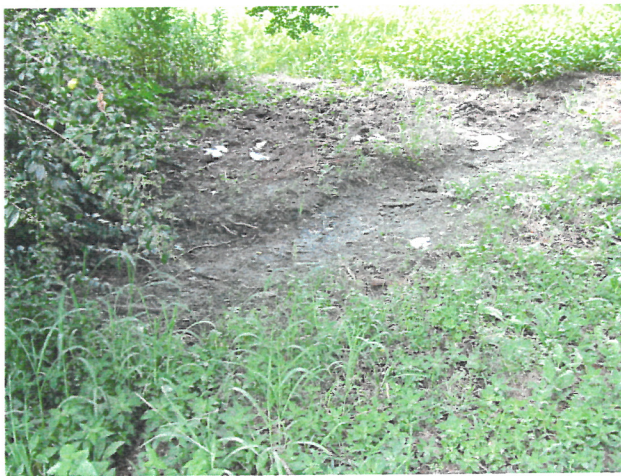
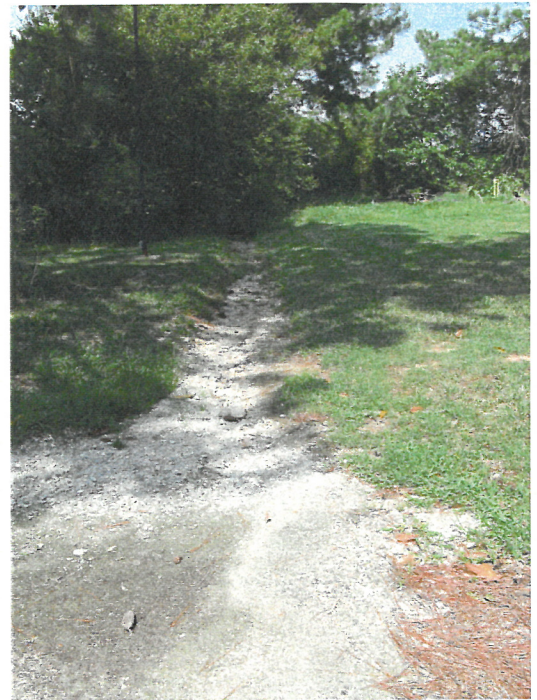
Identifier:	Kristiansand - 2
Location:	Go-Karts Plus (overflow parking to the north)
<u>Existing Conditions:</u>	Runoff from parking lot discharges via gravel channel to low spot near railroad tracks and adjacent field.
<u>Potential Improvements:</u>	Construct infiltration/bioretention basin or shallow marsh facility, pending further soil evaluation at outfall.

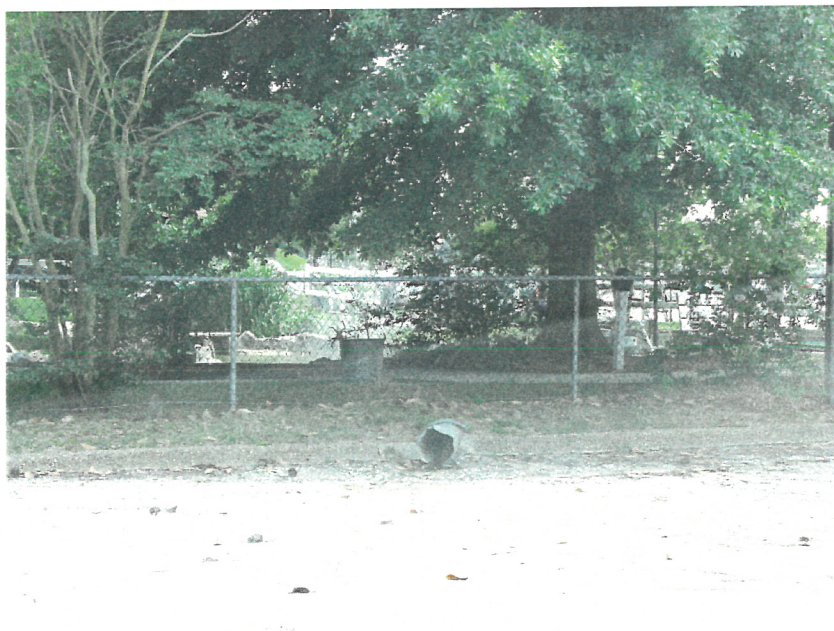
Identifier:	Kristiansand - 3
Location:	Go-Karts Plus
<p><u>Existing Conditions:</u></p> <p>Overflow from water feature discharges to parking lot. Depending on treatment techniques employed, could be a point source pollution problem. Additional review of facility needed to identify other potential point sources such as fuel and vehicle storage areas.</p>	
<p><u>Potential Improvements:</u></p> <p>Modify water feature overflow or treatment techniques to avoid discharge of harmful chemicals downstream to surface waters. Employ spill prevention and/or containment measures at any other hot spots onsite.</p>

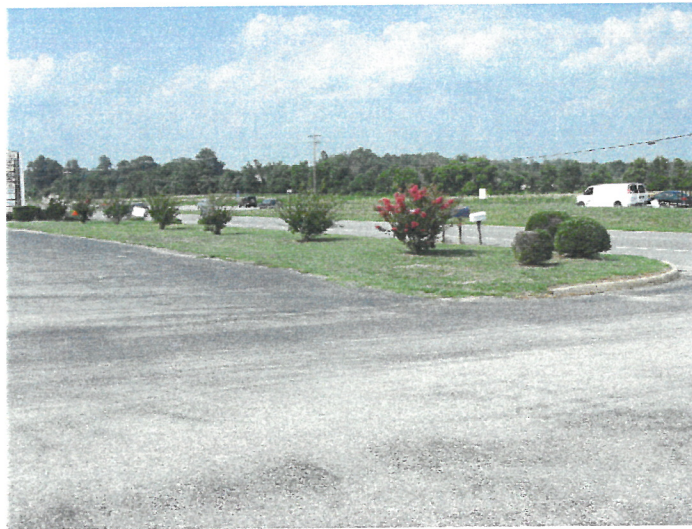
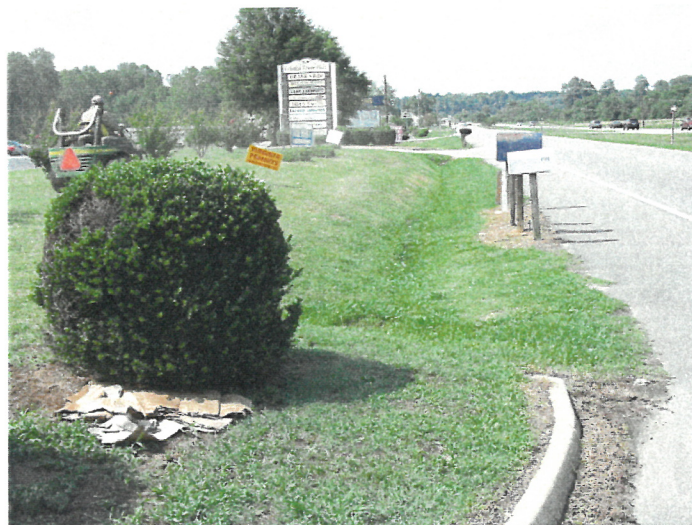
Identifier:	Kristiansand - 5
Location:	Colonial Towne Plaza (southeast of shopping center near Tequila Rose)
<p><u>Existing Conditions:</u></p> <p>Uncontrolled runoff from parking lot draining towards Rt. 60. Some trash present near roadway.</p>	
<p><u>Potential Improvements:</u></p> <p>Construct bioretention filter to treat parking lot runoff immediately north of the entrance near Tequila Rose. Biofilter could be installed within the open space adjacent to the Rt. 60 right-of-way. Removal of excess pavement could be considered to increase biofilter size. Likely, a trench drain will need to be installed across the entrance to capture the parking lot runoff. Underdrains could daylight into Rt. 60 ditch. Remove existing trash.</p>

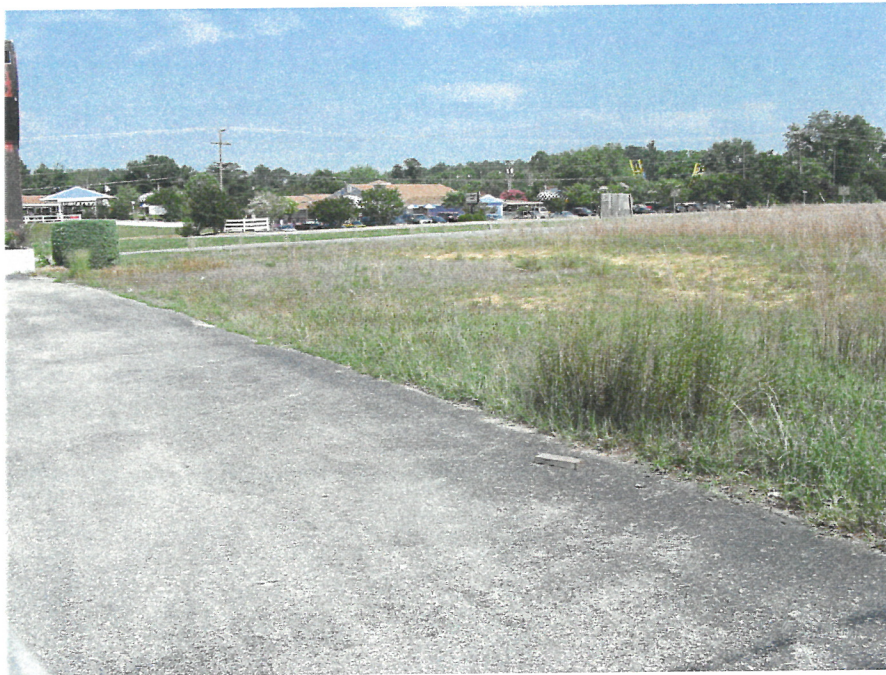
Identifier:	Kristiansand - 6
Location:	Colonial Towne Plaza (southeast of Shopping Center behind Tequila Rose)
<u>Existing Conditions:</u>	Uncontrolled runoff from Tequila Rose draining to adjacent open field. Some bare soil in field.
<u>Potential Improvements:</u>	Treat runoff with bioretention filter or level spreader/filter strip. Stabilize any barren areas with permanent seeding and soil amendments (as needed).

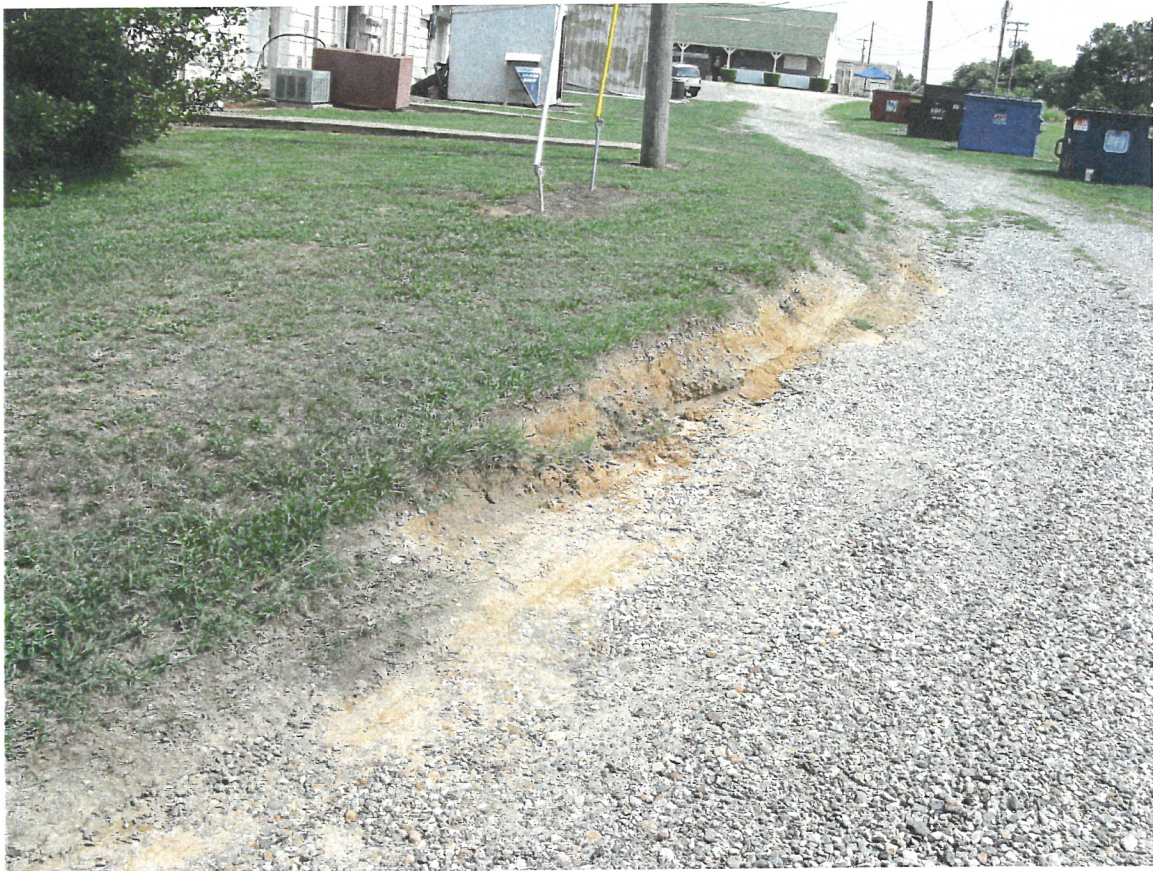
Identifier:	Kristiansand - 7
Location:	Colonial Towne Plaza (northwest of Shopping Center, behind buildings)
<u>Existing Conditions:</u>	Bare soils resulting in noticeable sediment discharge during storm events (as observed on 7/8/08) as surface runoff flows across this area.
<u>Potential Improvements:</u>	Provide sufficient erosion stabilization in barren areas (such as minor grading, soil amendments, and matting). Evaluate the need for a conveyance channel adjacent to the existing gravel access road.

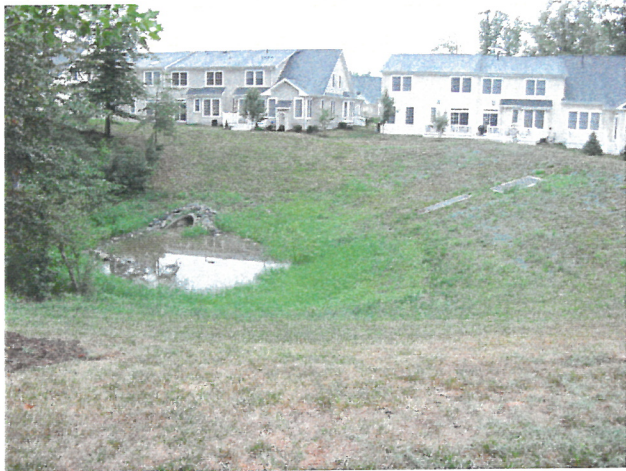
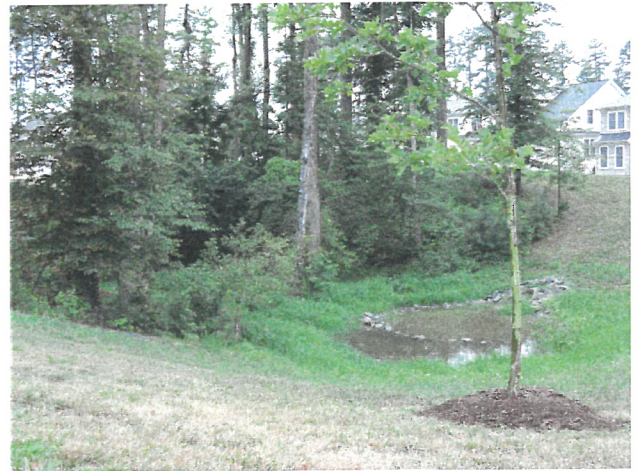
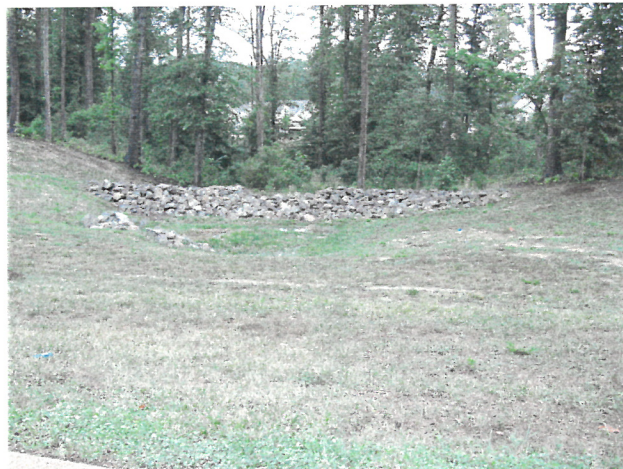
Identifier:	Kristiansand - 20
Location:	Northwest of intersection of Arthur Hills Dr and Pinebrook Rd
<u>Existing Conditions:</u>	Existing detention basin with forebay near intersection and preserved wooded buffer within basin interior.
<u>Potential Improvements:</u>	Enhance the cleared portions of basin (including forebay) with shallow marsh plantings and/or micro-pools. Avoid disturbance of mature trees during retrofit activities.

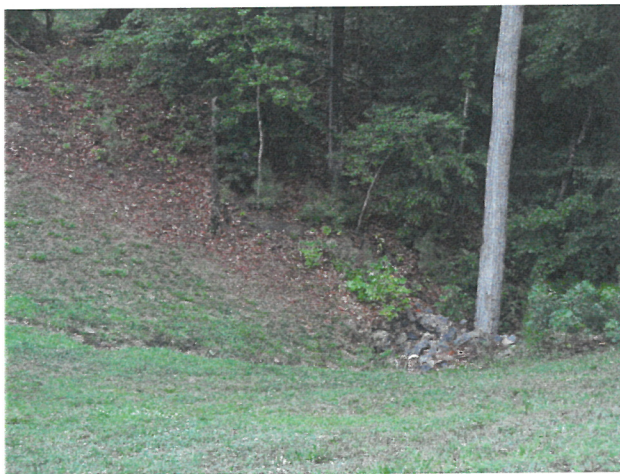
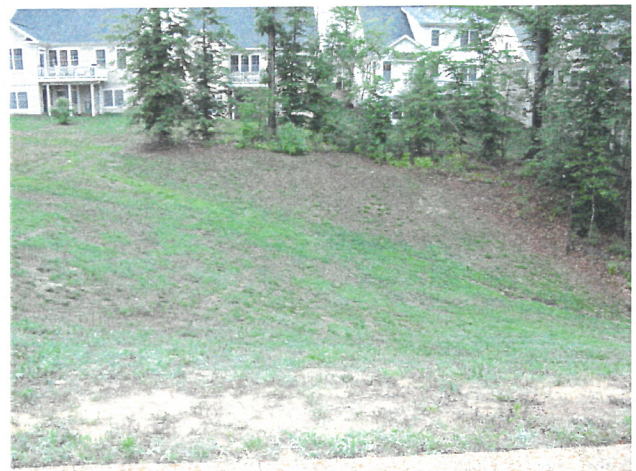
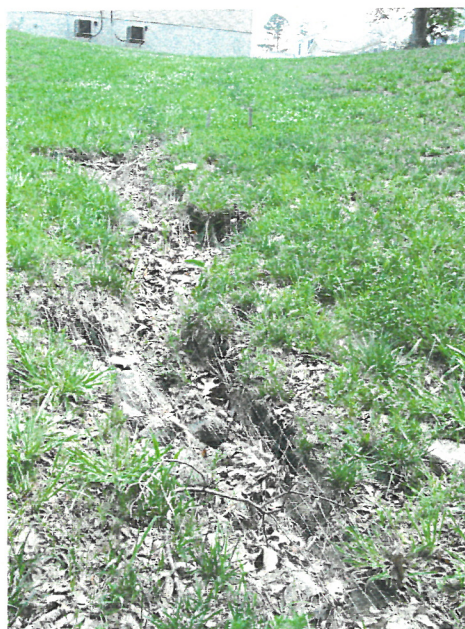
Identifier:	Kristiansand - 21
Location:	West of Sprucemont
<p><u>Existing Conditions:</u></p> <p>Overland flow down grassed slope to riprap check dam at transition to stream. Erosion occurring along slope and at interfaces of riprap berm.</p>	
<p><u>Potential Improvements:</u></p> <p>Repair erosion and provide a stabilized flow path down slope. May also be potential to construct biofiltration filter or shallow marsh basin pending further soil review.</p>

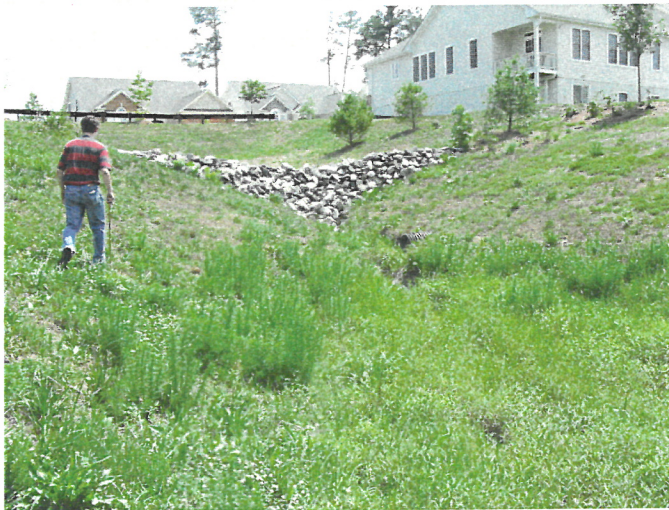
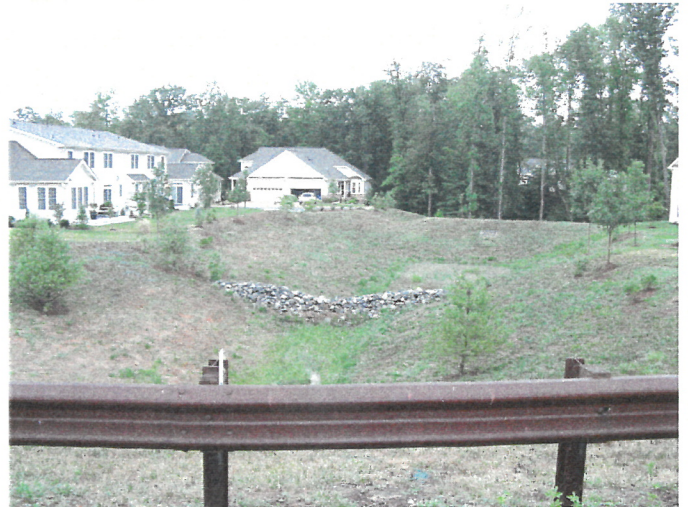
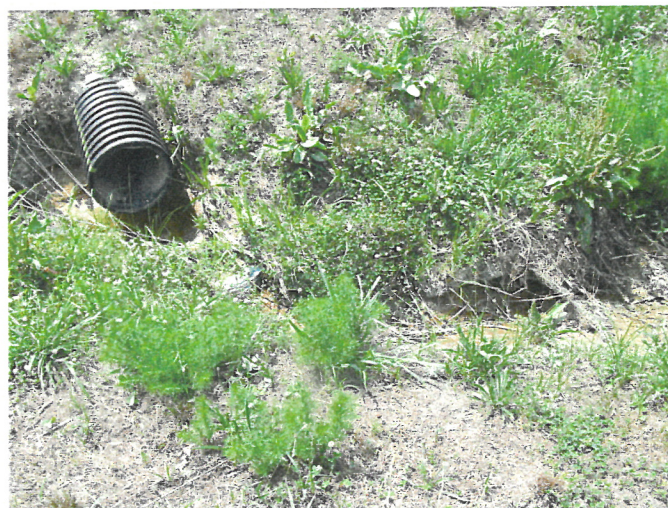
Identifier:	Kristiansand - 22
Location:	North of Arthur Hills Dr, between St Albans and Garden View
<u>Existing Conditions:</u>	Existing dry detention basin, with forebay separated by riprap berm. Some erosion present on bottom of basin.
<u>Potential Improvements:</u>	Maximize the basin area and convert to a wet pond or an enhanced shallow marsh facility. Provide additional upland buffer plantings around basin perimeter. At a minimum, repair erosion areas and construct a more stable pilot channel.

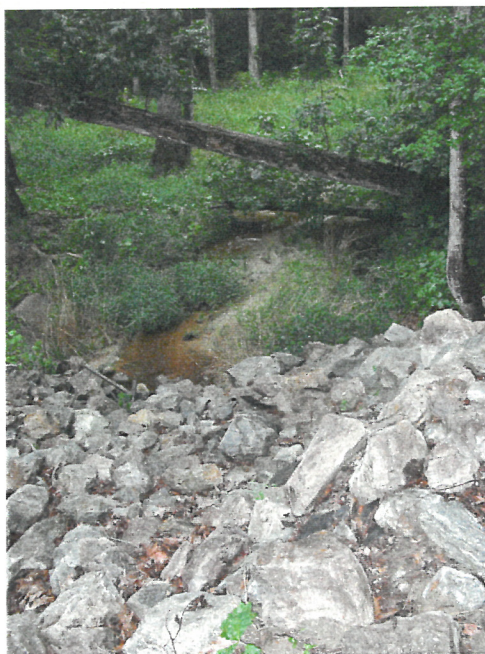
Identifier:	Kristiansand - 23
Location:	North of Valley Green
<u>Existing Conditions:</u>	
Riprap apron at storm sewer outfall. Appears to be stable.	
<u>Potential Improvements:</u>	
Construct small stormwater basin (such as a shallow marsh) within apron area for improved water quality treatment.

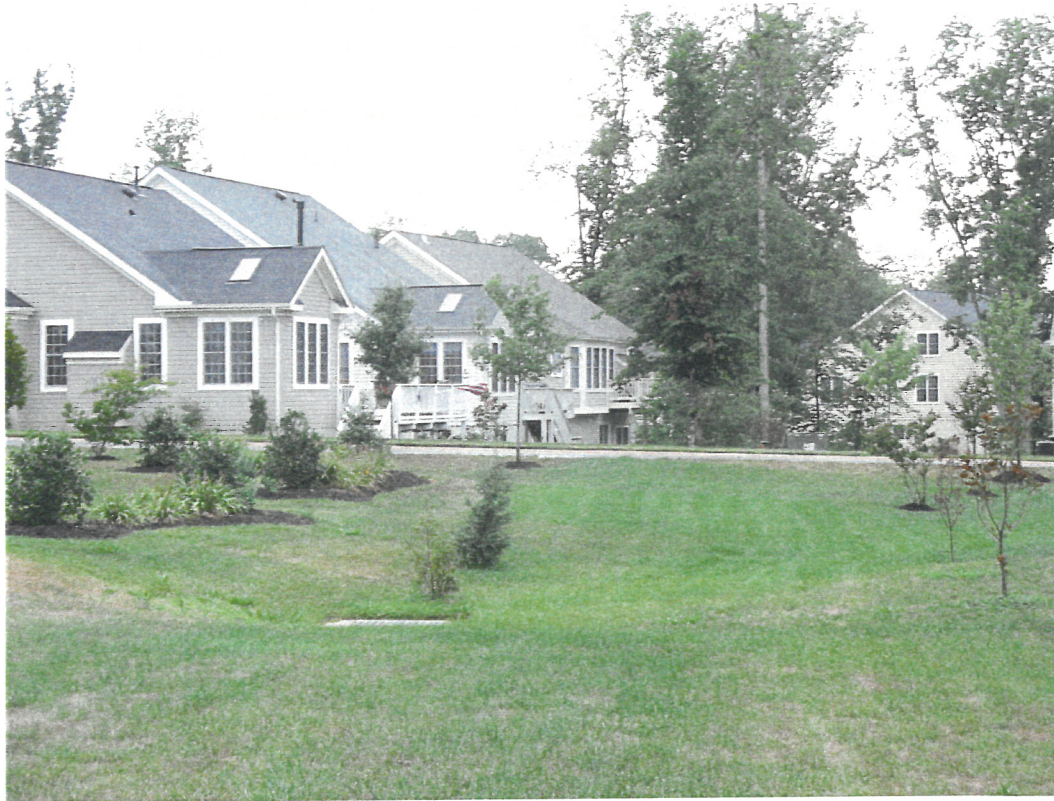
Identifier:	Kristiansand – 24
Location:	North of Arthur Hills Dr, between Cliffside Drive and St. Albans
<u>Existing Conditions:</u>	Existing drop inlet receiving residential drainage in between multiple lots.
<u>Potential Improvements:</u>	Construct bioretention filter around existing drop inlet.

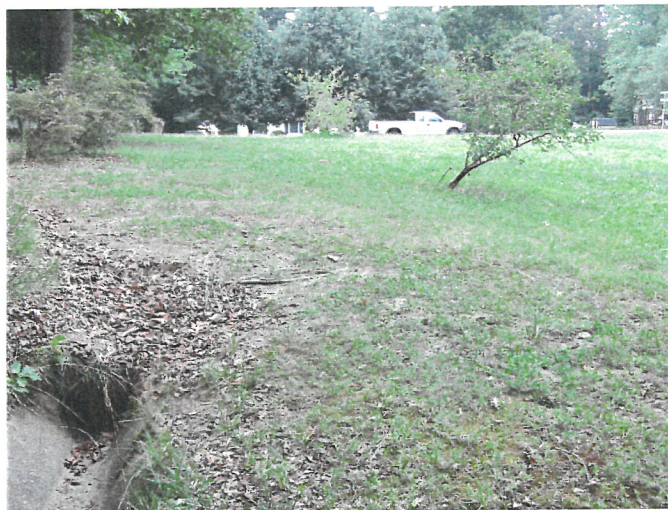
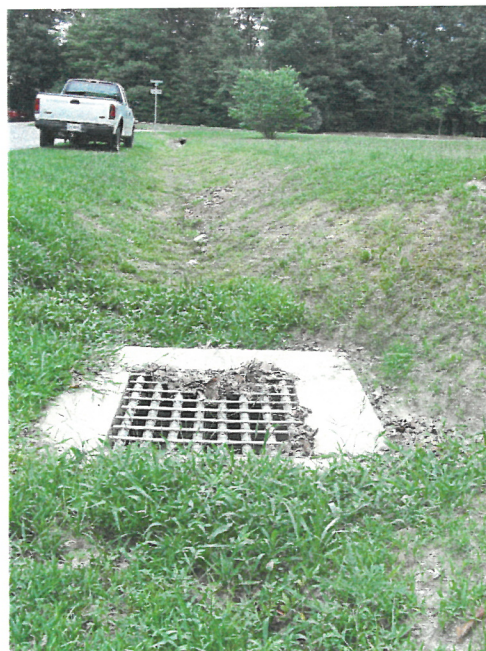
Identifier:	Kristiansand - 26
Location:	South of Nina Lane, between Drammon Ct and Sandstad Ct
<p><u>Existing Conditions:</u></p> <p>Drop inlet conveying roadside drainage to concrete channel between the existing residences.</p>	
<p><u>Potential Improvements:</u></p> <p>Install a bioretention filter in the location of the drop inlet which may require a moderate amount of earthwork to construct, but there is ample space. Coordination with the homeowner will be critical.</p>

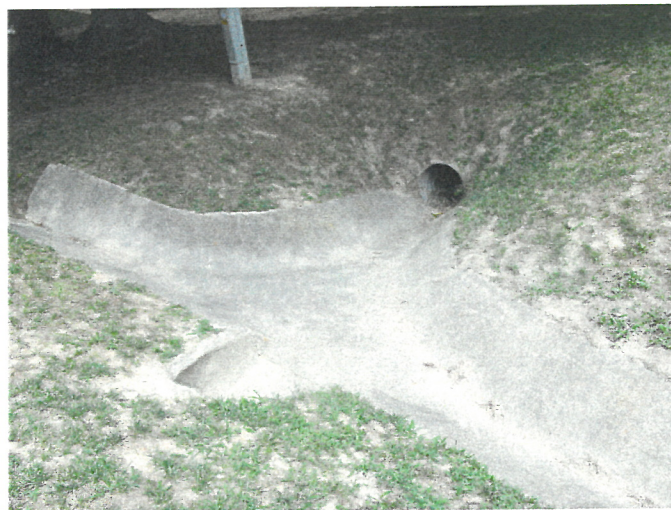
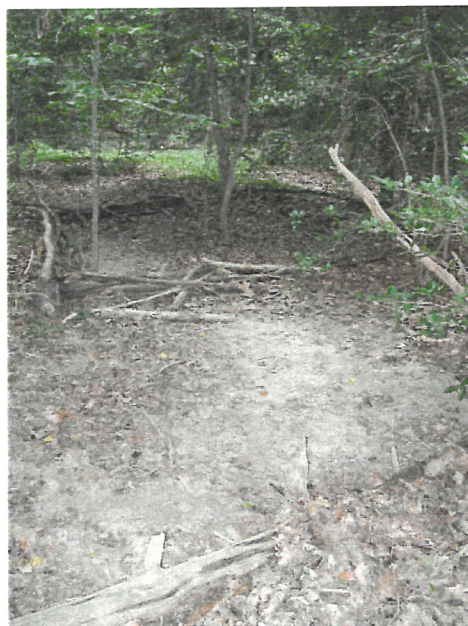
Identifier:	Kristiansand - 29
Location:	South of Nina Lane, between Kroken Court and Haradd Lane
<u>Existing Conditions:</u>	
<p>A culvert outfall from the roadside ditch to an open space parcel behind the existing residences. The precise outfall location could not be determined and may be buried beneath yard waste. Ultimately, the runoff is conveyed into a shallow swale through the existing woods.</p>	
<u>Potential Improvements:</u>	
<p>Remove any debris blocking culvert outfall and provide adequate outlet protection and/or transition channel. Potential for installation of BMP within the open space parcel, such as a shallow marsh or infiltration/bioretention basin pending further review.</p>

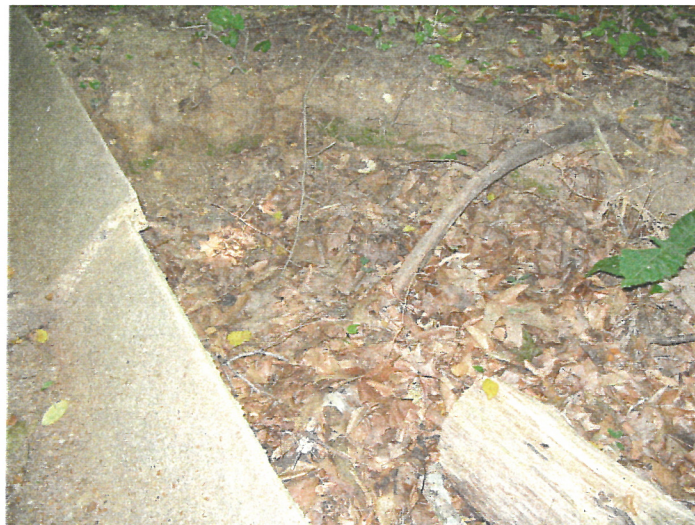
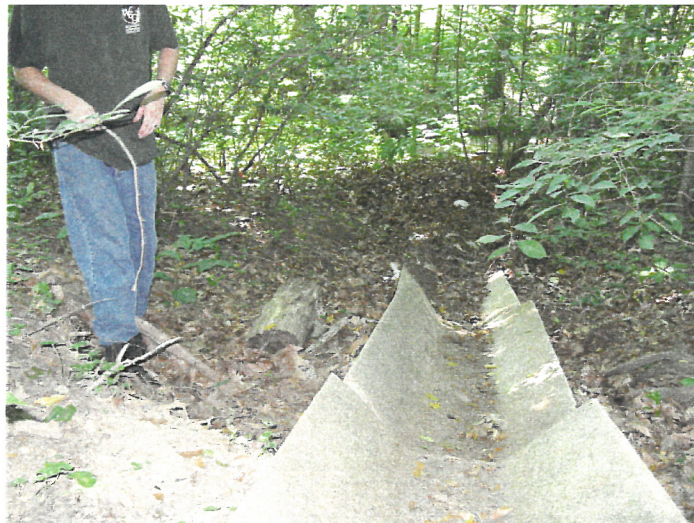
Identifier:	Kristiansand - 30
Location:	Stravenger Ct Cul-de-sac
<u>Existing Conditions:</u> Existing concrete channel conveying stormwater from roadway to stream. Segments at the channel are damaged and undermined by scour along sides.	
<u>Potential Improvements:</u> Repair damaged segments of channel. Fill back in scour holes and stabilize. Modify outfall and/or provide outlet protection as needed to ensure stable transition to stream channel.

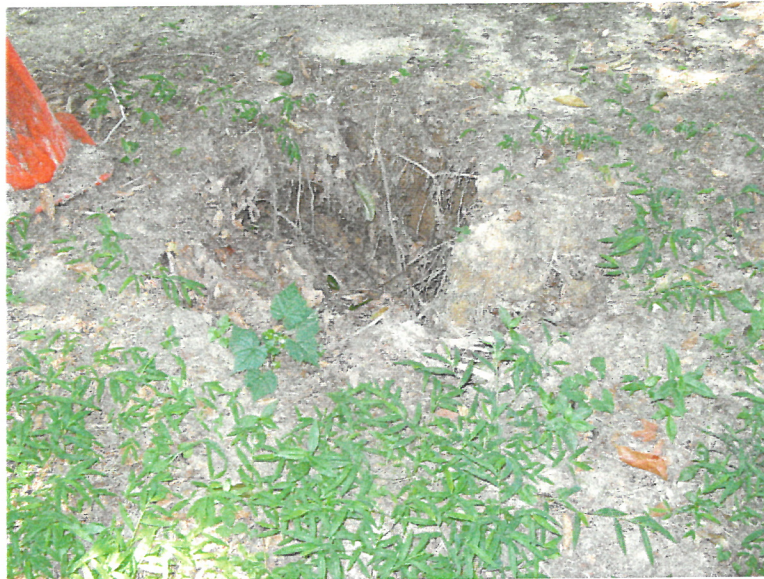
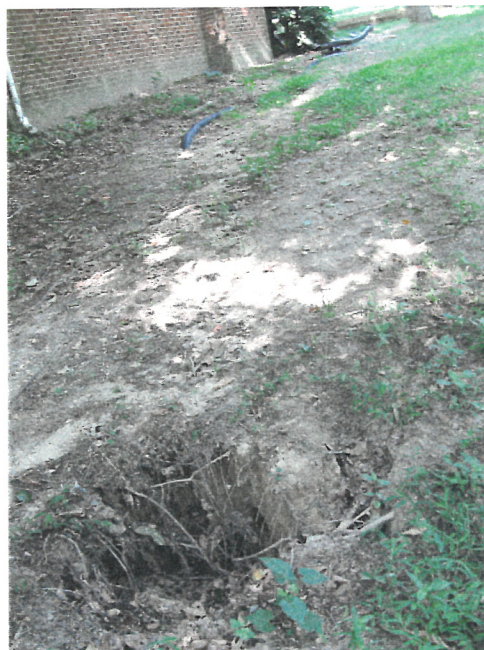
Identifier:	Kristiansand - 31
Location:	West of Haradd Lane before cul-de-sac
<u>Existing Conditions:</u>	Erosion noted at outfall of roof downspouts.
<u>Potential Improvements:</u>	Repair/stabilize erosion areas and ensure surface drainage is conveyed down the slope in a stabilized manner (such as slope drains, conveyance channels, or rock chutes).
