September 5, 2008

**Re: Site Assessment and Conceptual Plan
 Kristiansand Tributary Project, James City County, Virginia
 WEG Project #3935**

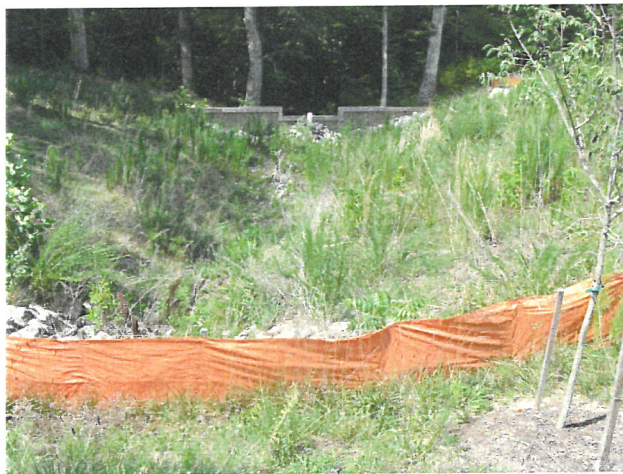
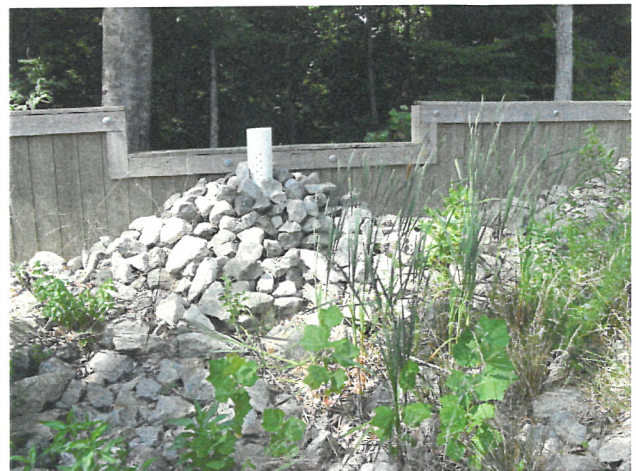
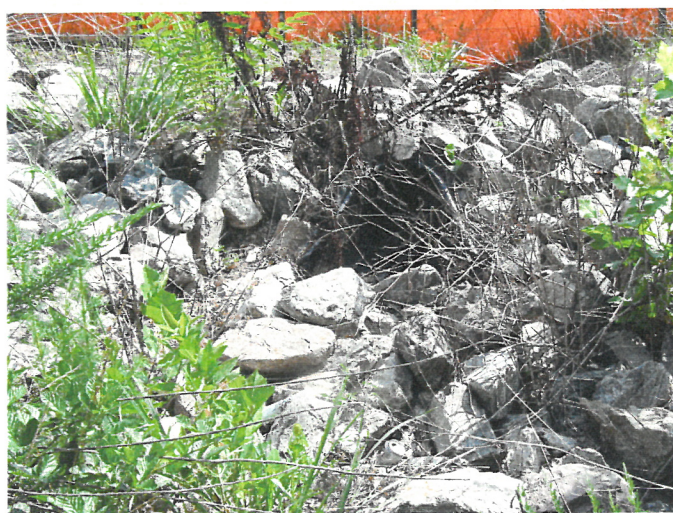
Identifier:	Kristiansand - 34
Location:	Southern edge of Williamsburg Village
<u>Existing Conditions:</u> Dry detention basin with timber weir wall and perforated pipe outlet.	
<u>Potential Improvements:</u> Convert to an infiltration/bioretention basin or shallow marsh facility pending further soil evaluation. Ensure ends of weir wall are fully tied into slopes.

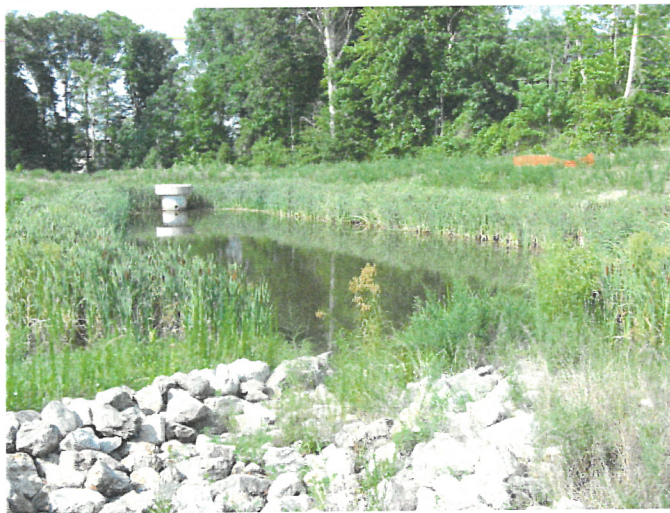
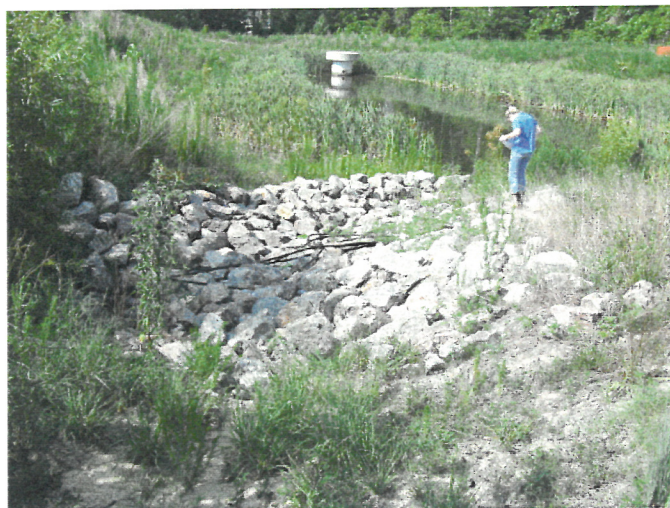
Identifier:	Kristiansand - 35
Location:	Between Williamsburg Village and Williamsburg Dodge
<p><u>Existing Conditions:</u></p> <p>Existing wet pond and wetland fringe. Low flow orifice does not have a debris rack, but currently not clogged. Large areas of riprap at inflow points. Some barren areas in uplands.</p>	
<p><u>Potential Improvements:</u></p> <p>Install debris rack over low flow orifice. Provide soil amendments and permanent seeding in any barren areas. Provide joint plantings within riprap areas, where appropriate, or replace with vegetated buffer. Evaluate the potential to expand the pond size (may be some room adjacent to parking lot of Williamsburg Dodge) and/or adjust outlet structure to treat other contributing areas than initially designed for. Should also consider installing submerged gabion wall across inflow points to create sediment forebays.</p>

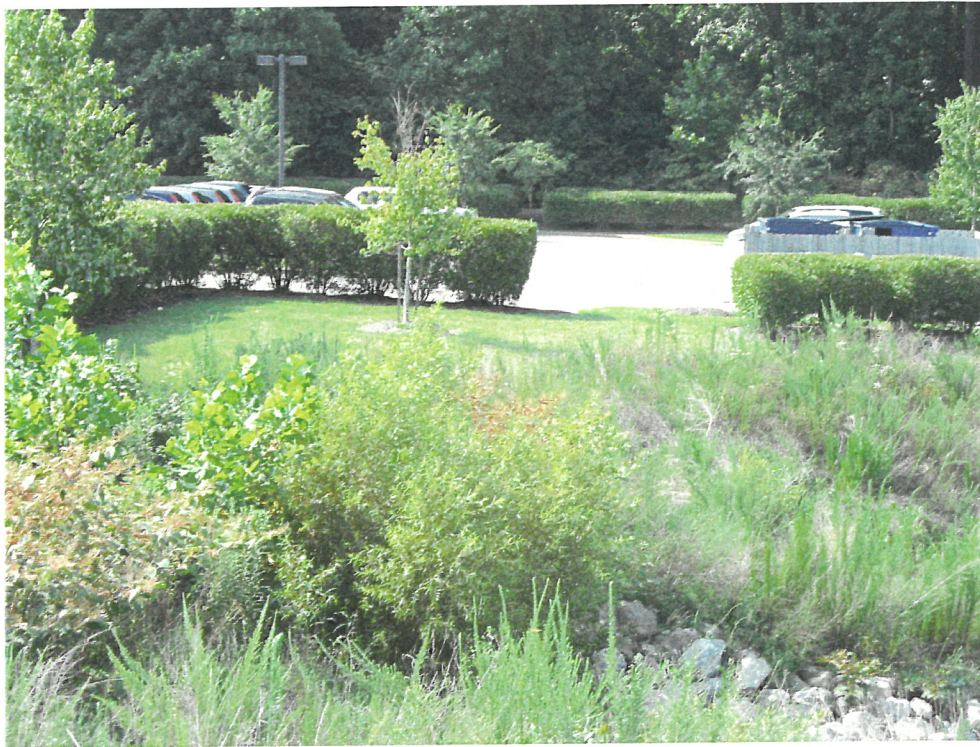
Identifier:	Kristiansand - 36
Location:	Parking lot in rear of Williamsburg Dodge
<u>Existing Conditions:</u>	Open area adjacent to parking lot near existing curb inlet.
<u>Potential Improvements:</u>	Construct curb cuts and offline bioretention filter or infiltration trench between parking lot and existing pond.

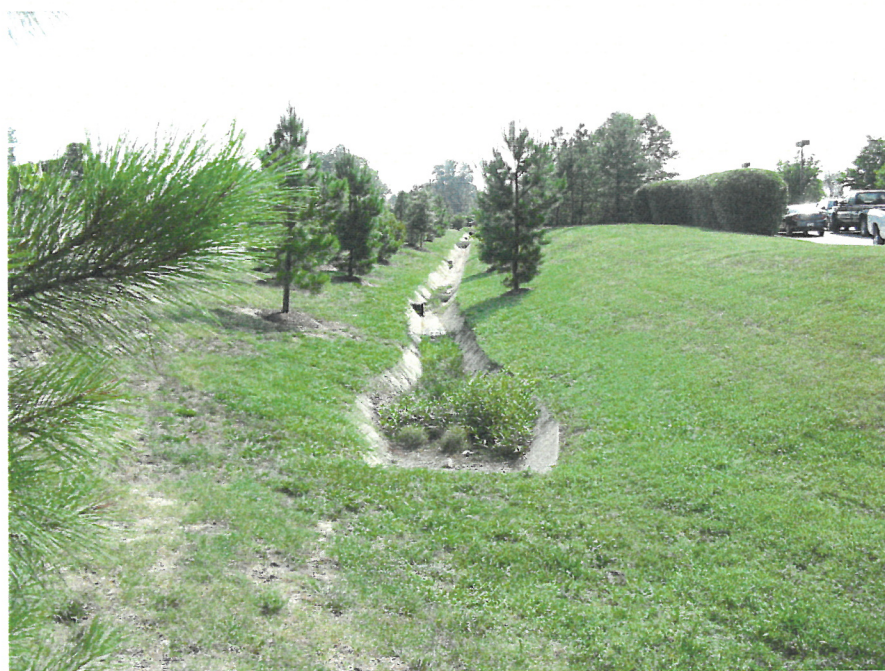
Identifier:	Kristiansand - 37
Location:	Between Williamsburg Village and Williamsburg Dodge
<p><u>Existing Conditions:</u></p> <p>Concrete channel receiving flow from Rt. 60 and adjacent development. Channel ultimately outfalls to existing pond discussed in Retrofit #35. A large amount of sediment accumulation is present at bottom of channel, burying what is assumed to be a drop inlet connecting to the pond.</p>	
<p><u>Potential Improvements:</u></p> <p>Remove and dispose of accumulated sediment. Construct an offline bioretention filter at end of channel (downslope of drop inlet). Alternately, a pre-treatment sediment forebay could be constructed at the end of the channel and outfall adjusted accordingly. Further evaluation could also be provided to determine the feasibility of replacing the concrete-lined channel with another which better promotes infiltration. This may consist of a grassed swale with soil amendments and check dams (however the longitudinal slope and number of check dams could be problematic).</p>

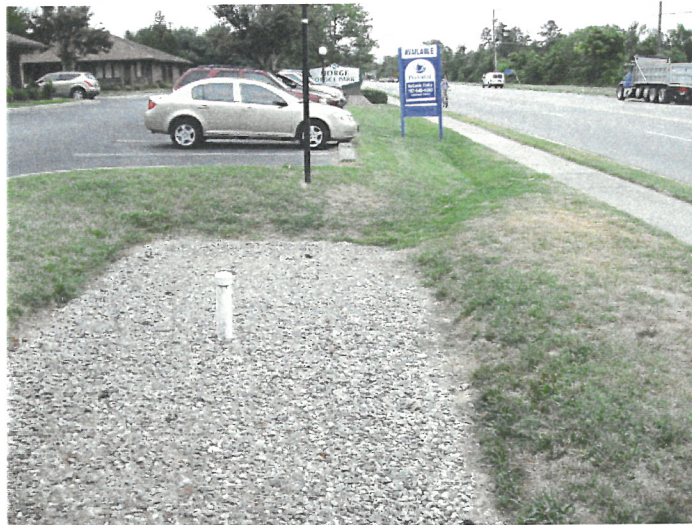
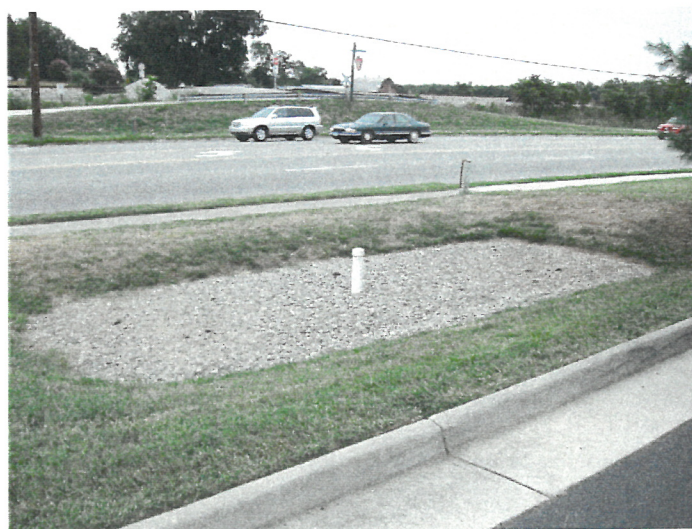
Identifier:	Kristiansand - 39
Location:	Norge Office Park (southeast corner)
<p><u>Existing Conditions:</u></p> <p>Existing gravel infiltration trench adjacent to parking lot. Appears to be functioning well.</p>	
<p><u>Potential Improvements:</u></p> <p>To improve the aesthetic value of the facility, perimeter landscaping and/or a surface layer of topsoil and vegetative ground cover could be employed. If the basin is to be topdressed, further evaluation of its function should be performed to ensure water quality benefits are not compromised and to determine the new design configuration (may require an overflow structure).</p>

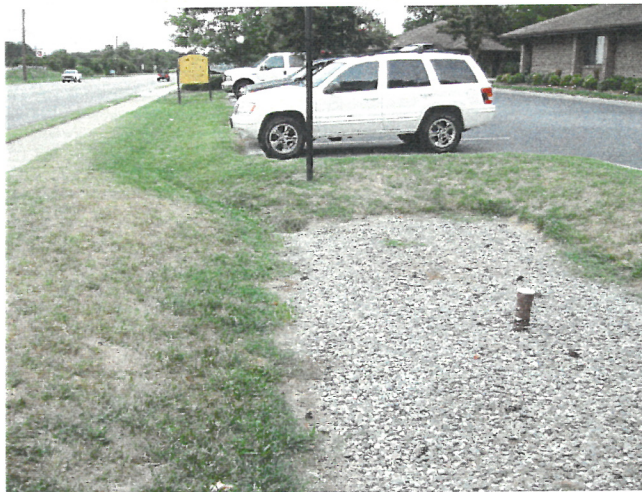
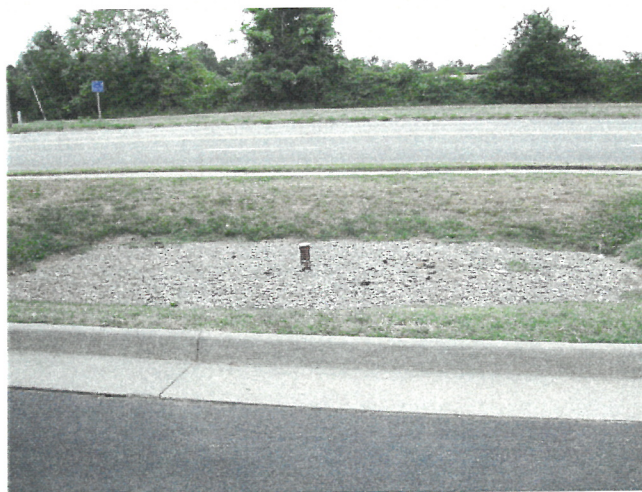
Identifier:	Kristiansand - 40
Location:	Norge Office Park (northeast corner)
<u>Existing Conditions:</u>	
Existing gravel infiltration trench adjacent to parking lot. Appears to be functioning well.	
<u>Potential Improvements:</u>	
To improve the aesthetic value of the facility, perimeter landscaping and/or a surface layer of topsoil and vegetative ground cover could be employed. If the basin is to be topdressed, further evaluation of its function should be performed to ensure water quality benefits are not compromised and to determine the new design configuration (may require an overflow structure).

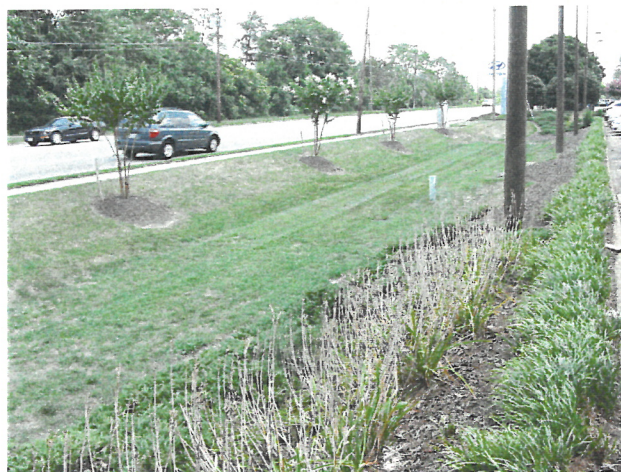
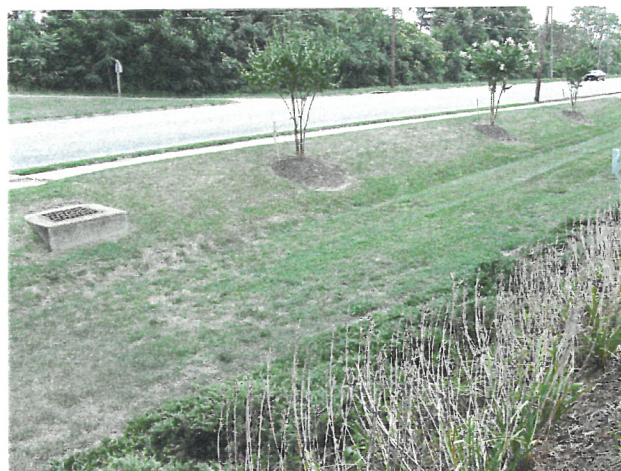
Identifier:	Kristiansand - 42
Location:	Front of Williamsburg Honda
<p><u>Existing Conditions:</u></p> <p>Existing infiltration basin between Rt. 60 and parking lot of Williamsburg Honda which appears to be functioning well.</p>	
<p><u>Potential Improvements:</u></p> <p>Identified in Yarmouth Creek Watershed Plan (104-R1). Enhance existing basin by adding landscaping and mulch layer to function more like a bioretention facility.</p>

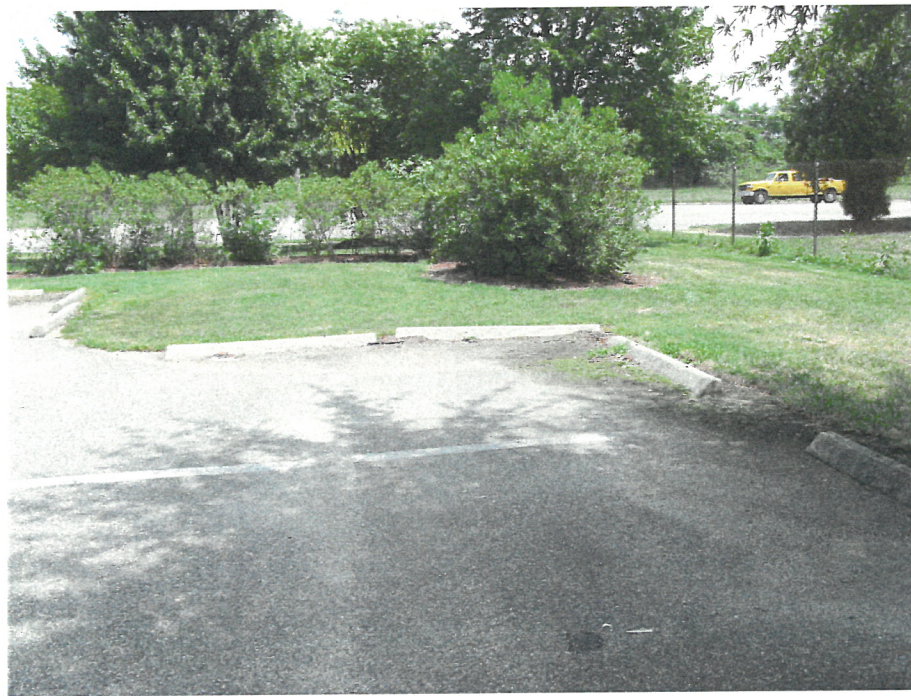
Identifier:	Kristiansand - 43
Location:	Norge Elementary School (southeast corner of parking lot near Rt. 60)
<u>Existing Conditions:</u>	
Open area adjacent to parking lot receiving surface runoff from pavement. Some sediment accumulation at edge of parking lot.	
<u>Potential Improvements:</u>	
Construct a bioretention filter or infiltration trench to treat the parking lot runoff. Remove and dispose of accumulated sediment and configure entrance to biofilter to help prevent future sediment buildup. Stabilized overflow or level spreader needed as biofilter outlet. Cooperation with the school as an educational tool is also recommended. Other retrofits not identified herein may also be feasible at the school pending further evaluation.

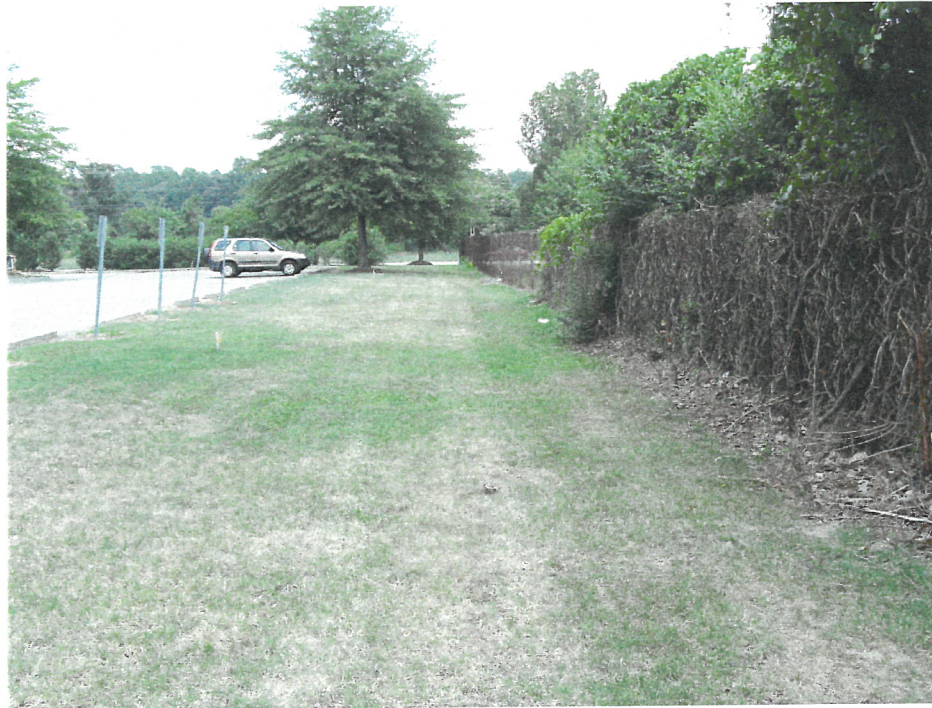
Identifier:	Kristiansand - 44
Location:	Norge Elementary School (southern edge of parking lot)
<u>Existing Conditions:</u> Open area adjacent to parking lot receiving surface runoff from pavement.	
<u>Potential Improvements:</u> Construct bioretention filters, an infiltration trench, or an engineered swale to treat the parking lot runoff. Discharge into proposed Retrofit #43. Cooperation with the school as an educational tool is also recommended. Other retrofits not identified herein may also be feasible at the school pending further evaluation.

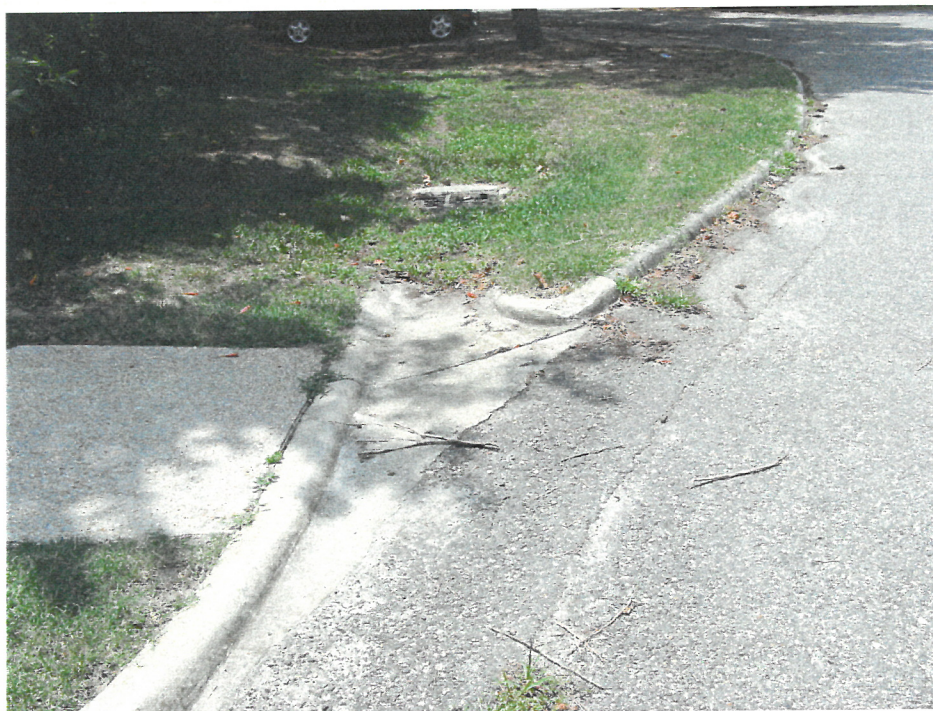
Identifier:	Kristiansand - 45
Location:	Norge Elementary School (south behind school, near bend in access road)
<u>Existing Conditions:</u>	
Concrete flume conveying roadway runoff into drop inlet.	
<u>Potential Improvements:</u>	
Construct a bioretention filter around existing drop inlet. Ensure adequate protection at inflow from flume. Tie underdrains of biofilter into existing inlet. Cooperation with the school as an educational tool is also recommended. Other retrofits not identified herein may also be feasible at the school pending further evaluation.

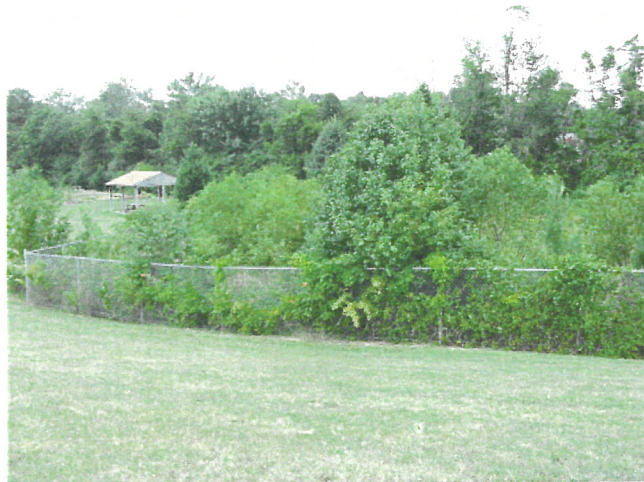
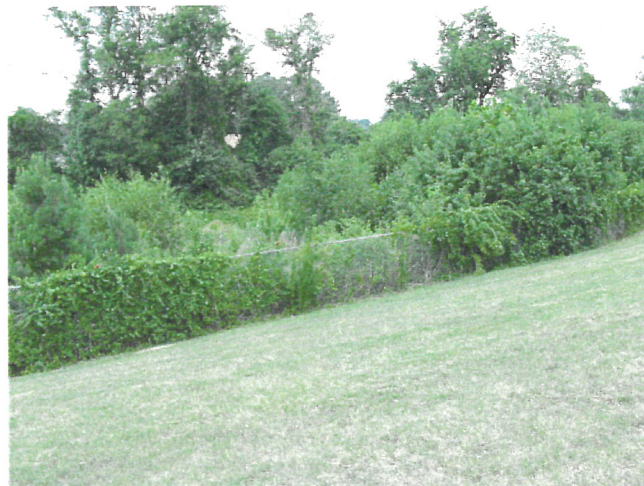
Identifier:	Kristiansand - 47
Location:	Norge Elementary School (behind school to the west)
<p><u>Existing Conditions:</u></p> <p>Existing wetland area or shallow BMP surrounded by chain link fence. Appears to be outfall from the school storm sewer system.</p>	
<p><u>Potential Improvements:</u></p> <p>Even though this area drains away from the tributary of concern for this study (as may other portions of Norge Elementary School), it could be evaluated for potential retrofits. This area was not reviewed in great detail in this study, but there may be potential for a shallow marsh BMP retrofit, outlet protection, pre-treatment forebay, and/or existing wetland enhancement pending further evaluation.</p>

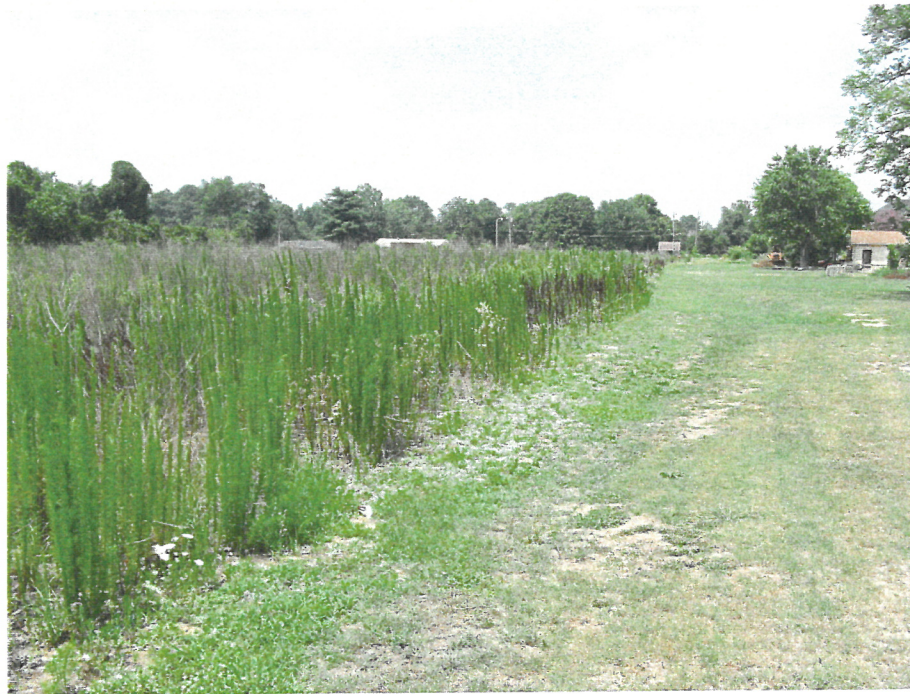
Identifier:	Kristiansand - 48
Location:	Open field west of development on Rt. 60, immediately north of school
<u>Existing Conditions:</u>	
Runoff from commercial areas west of Rt. 60 discharge into existing open field with no defined outfall.	
<u>Potential Improvements:</u>	
Construct treatment practices downslope of developed areas. May include practices such as level spreaders, filter strips, engineered swales, bioretention filters, or infiltration basins pending further evaluation.

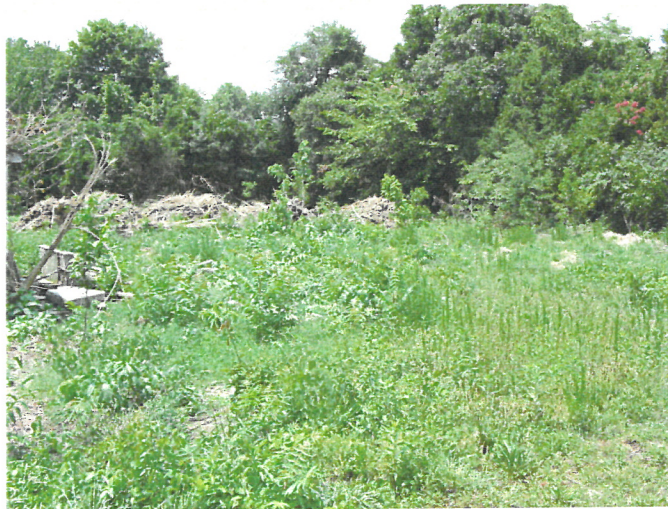
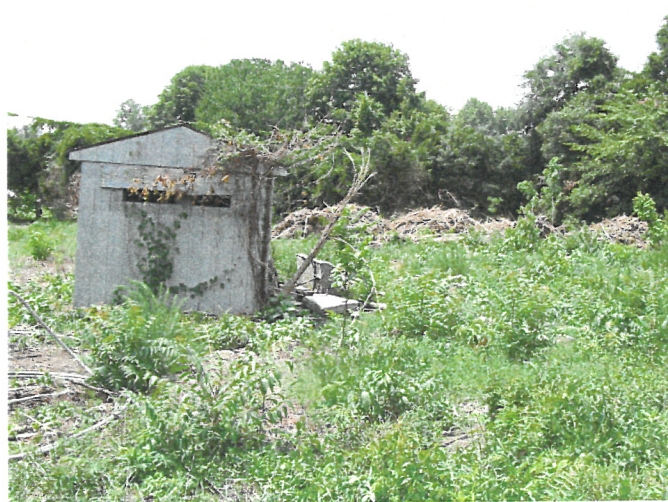
Identifier:	Kristiansand - 49
Location:	Open field west of Motor Lodge on Rt. 60
<u>Existing Conditions:</u> Runoff from commercial areas west of Rt. 60 discharge into existing open field with no defined outfall.	
<u>Potential Improvements:</u> Construct treatment practices downslope of developed areas. May include practices such as level spreaders, filter strips, engineered swales, bioretention filters, or infiltration basins pending further evaluation.
