**BMP NUMBER:** MC020

MILL CREEK / LAKE POWELL  
WATERSHED STUDY  
MAIN CHANNELS AND LAKES

REPAIR LAKE POWELL  
 DAM & SPILLWAY  
 JAMES CITY CO.  
 VIRGINIA  
 APPLICATION BY:  
 FLORENCE ADEIT

LAKE POWELL DAM REPAIR PROJECT

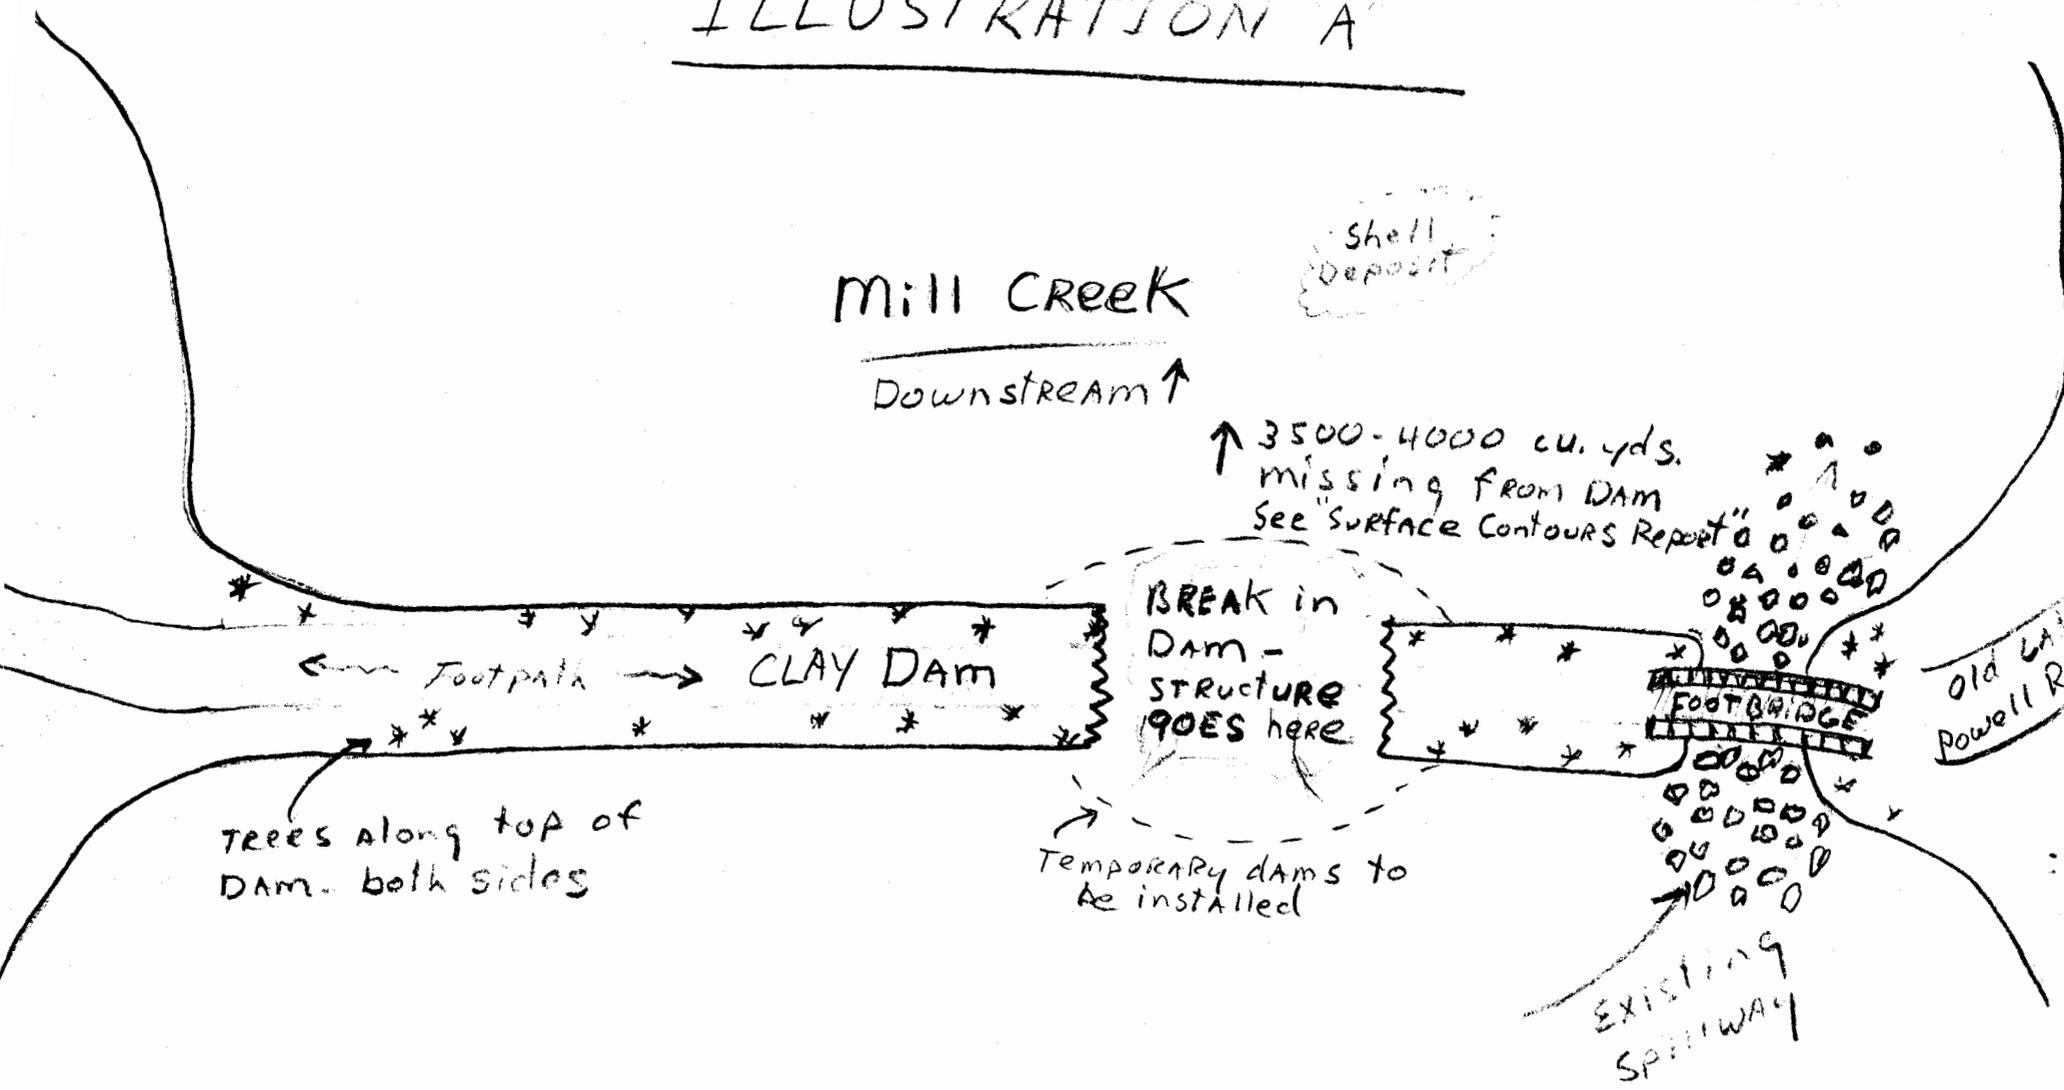
Shell Deposit

↑ 3500-4000 cu. yds.  
missing from DAM  
See "Surface Contours Report"

Trees along top of DAM - both sides

BREAK in Dam - STRUCTURE GOES here

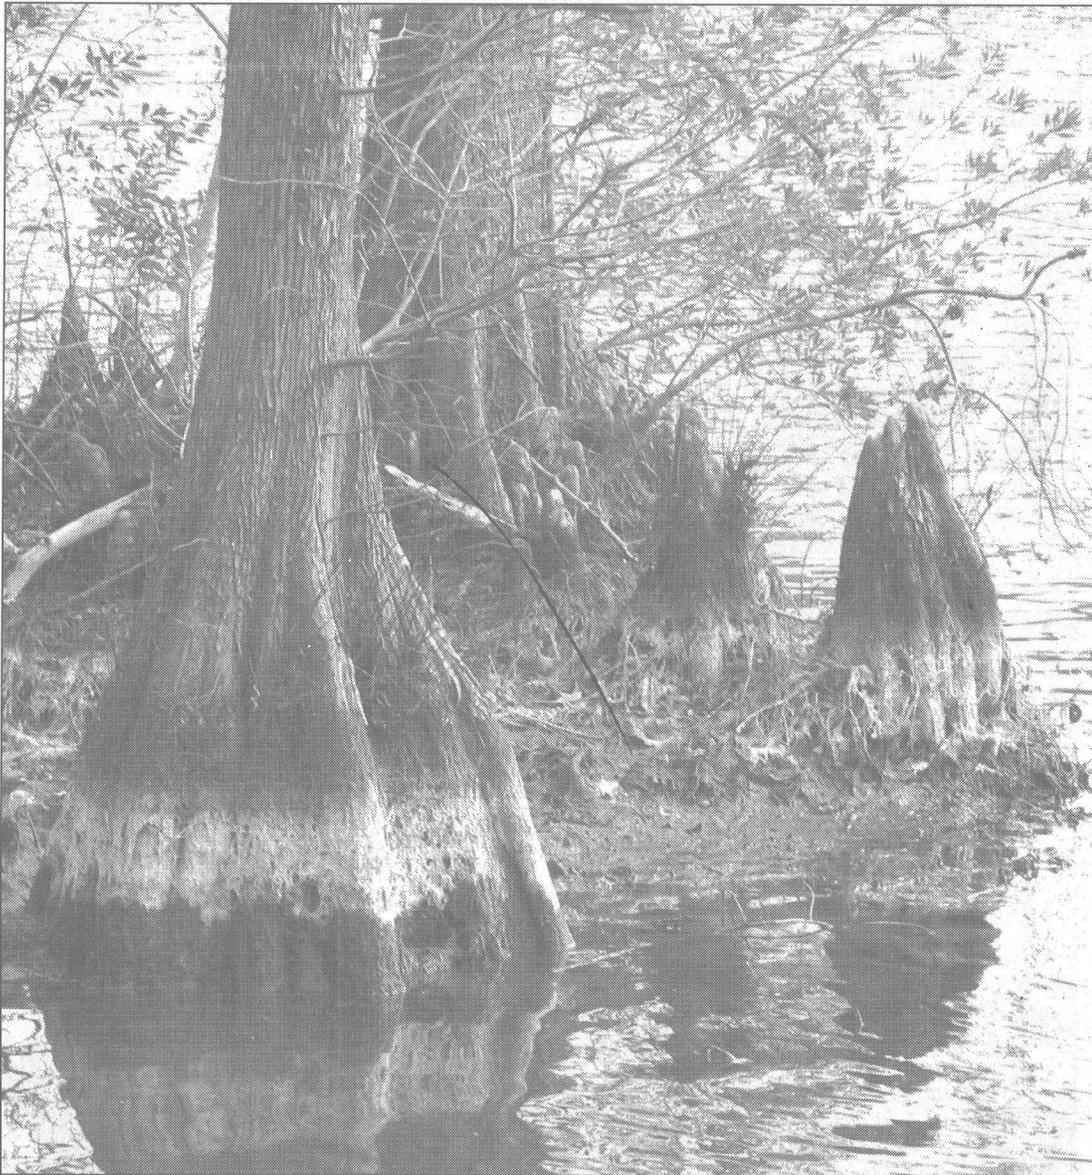
Former water lines can be seen on these stumps exposed as the lake's level dropped.

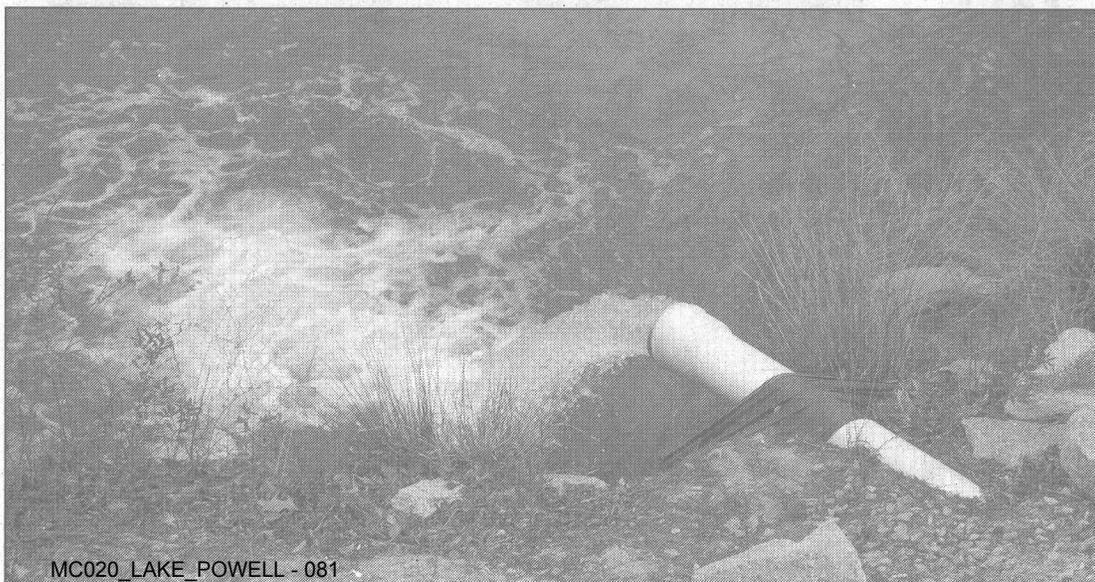
Water flows from a pipe at the base of the Lake Powell dam.

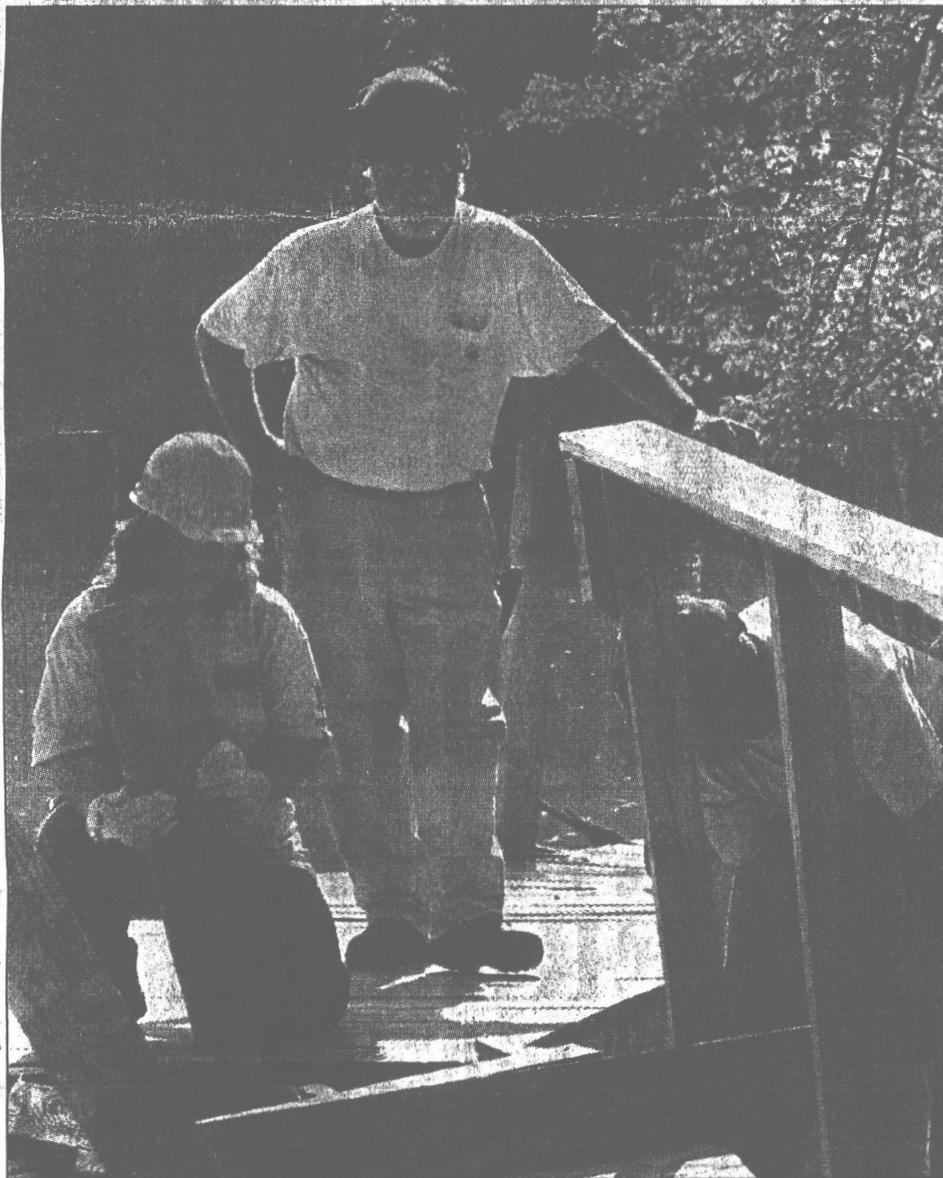
County workers dismantle a wooden bridge across the Lake Powell dam. The bridge was dismantled when the dam breached and became a safety hazard.

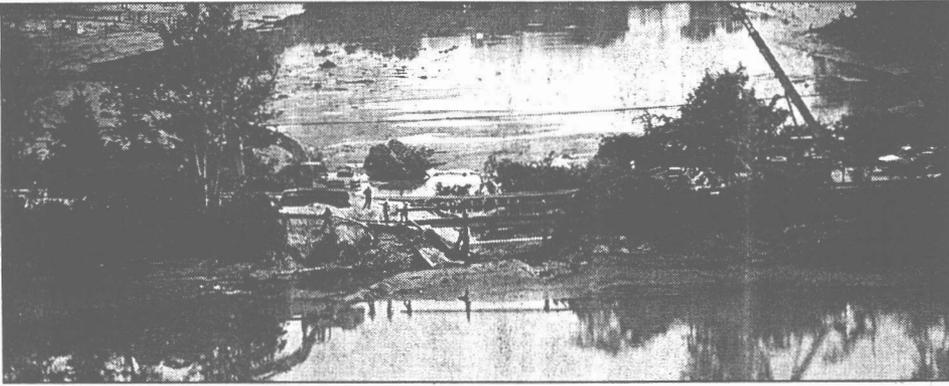
An aerial view of Lake Powell in 1999 after the dam broke during Hurricane Floyd.

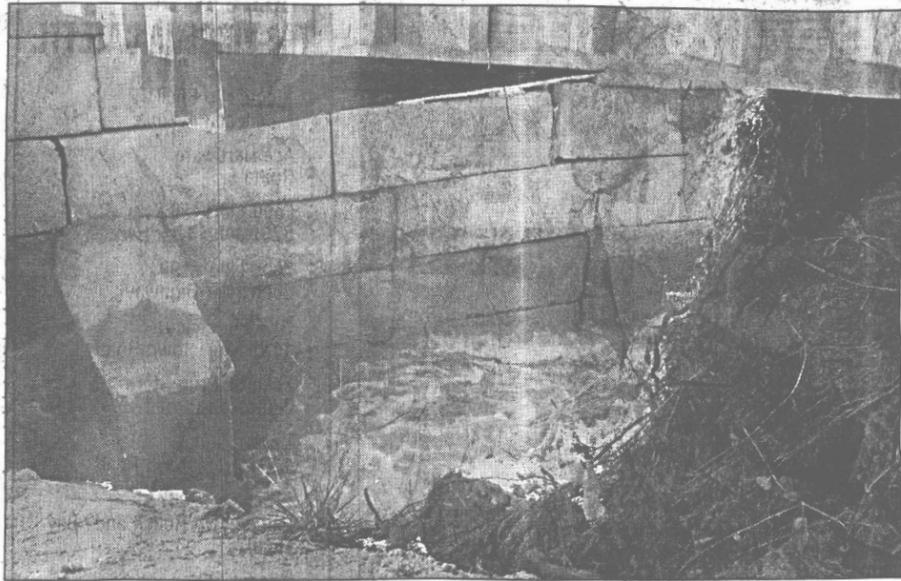
Megan Zirkle  
Water from Lake Powell flows through a hole in the dam right after heavy rains dropped about 10" of water.

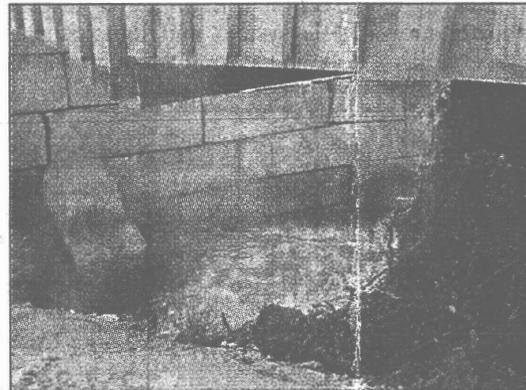
The breached area of the dam causes an eroding slope to form a pool of water.

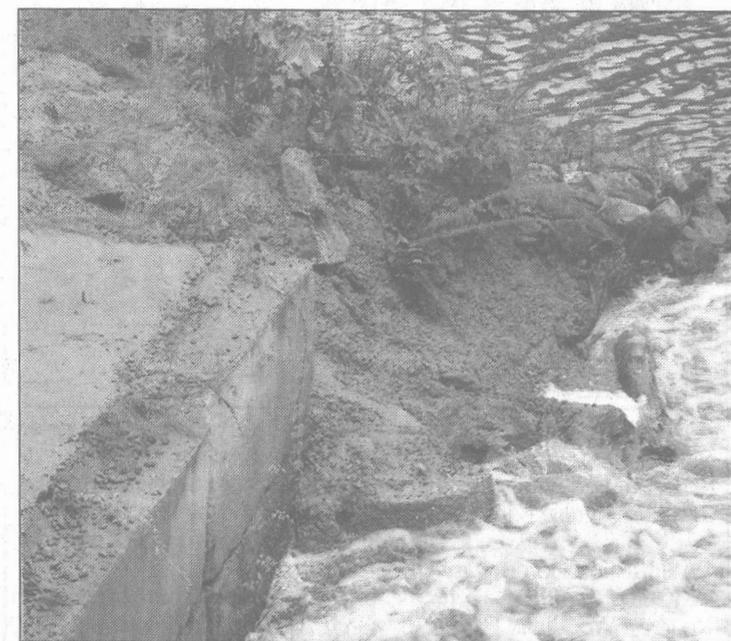
**Concrete now fills sinkholes created by the water.**

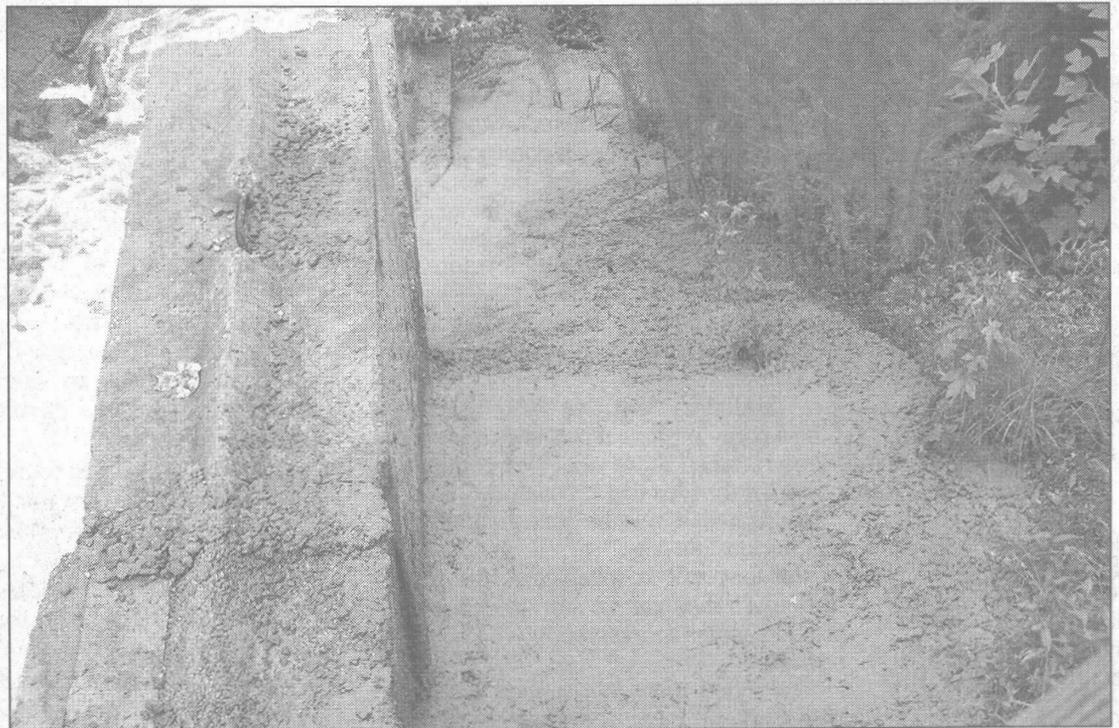
Volunteers used about \$5,000 worth of concrete to repair the dam on Thursday.

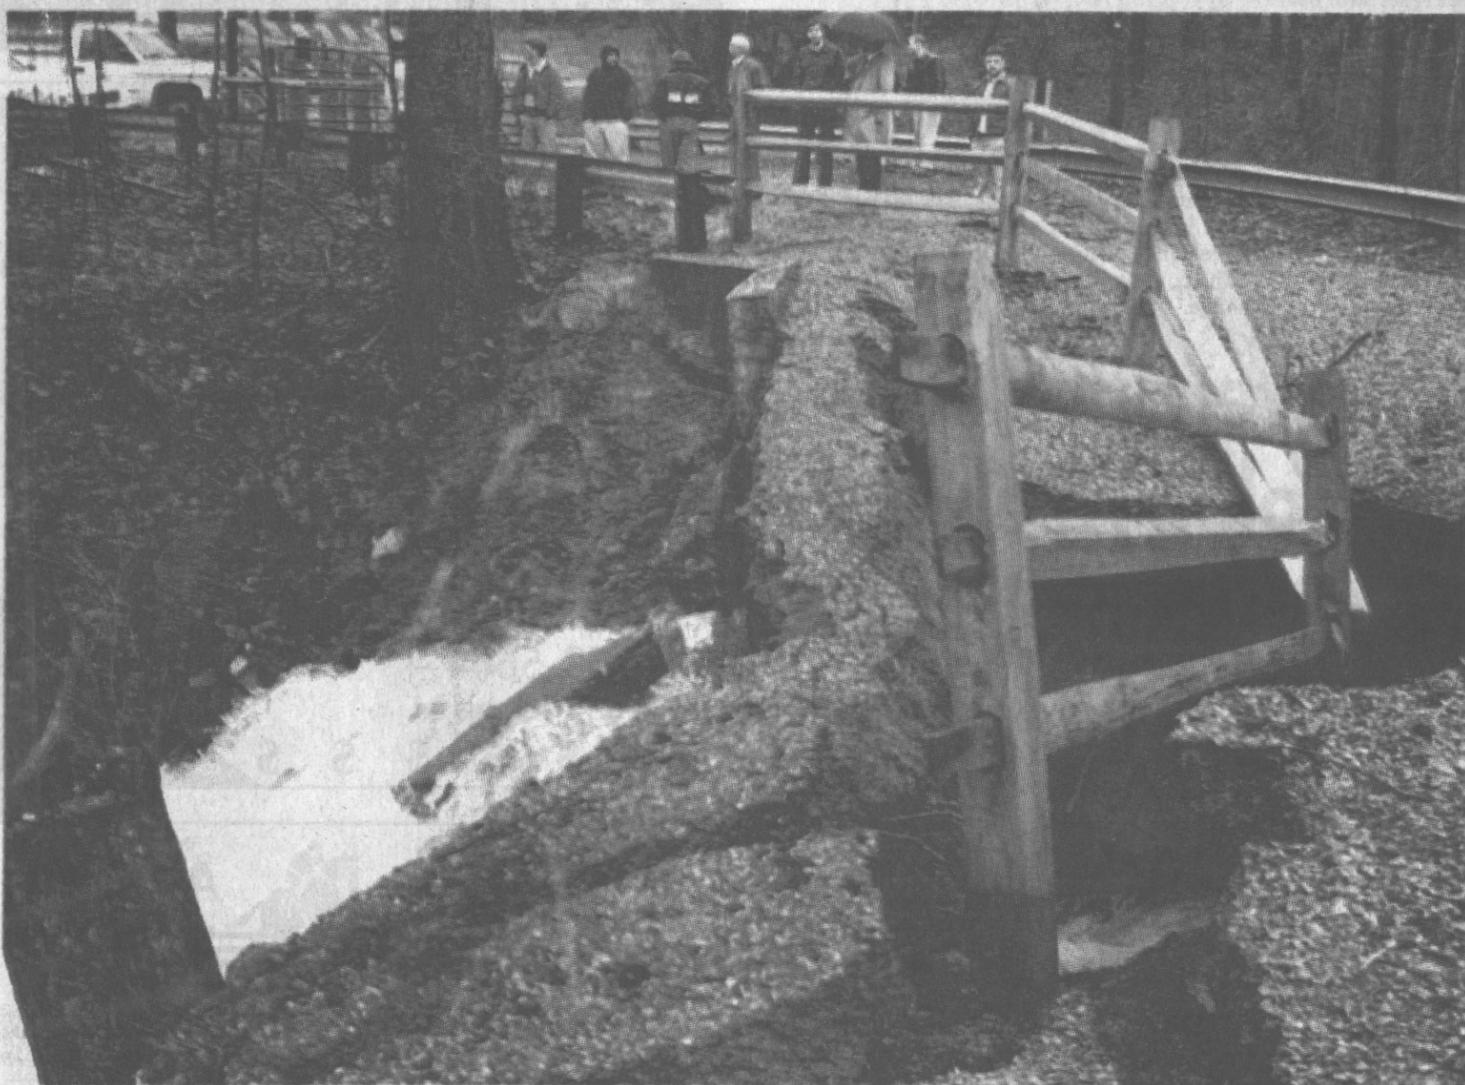
Onlookers watch as the dam starts to claim a split-rail fence. By Thursday morning, the fence was completely engulfed.
