BMP NUMBER: WC037

RECORD DRAWING
C.F.
BASIN A
SECTION IVA
AT STONEHOUSE

Re: Stonehouse Section 4A Leather Leaf, Basin A
Dry Pond at Road near 2932 Leather Leaf
County BMP ID Code: WC 037

**James City County Environmental Division
Stormwater Management / BMP Inspection Report
Detention and Retention Pond Facilities**

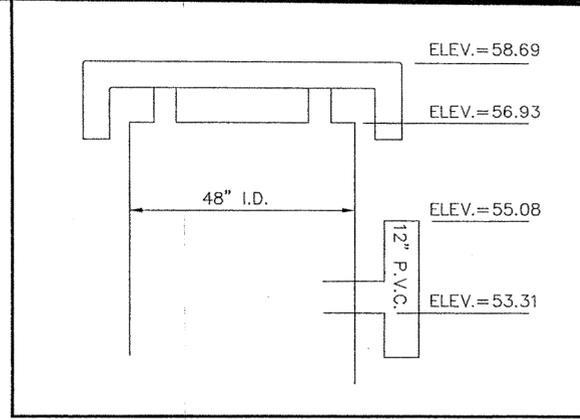
RECORD DRAWING
OF
BASIN A
SECTION IVA
AT STONEHOUSE

2. ~~Add the detention basin outlet structure detail as provided on Sheet 11 of the approved plan set to the as-built (record) drawing for the facility. This detail provides important information about the facility. Annotate the detail as necessary with field-obtained construction information.~~

3. Show the following additional information on the record drawing: size of riser; size of the higher level (dewatering) orifice; invert elevation on the upstream side of the low flow orifice (at the EW-11 grate) within the bottom of the pond; and show the street address on Lot 9 as 2932 Leather Leaf Drive.

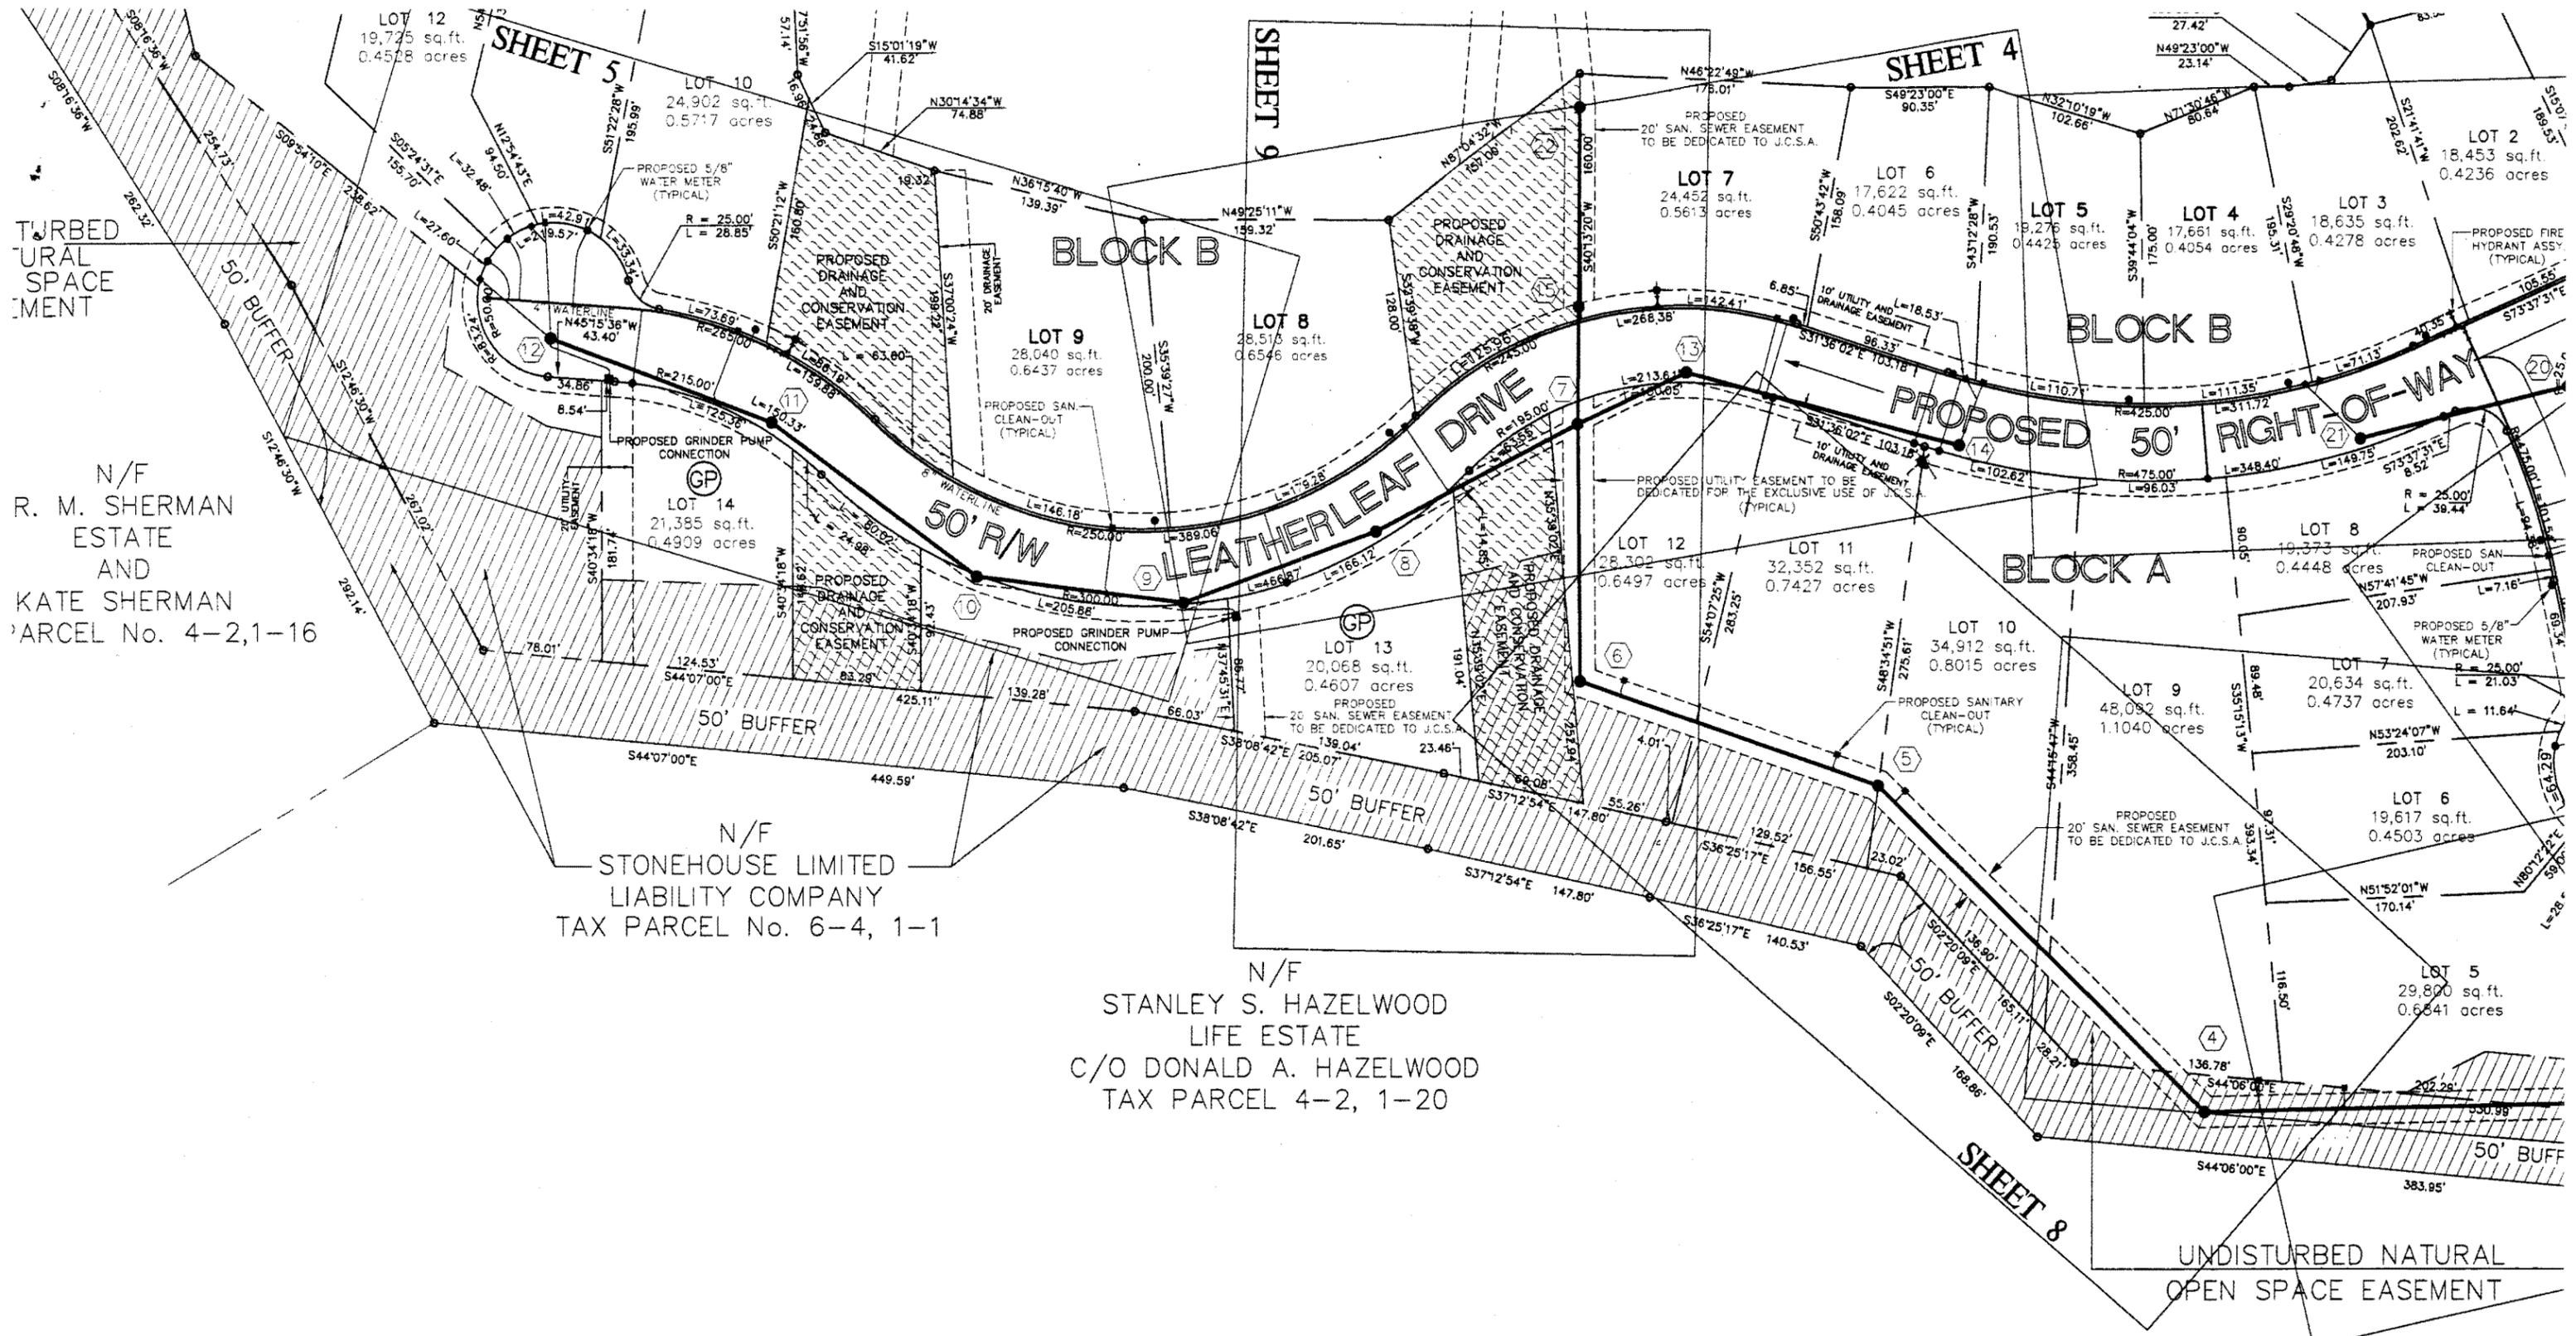
wc037

Need Pond Detail.
- MP
- Riser size?
- Low Flow or if clogged
- check 25' Pond Buffer
from Lot 2932 to other.
