BMP NUMBER: CC-014

Re: Kingspoint Subdivision Large Lake (County ID No. CC 014) East Side/Overlook Drive Vicinity

Kingspoint Dam Repair

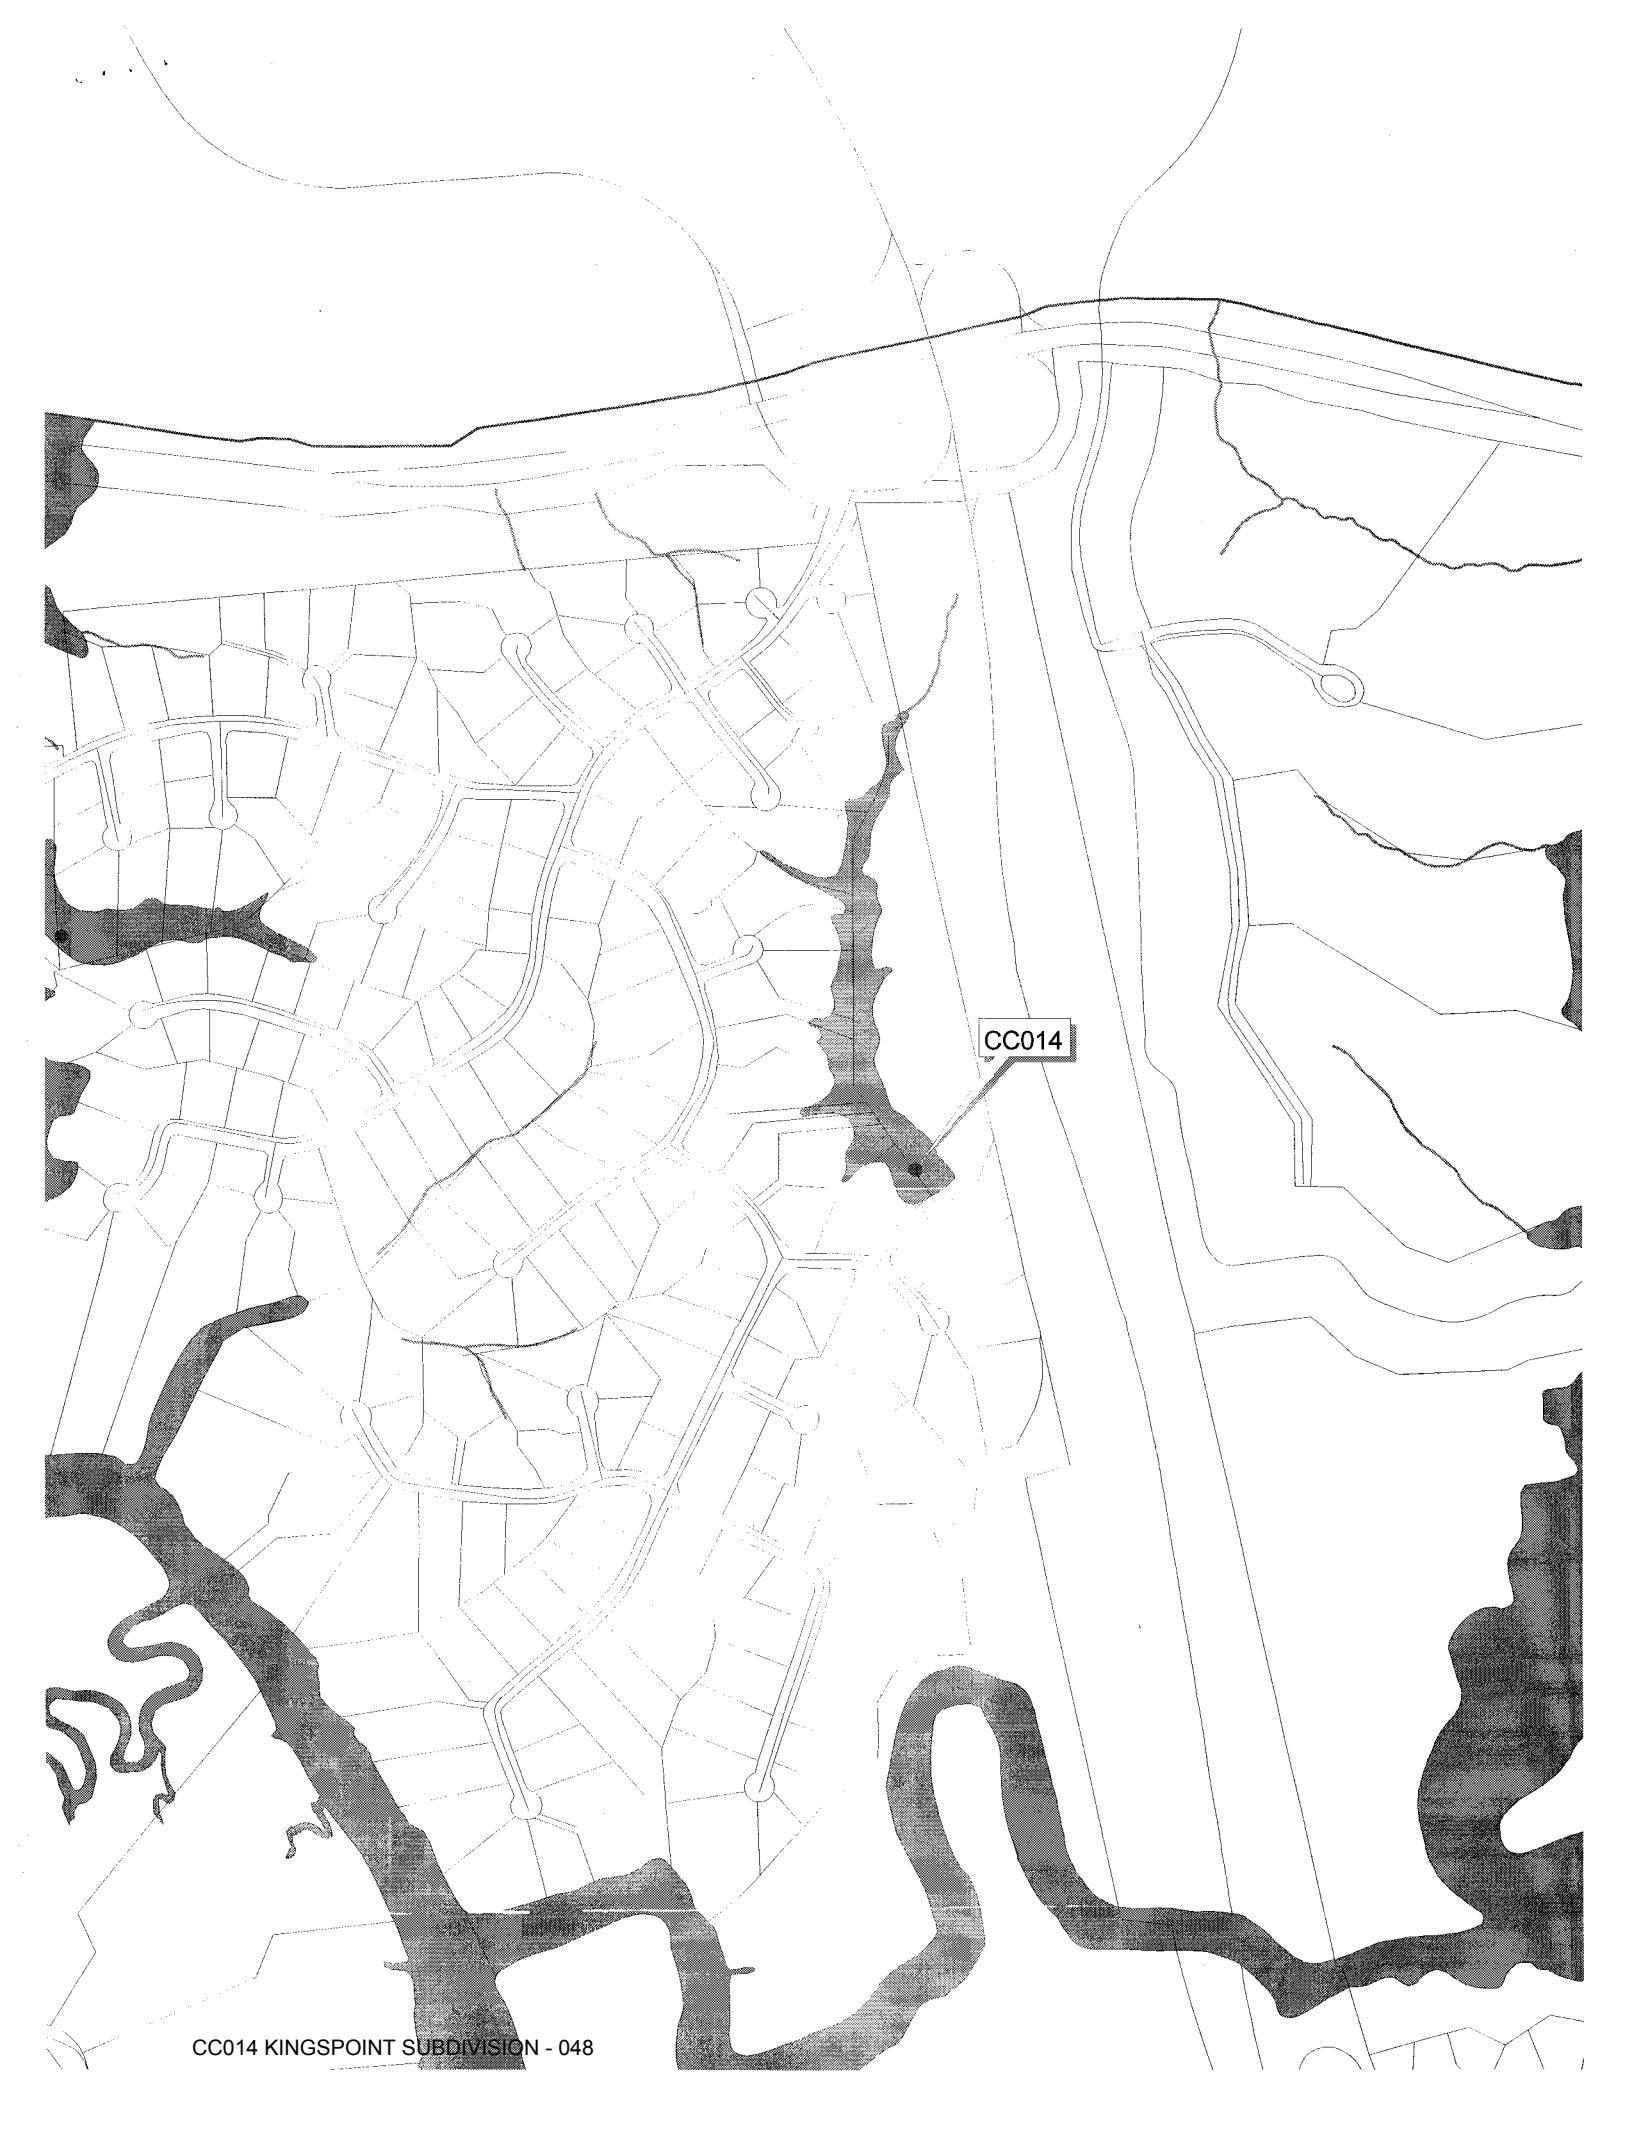
Notes cause negressive enosition Failure at desemb borset outlet harrel. Ad, the rundt 110 Overlook Prive 6PIN 4910250026 RAM EMB GPIN 4910200006 110 Overlood Drive UN 23185. Eloise A. JACOBS (Trustee) TAN, DR. HOATT. from 204 Jones MILL CANC WMBG VA 23185 1.728AC TONCA! LOT ZO SELS KP 6PIN 0VEV 101 23105 A 109 DVEV 101 23105 A 109 DMBY + KITSTEN MA 100 DMBY + KITSTEN MA And North Lot 10, 3. AC. APJ COLPKNY PB 55 Trees! ~1 10727, 525th BANK SUDE FAIL 110 erlock Drive CC014 KINGSPOINT SUBDIVISION

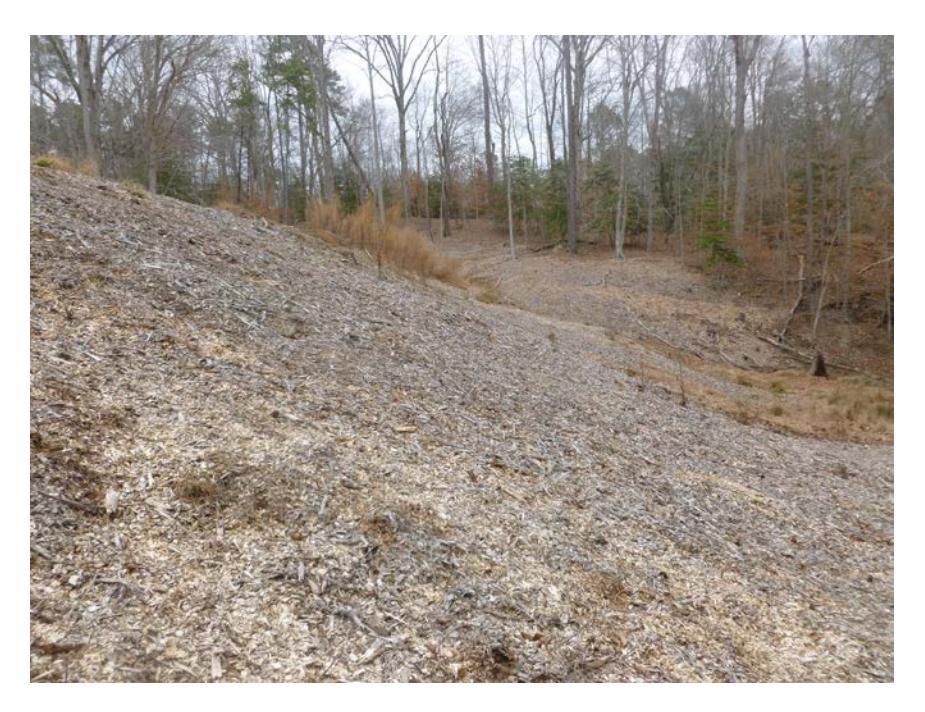
View of downstream face of embankment, covered with wood chips from tree removal.

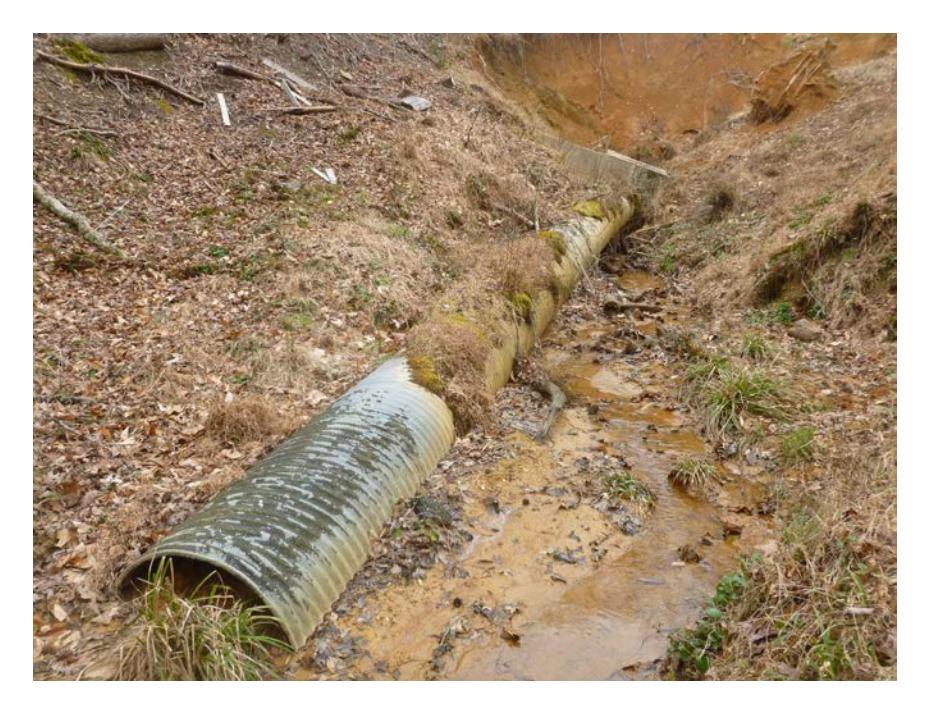
View of downstream portion of displaced outfall barrel, from downstream end towards slope failure area.

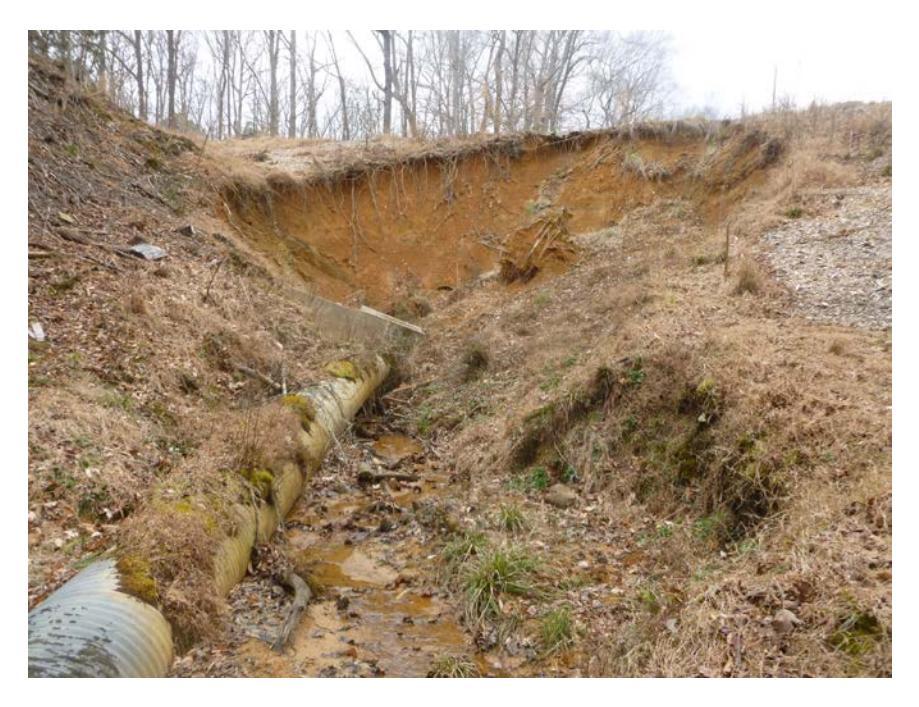
Overview of displaced outfall barrel and slope failure area.

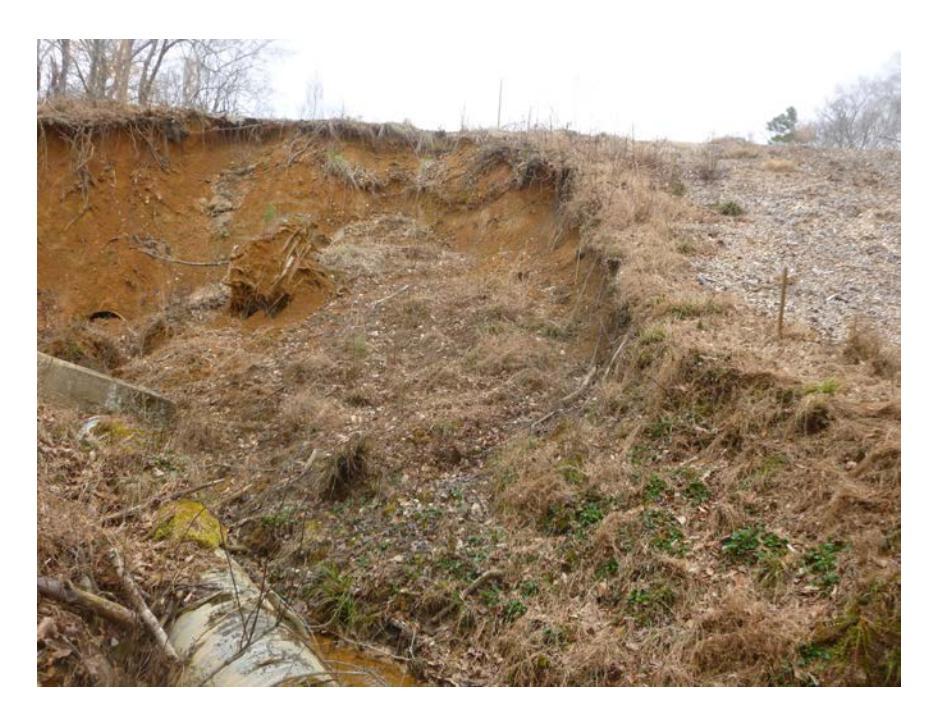
Slope failure area.

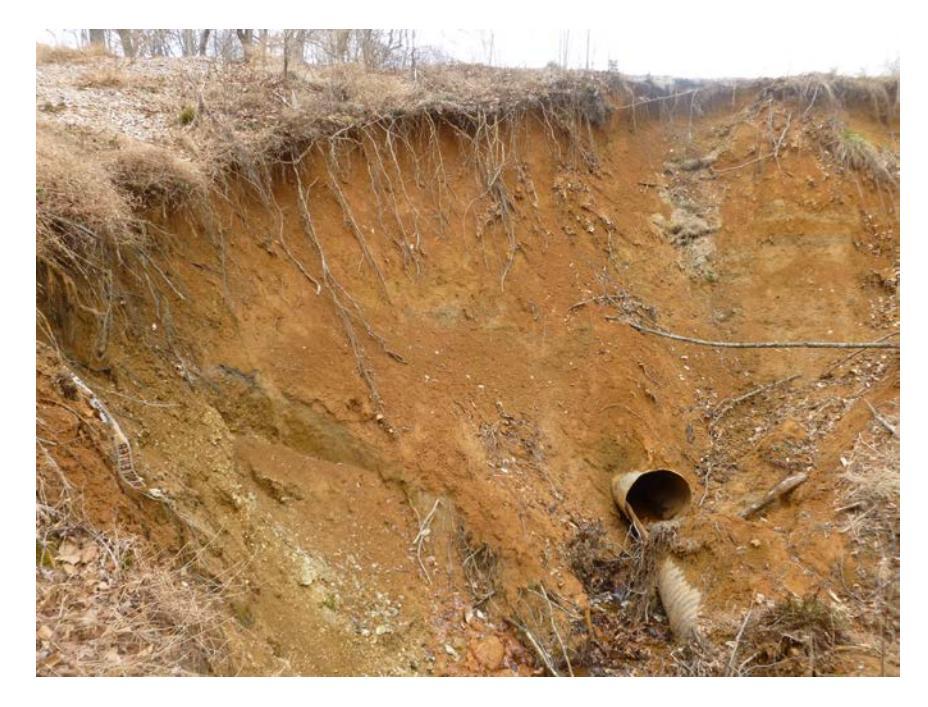
View of failure area.

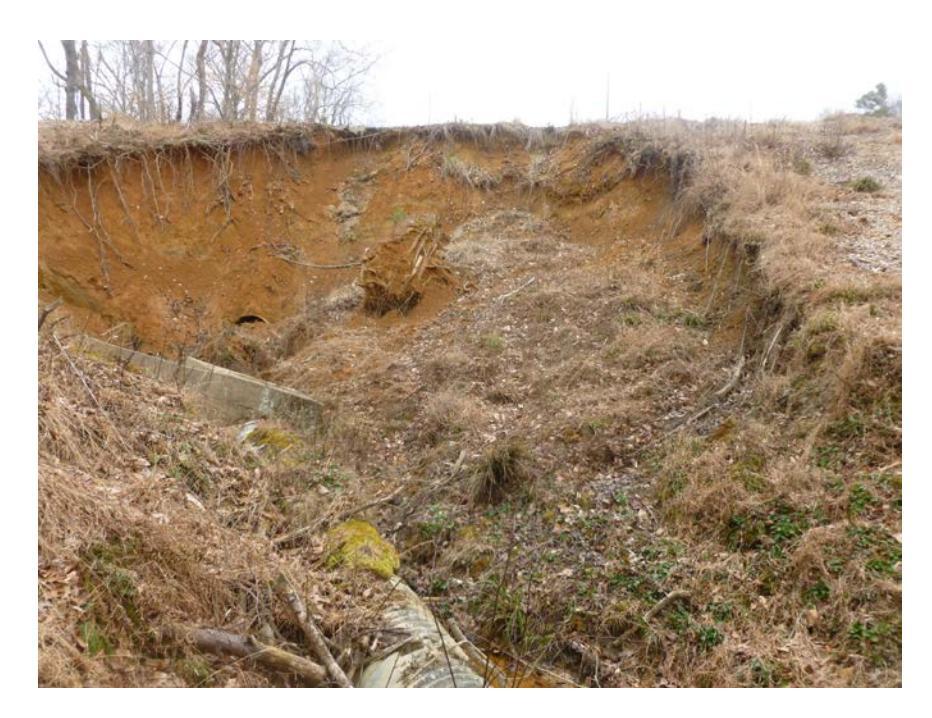
Overview of failure area.

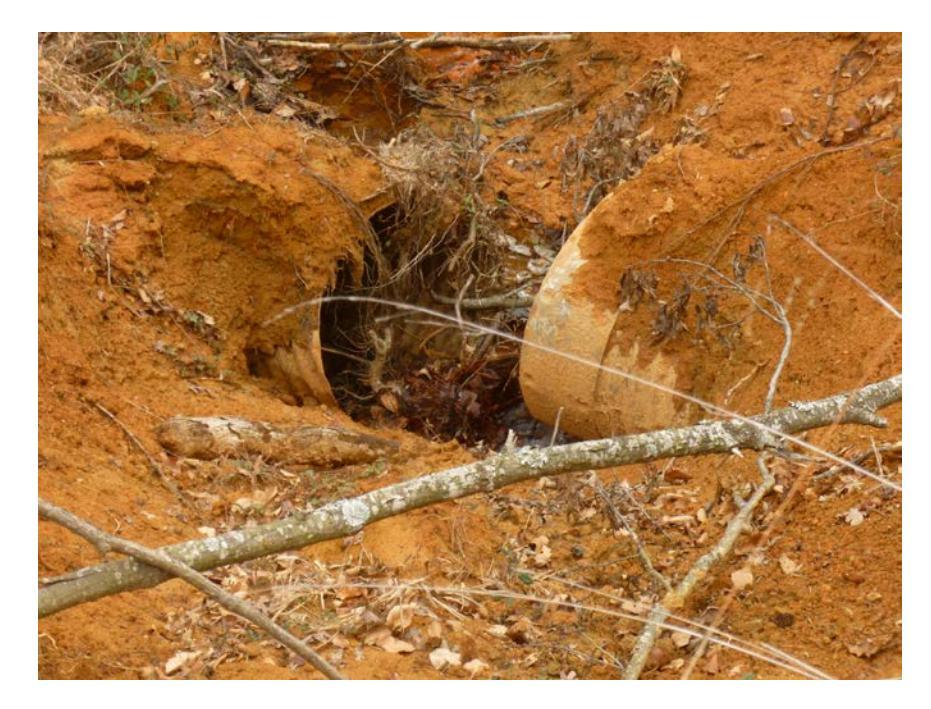
Pipe separation area.

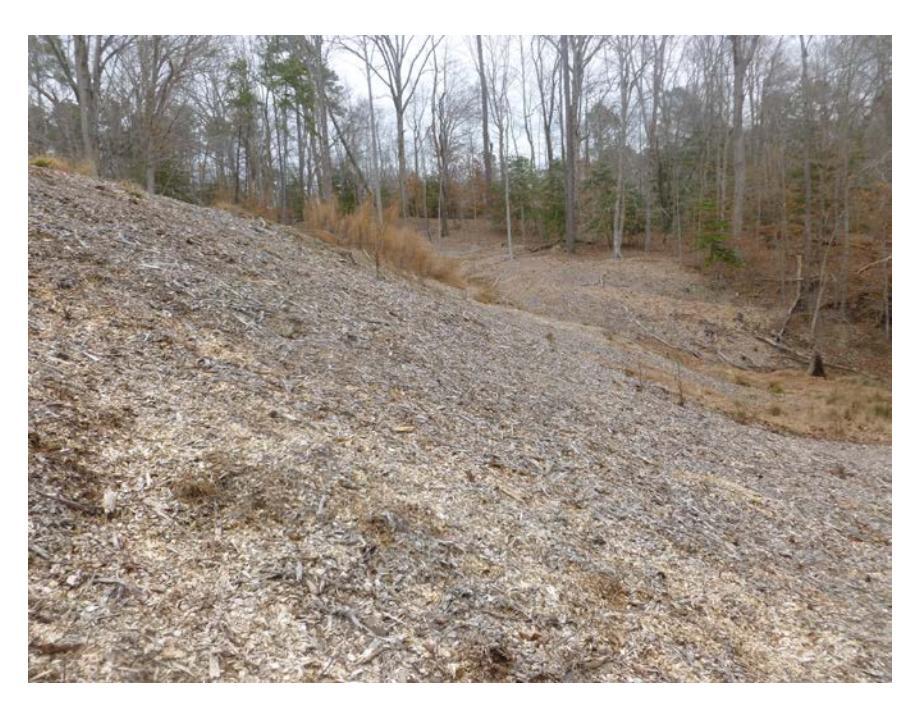
View of downstream face of embankment, covered with wood chips from tree removal.

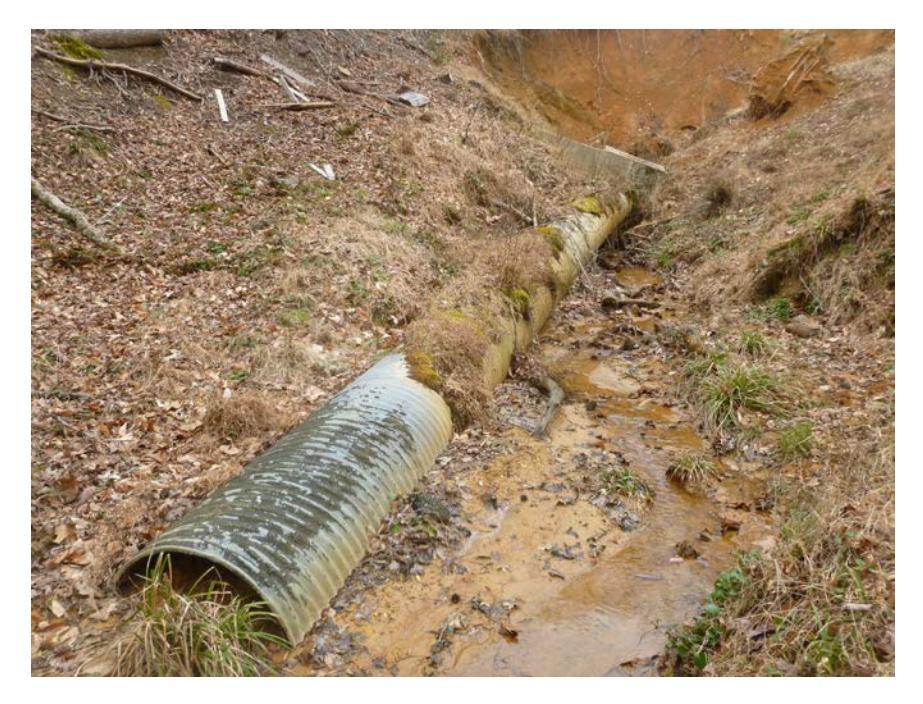
View of downstream portion of displaced outfall barrel, from downstream end towards slope failure area.

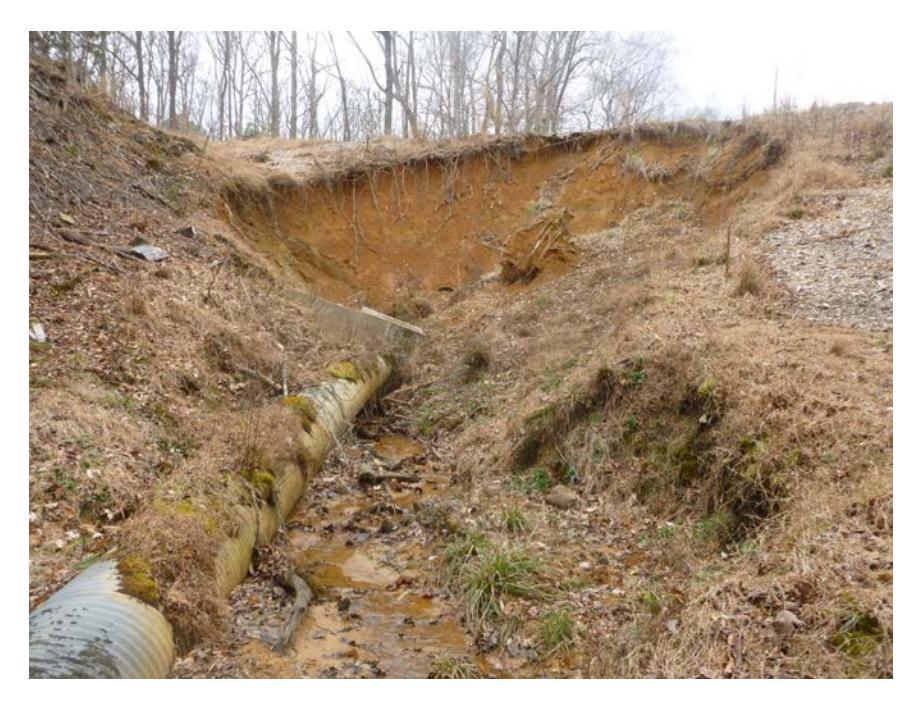
Overview of displaced outfall barrel and slope failure area.

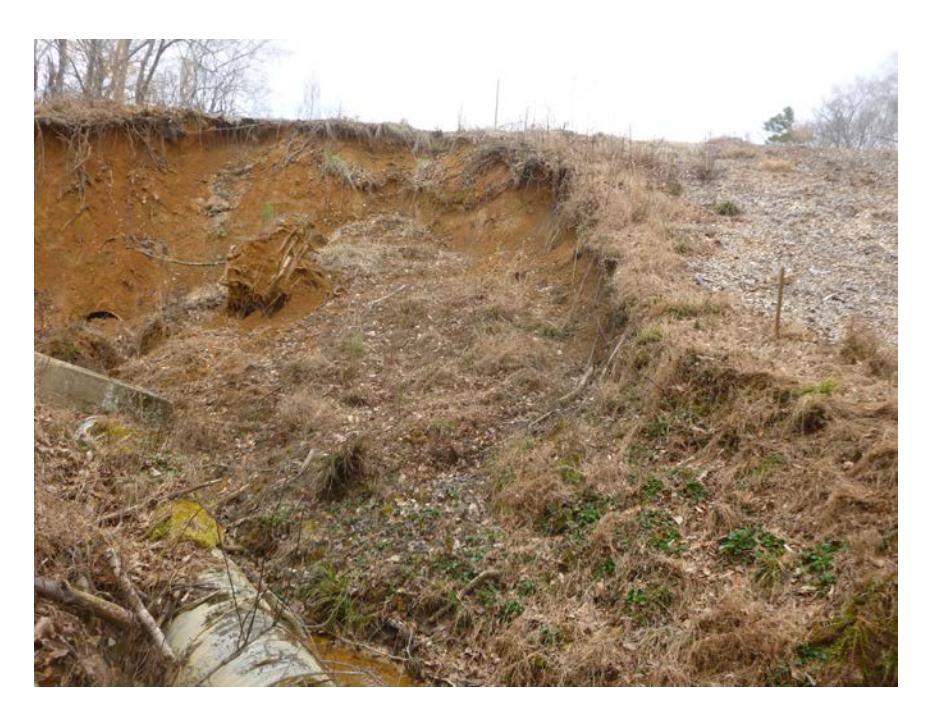
Slope failure area.

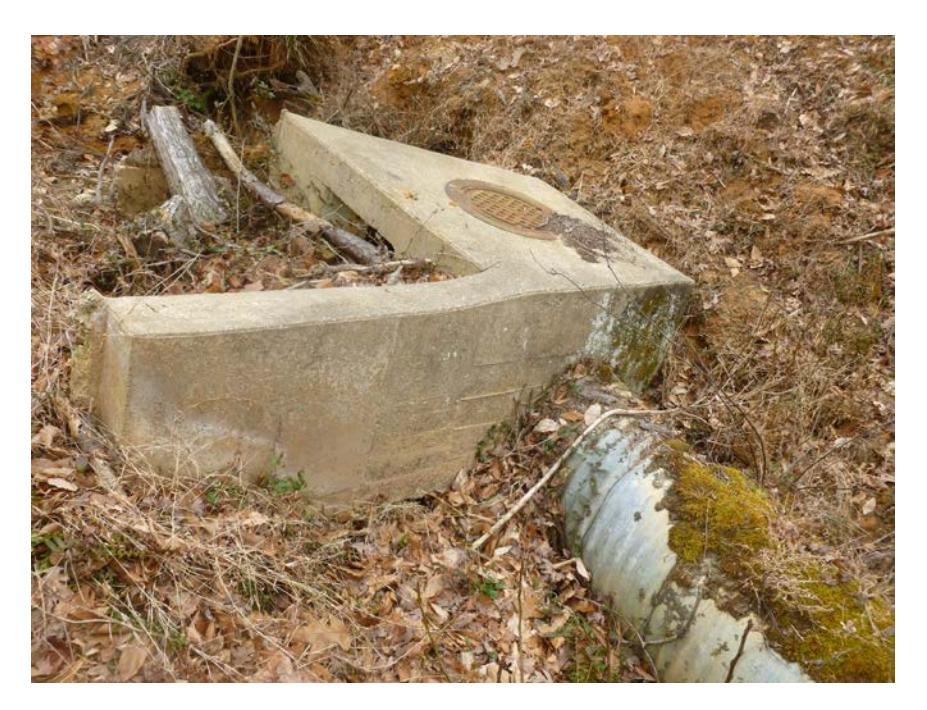
Displaced junction box.

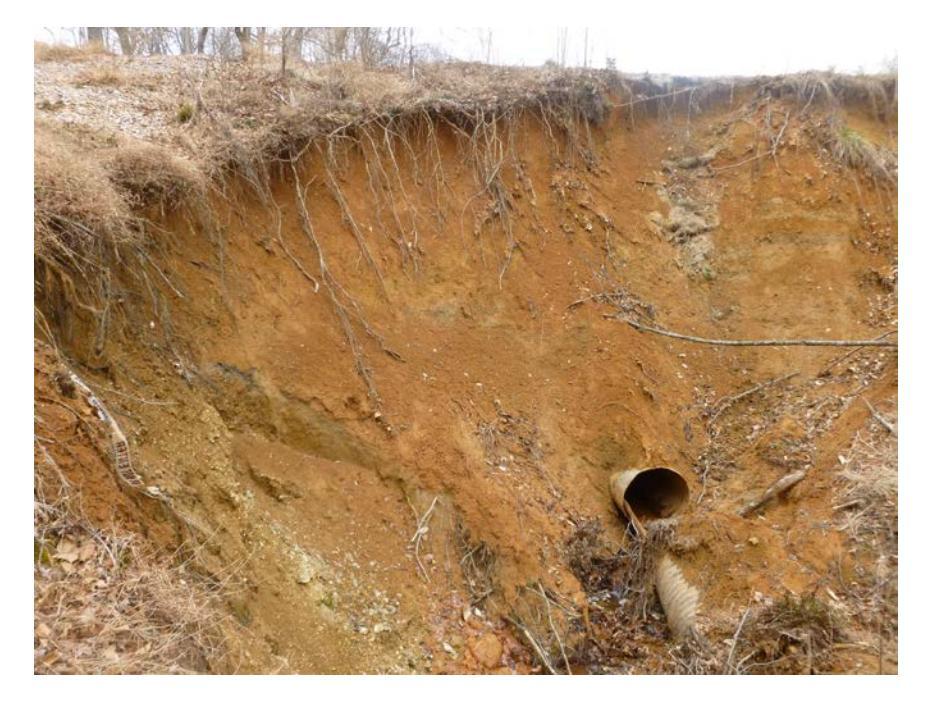
View of failure area.

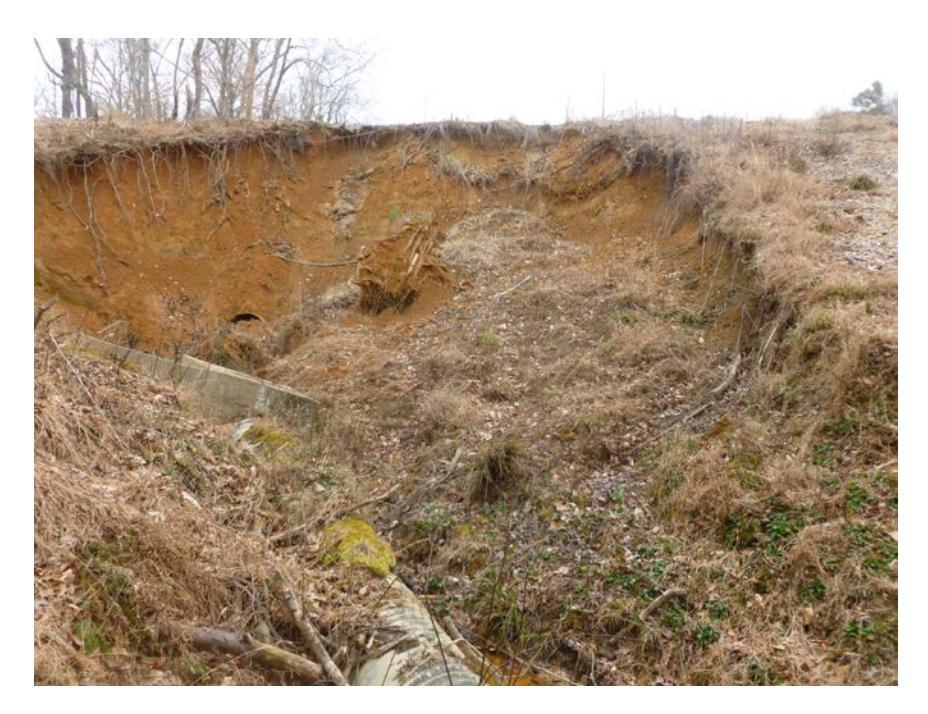
Overview of failure area.

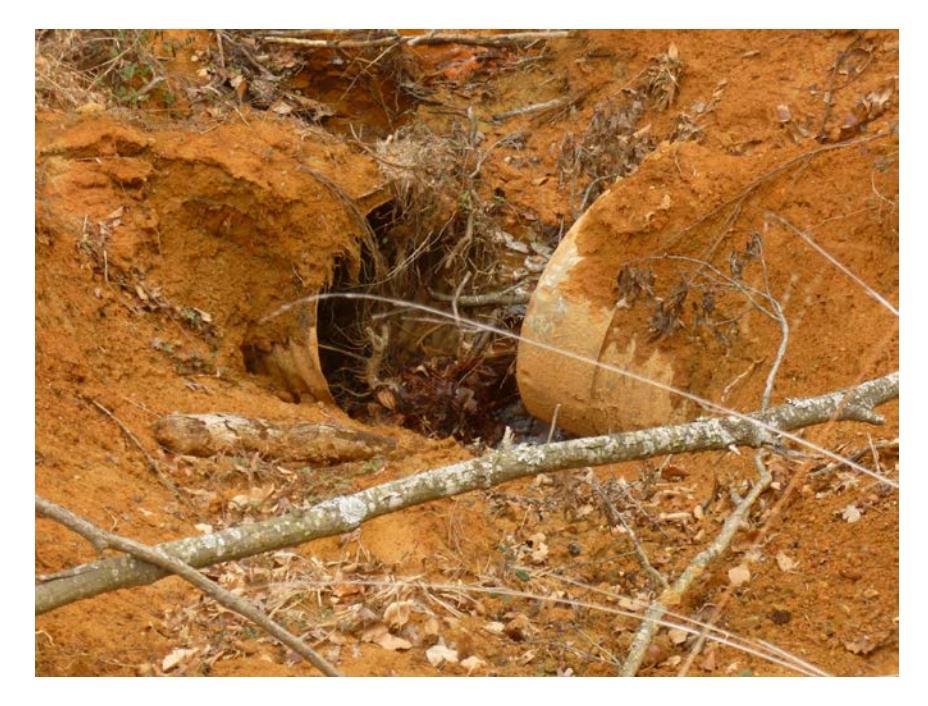
Pipe separation area.
