# Kristiansand Subdivision

# STREAM CONDITION SUMMARY MAP JCC - KRISTIANSAND TRIBUTARY JAMES CITY COUNTY, VIRGINIA

WATERSHED EVALUATION  
SUMMARY MAP

JCC - KRISTIANSAND TRIBUTARY  
JAMES CITY COUNTY, VIRGINIA

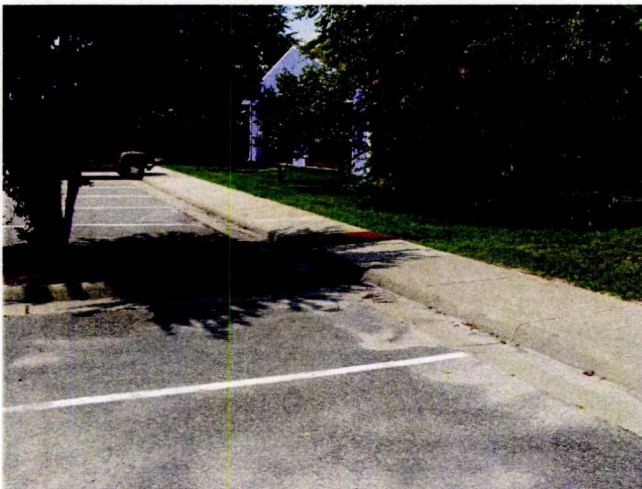
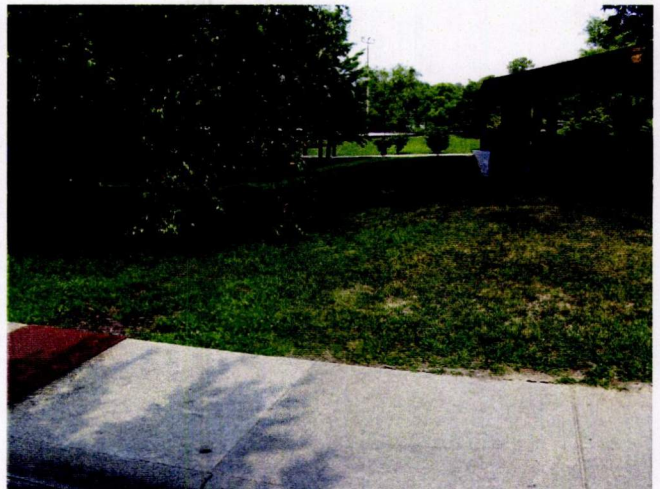
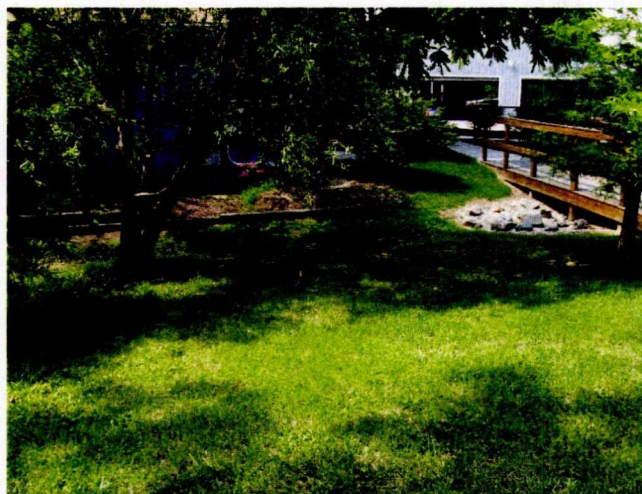
<b>Identifier:</b>	Kristiansand - 1
<b>Location:</b>	Go-Karts Plus (southern end of parking lot)
<b><u>Existing Conditions:</u></b>	Existing curb cut from parking lot into grassed swale.
<b><u>Potential Improvements:</u></b>	Install bioretention filter or engineered swale. May be difficult to daylight underdrains.

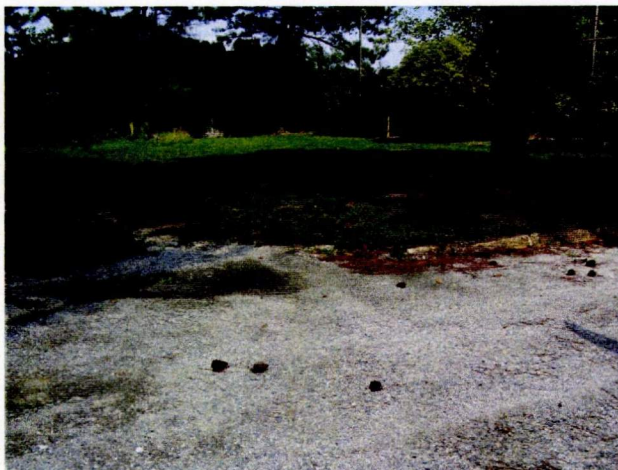
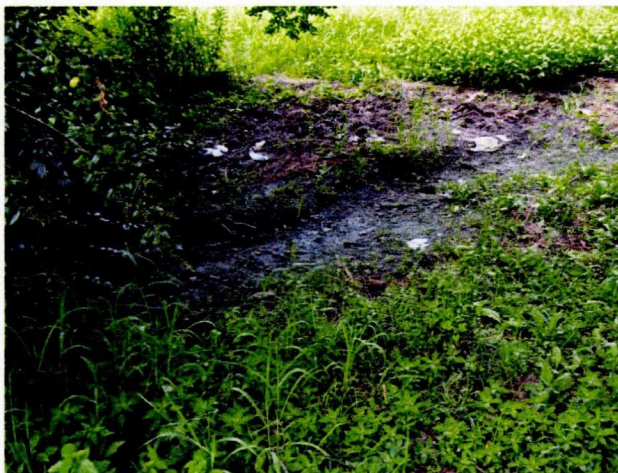
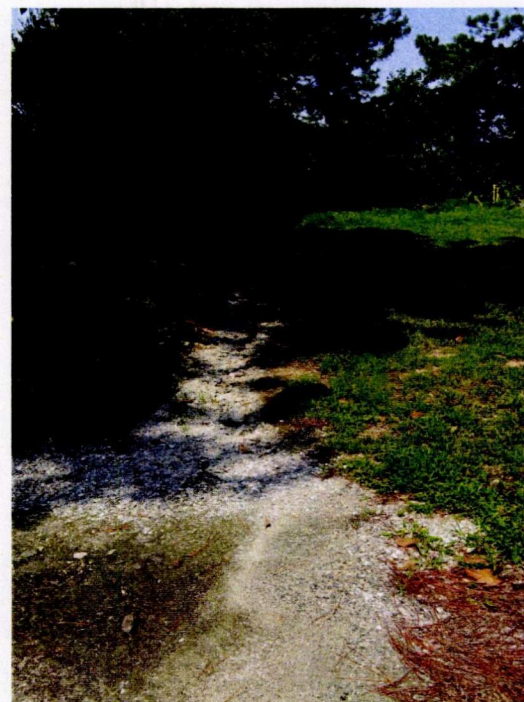
<b>Identifier:</b>	Kristiansand - 2
<b>Location:</b>	Go-Karts Plus (overflow parking to the north)
<b><u>Existing Conditions:</u></b>	
Runoff from parking lot discharges via gravel channel to low spot near railroad tracks and adjacent field.	
<b><u>Potential Improvements:</u></b>	
Construct infiltration/bioretention basin or shallow marsh facility, pending further soil evaluation at outfall.

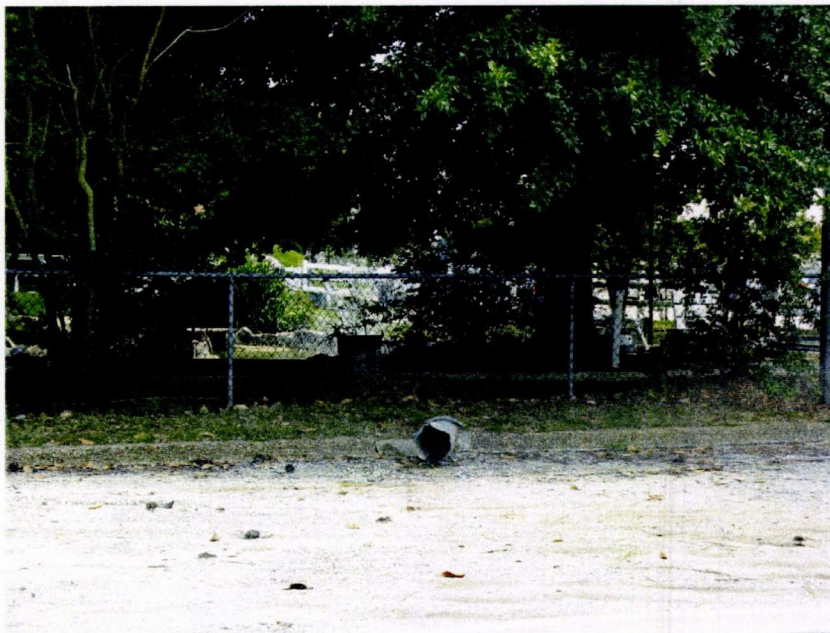
<b>Identifier:</b>	Kristiansand - 3
<b>Location:</b>	Go-Karts Plus
<b><u>Existing Conditions:</u></b>	
Overflow from water feature discharges to parking lot. Depending on treatment techniques employed, could be a point source pollution problem. Additional review of facility needed to identify other potential point sources such as fuel and vehicle storage areas.	
<b><u>Potential Improvements:</u></b>	
Modify water feature overflow or treatment techniques to avoid discharge of harmful chemicals downstream to surface waters. Employ spill prevention and/or containment measures at any other hot spots onsite.

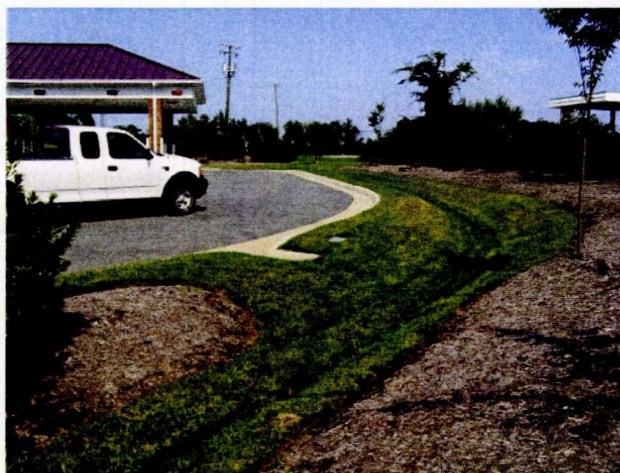
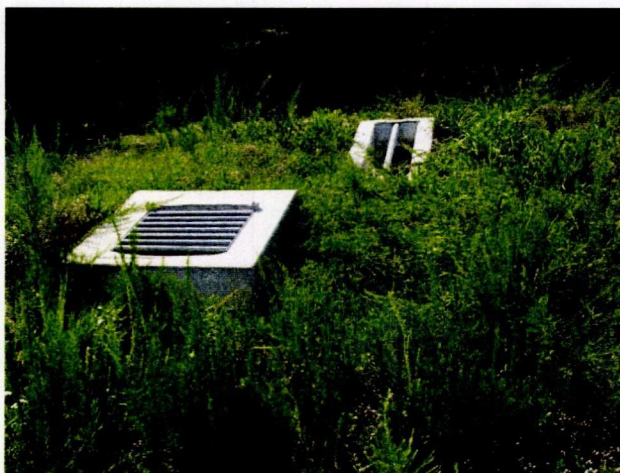
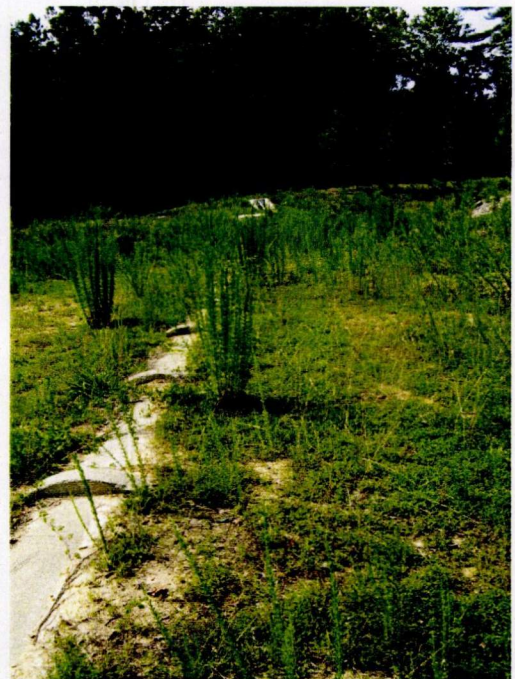
<b>Identifier:</b>	Kristiansand - 9
<b>Location:</b>	Behind BayLands Federal Credit Union west of Rt. 60
<b><u>Existing Conditions:</u></b>  Grassed swales convey runoff from bank into detention basin. An existing pipeline is exposed across the facility.	
<b><u>Potential Improvements:</u></b>  Improve grassed swales to better promote infiltration. Improvements may include soil amendments and/or installation of check dams. Convert detention basin into a shallow marsh facility. Further review of existing pipeline needed to determine any design implications it may introduce, such as limited wet pool areas.

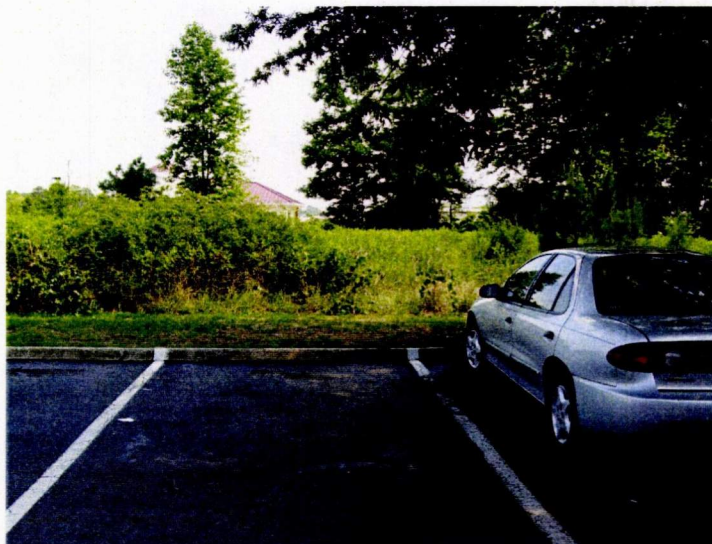
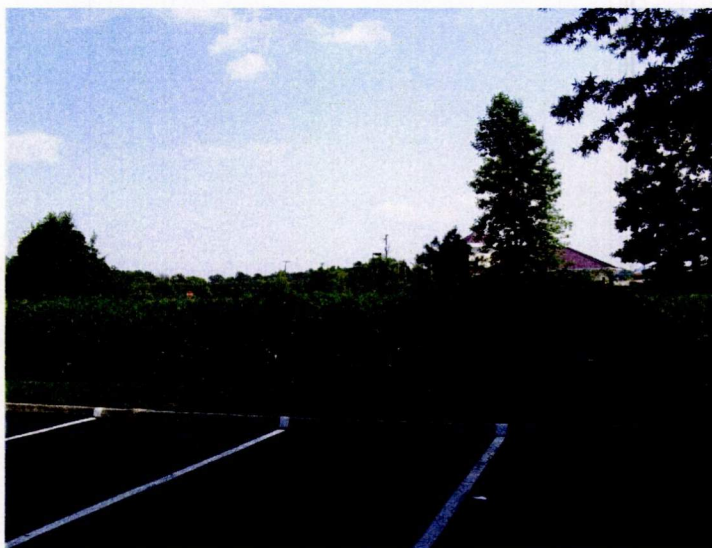
<b>Identifier:</b>	Kristiansand - 12
<b>Location:</b>	Econo Lodge (along southern edge of parking lot)
<b><u>Existing Conditions:</u></b>	Open space/brush adjacent to parking lot, curb and gutter along parking lot edge.
<b><u>Potential Improvements:</u></b>	Install curb cuts and offline bioretention filter within adjacent open area.

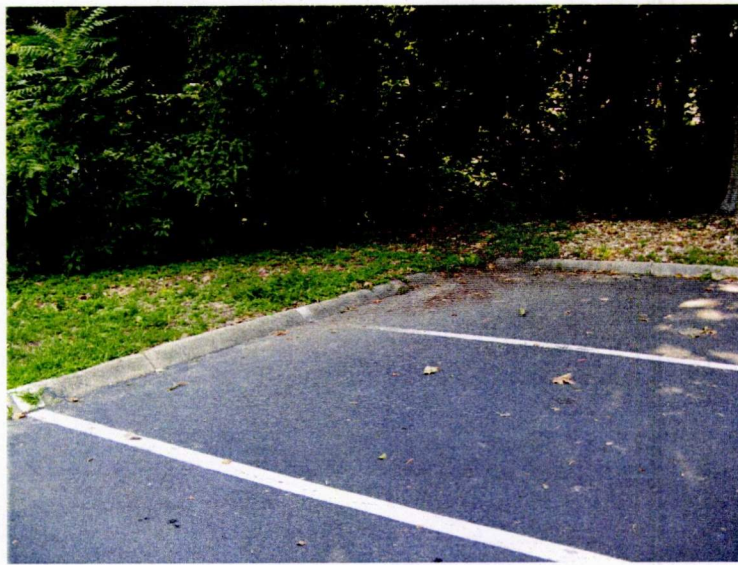
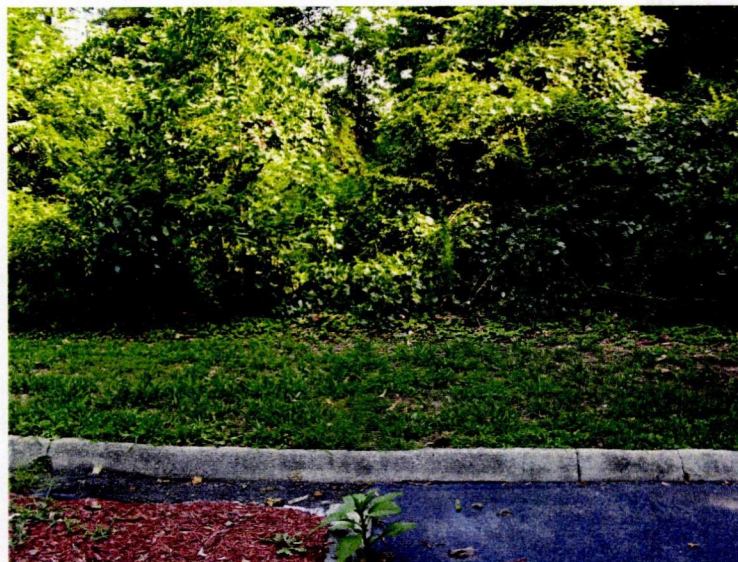
<b>Identifier:</b>	Kristiansand - 13
<b>Location:</b>	Econo Lodge (southwest corner of parking lot near dumpster)
<b><u>Existing Conditions:</u></b>	Open space/brush adjacent to parking lot, curb and gutter along parking lot edge.
<b><u>Potential Improvements:</u></b>	Install curb cuts and offline bioretention filter within adjacent open area.

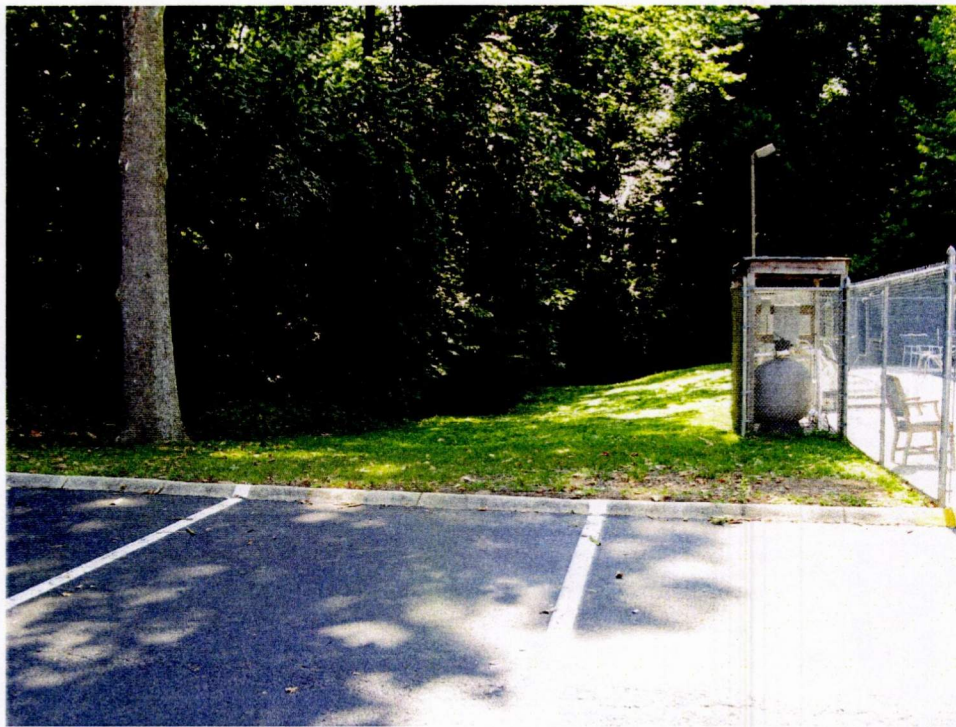
<b>Identifier:</b>	Kristiansand - 14
<b>Location:</b>	Econo Lodge (western edge of parking lot near swimming pool)
<b><u>Existing Conditions:</u></b>	Open space adjacent to parking lot. Curb and gutter along parking lot edge.
<b><u>Potential Improvements:</u></b>	Install curb cuts and offline bioretention filter within adjacent open area.

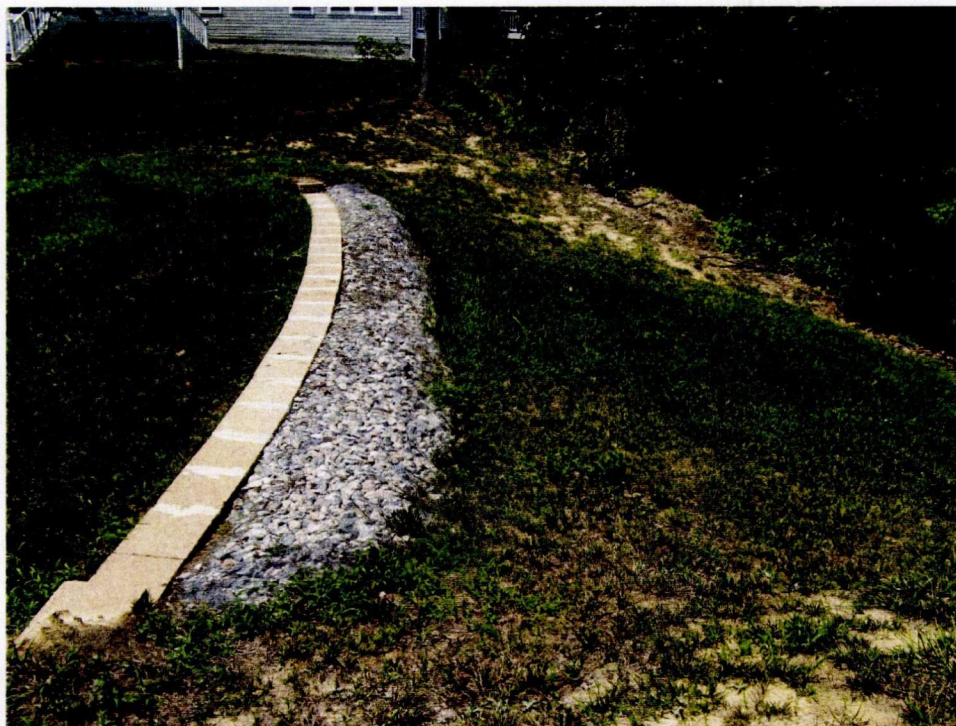
<b>Identifier:</b>	Kristiansand - 17
<b>Location:</b>	Behind houses north of Pinebrook Rd and east of Levingston Ln
<b><u>Existing Conditions:</u></b>	Concrete level spreader and filter strip which appears to be functioning well. Some barren areas near treeline.
<b><u>Potential Improvements:</u></b>	Install bioretention filter upslope of level spreader. Repair bare spots. Consider the use of natural buffer enhancement downslope rather than just maintained turf.

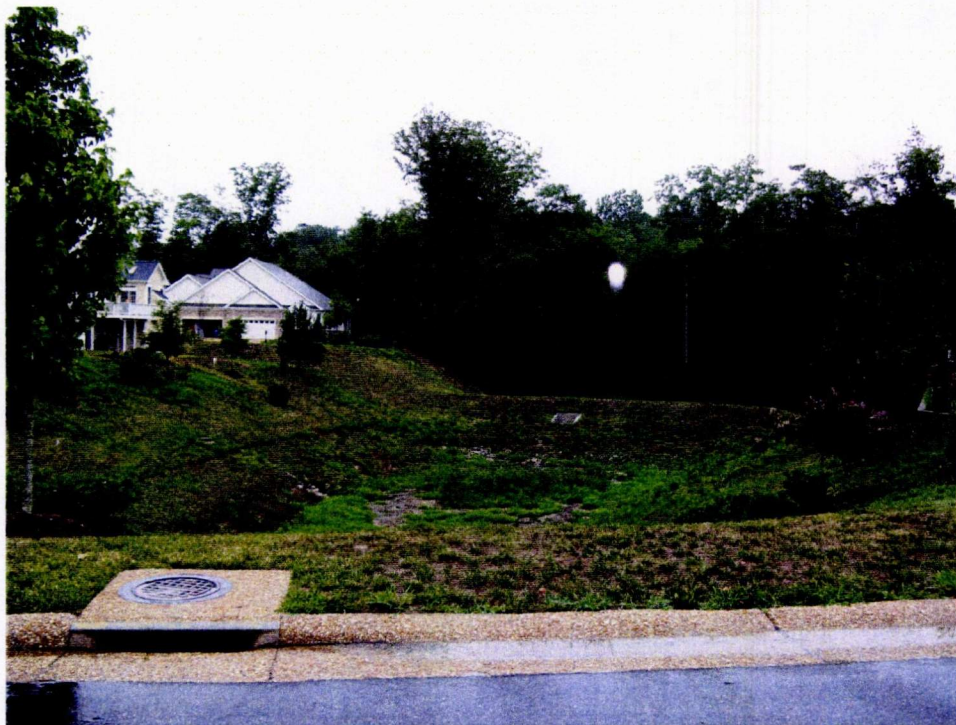
<b>Identifier:</b>	Kristiansand - 19
<b>Location:</b>	West of Pinebrook Rd, between Sandford Arms and Newport Forest
<b><u>Existing Conditions:</u></b>	Existing dry detention basin.
<b><u>Potential Improvements:</u></b>	Convert basin to an enhanced shallow marsh facility. Provide additional upland buffer plantings around buffer perimeter.

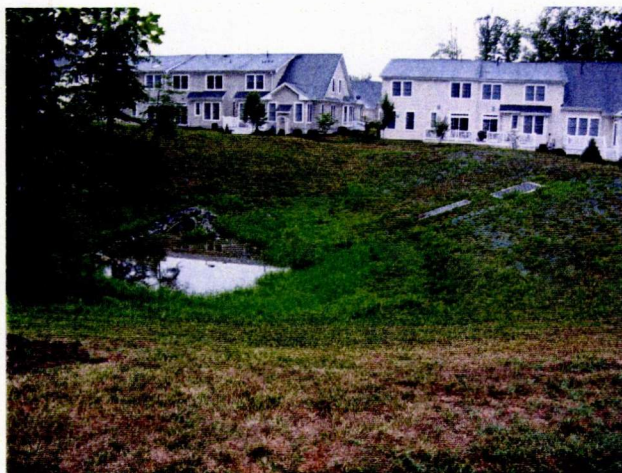
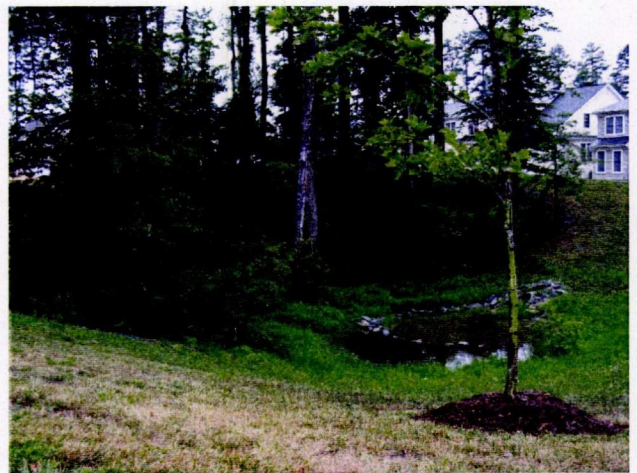
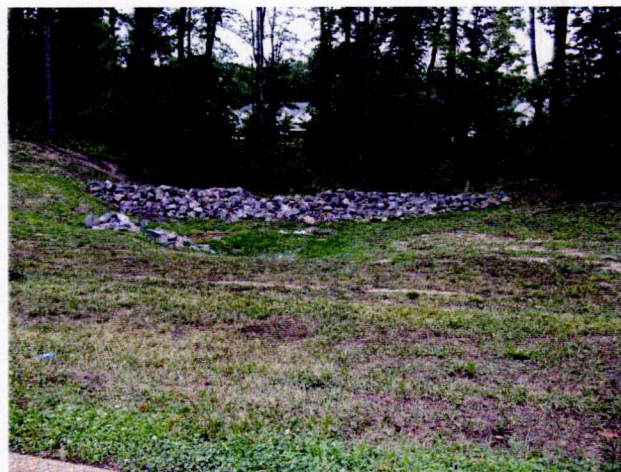
<b>Identifier:</b>	Kristiansand - 20
<b>Location:</b>	Northwest of intersection of Arthur Hills Dr and Pinebrook Rd
<b><u>Existing Conditions:</u></b>  Existing detention basin with forebay near intersection and preserved wooded buffer within basin interior.	
<b><u>Potential Improvements:</u></b>  Enhance the cleared portions of basin (including forebay) with shallow marsh plantings and/or micro-pools. Avoid disturbance of mature trees during retrofit activities.

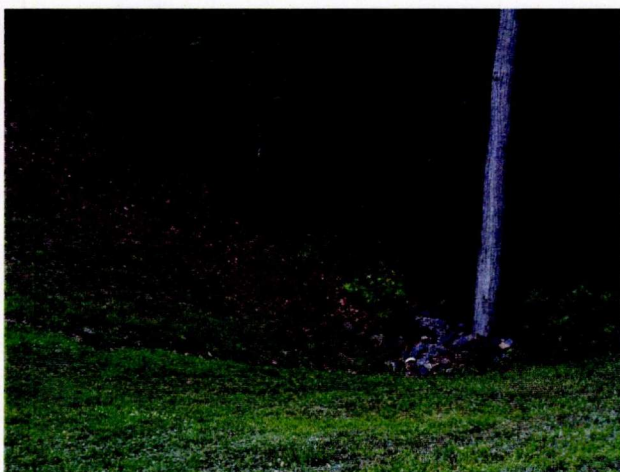
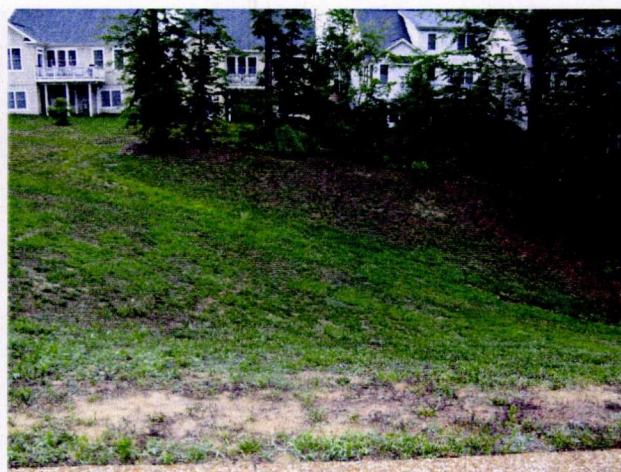
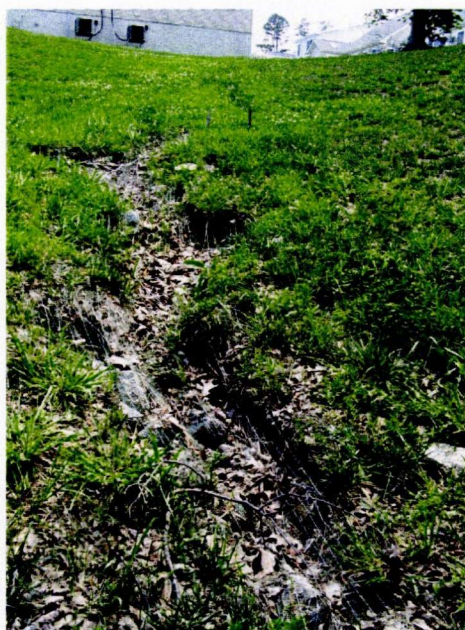
<b>Identifier:</b>	Kristiansand - 21
<b>Location:</b>	West of Sprucemont
<p><b><u>Existing Conditions:</u></b></p> <p>Overland flow down grassed slope to riprap check dam at transition to stream. Erosion occurring along slope and at interfaces of riprap berm.</p>	
<p><b><u>Potential Improvements:</u></b></p> <p>Repair erosion and provide a stabilized flow path down slope. May also be potential to construct biofiltration filter or shallow marsh basin pending further soil review.</p>

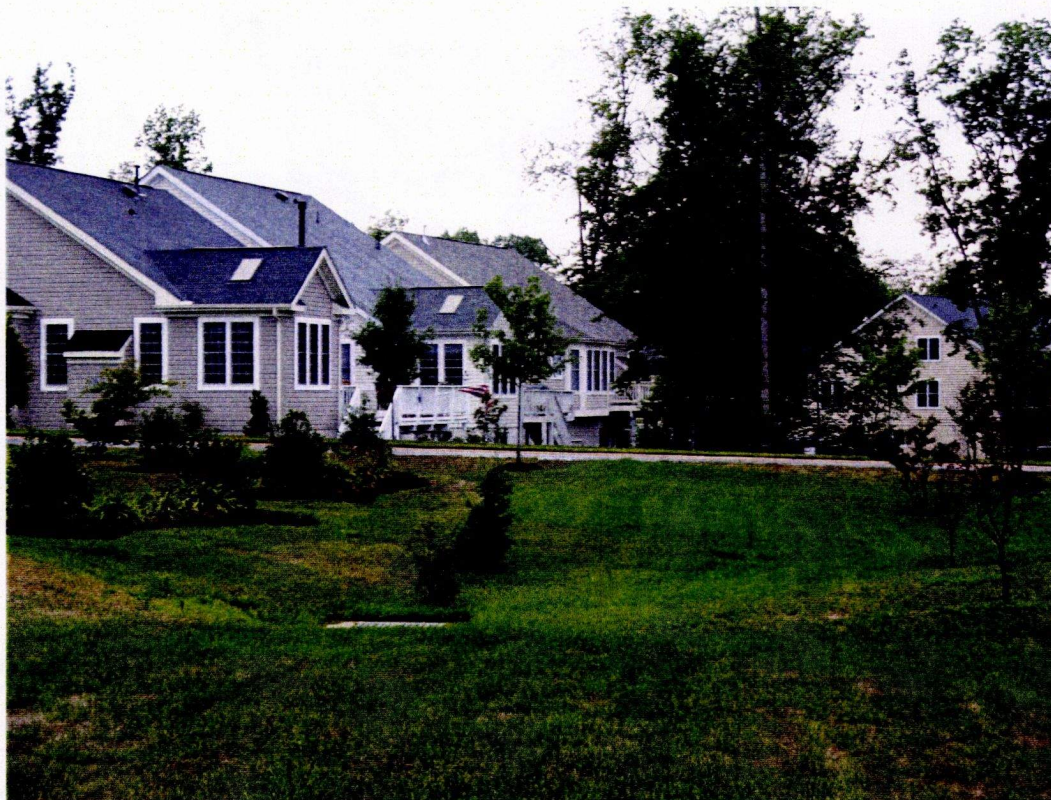
<b>Identifier:</b>	Kristiansand – 24
<b>Location:</b>	North of Arthur Hills Dr, between Cliffside Drive and St. Albans
<b><u>Existing Conditions:</u></b>	Existing drop inlet receiving residential drainage in between multiple lots.
<b><u>Potential Improvements:</u></b>	Construct bioretention filter around existing drop inlet.

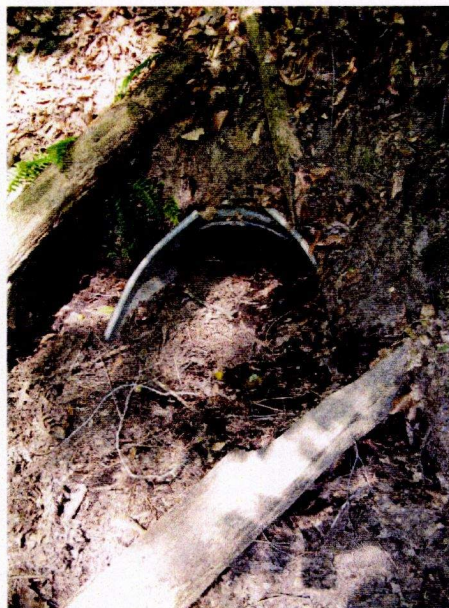
<b>Identifier:</b>	Kristiansand - 27
<b>Location:</b>	Herstad Ct Cul-de-sac
<b><u>Existing Conditions:</u></b>	Stormwater runoff from existing roadways is collected in concrete ditches and transported to this outfall culvert which connects to a manhole in the adjacent property owner's backyard and ultimately to the stream channel.
<b><u>Potential Improvements:</u></b>	Remove and dispose of sediment and debris from downstream invert. Modify outfall and/or provide outlet protection as needed to ensure stable transition to stream channel.

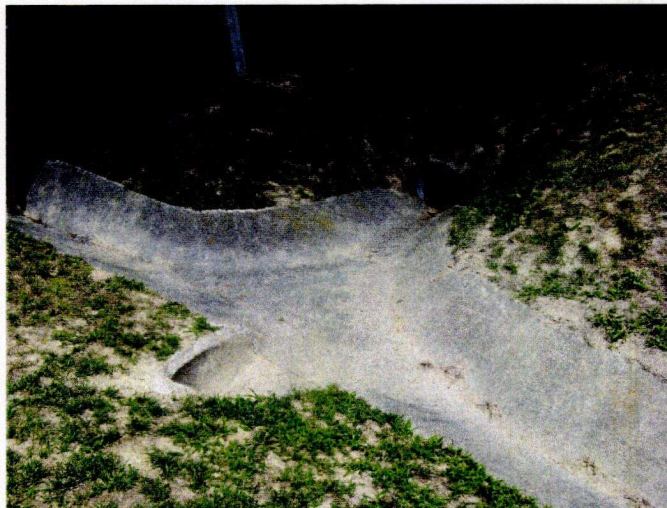
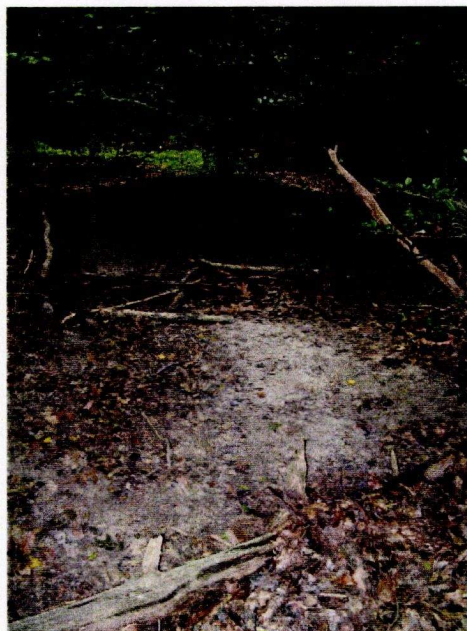
<b>Identifier:</b>	Kristiansand - 29
<b>Location:</b>	South of Nina Lane, between Kroken Court and Haradd Lane
<p><b><u>Existing Conditions:</u></b></p> <p>A culvert outfall from the roadside ditch to an open space parcel behind the existing residences. The precise outfall location could not be determined and may be buried beneath yard waste. Ultimately, the runoff is conveyed into a shallow swale through the existing woods.</p>	
<p><b><u>Potential Improvements:</u></b></p> <p>Remove any debris blocking culvert outfall and provide adequate outlet protection and/or transition channel. Potential for installation of BMP within the open space parcel, such as a shallow marsh or infiltration/bioretention basin pending further review.</p>

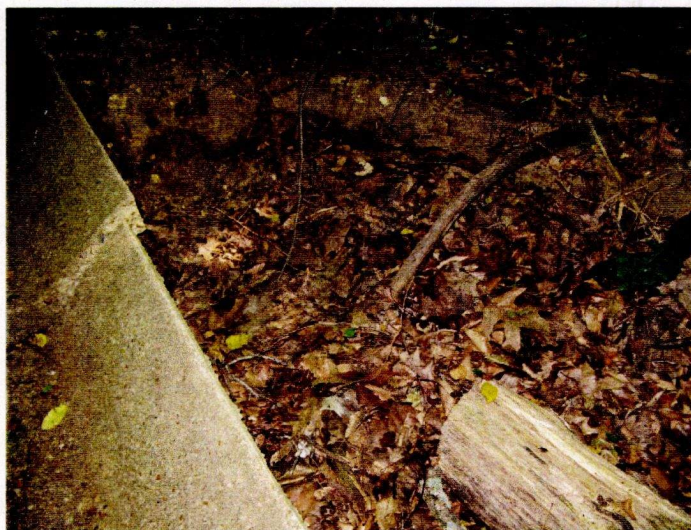
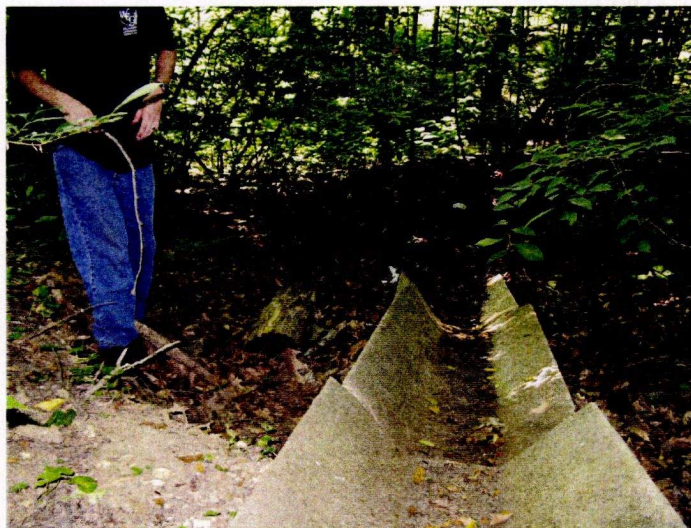
<b>Identifier:</b>	Kristiansand - 30
<b>Location:</b>	Stravenger Ct Cul-de-sac
<b><u>Existing Conditions:</u></b>	Existing concrete channel conveying stormwater from roadway to stream. Segments at the channel are damaged and undermined by scour along sides.
<b><u>Potential Improvements:</u></b>	Repair damaged segments of channel. Fill back in scour holes and stabilize. Modify outfall and/or provide outlet protection as needed to ensure stable transition to stream channel.

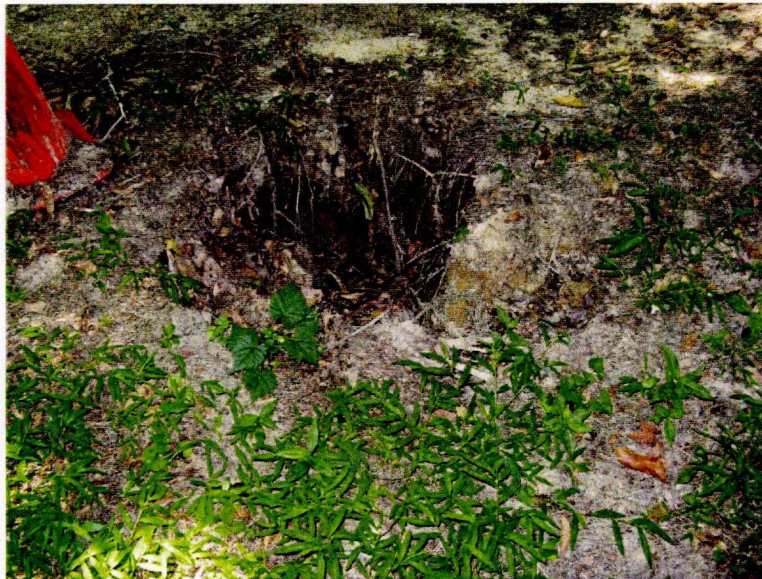
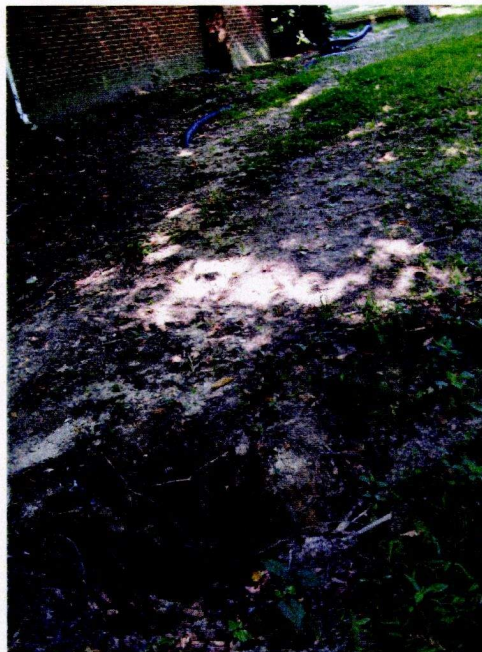
<b>Identifier:</b>	Kristiansand - 31
<b>Location:</b>	West of Haradd Lane before cul-de-sac
<b><u>Existing Conditions:</u></b>	Erosion noted at outfall of roof downspouts.
<b><u>Potential Improvements:</u></b>	Repair/stabilize erosion areas and ensure surface drainage is conveyed down the slope in a stabilized manner (such as slope drains, conveyance channels, or rock chutes).

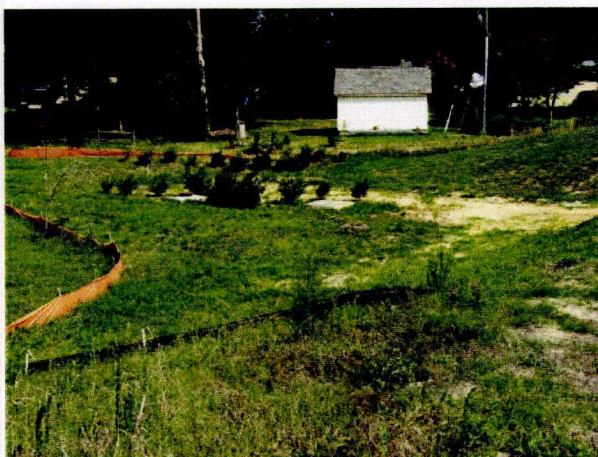
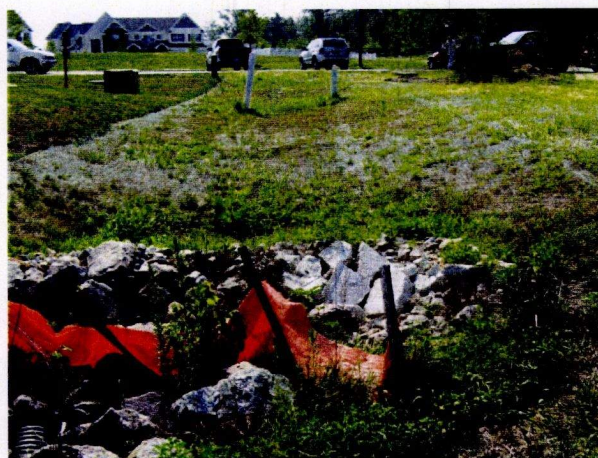
<b>Identifier:</b>	Kristiansand - 33
<b>Location:</b>	Western edge of Williamsburg Village
<b><u>Existing Conditions:</u></b>	<p>Appears to be a large, shallow dry detention/infiltration facility, but currently under construction. Some sediment accumulation and rill erosion present. Pretreatment swales direct runoff from condos to basin. Drop inlet structure uncovered and clogged with debris. Standing water within riser, and outfall pipe could not be located.</p>
<b><u>Potential Improvements:</u></b>	<p>Remove and dispose of accumulated sediment. Install nested bioretention filter within basin area. Potential for compost amended soils and enhanced vegetative cover for improved water quality treatment. Remove debris from drop inlet, locate and remove blockage, replace top of inlet structure, and ensure outfall pipe is properly daylighted. Additional review may yield potential to optimize outlet structure for improved water quality treatment and channel protection.</p>

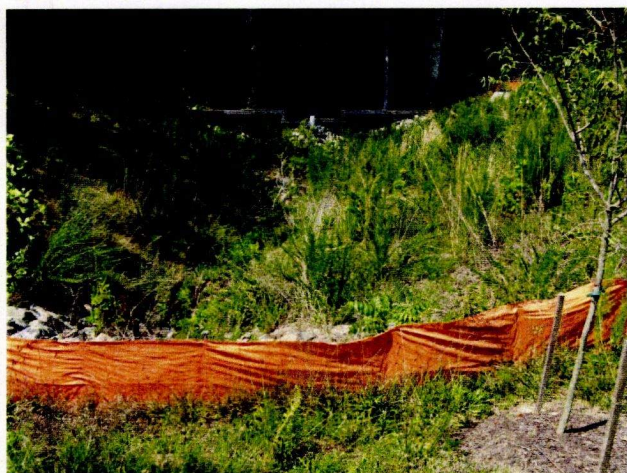
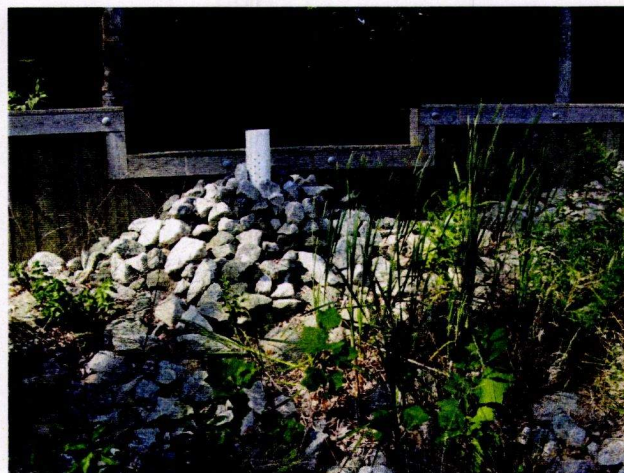
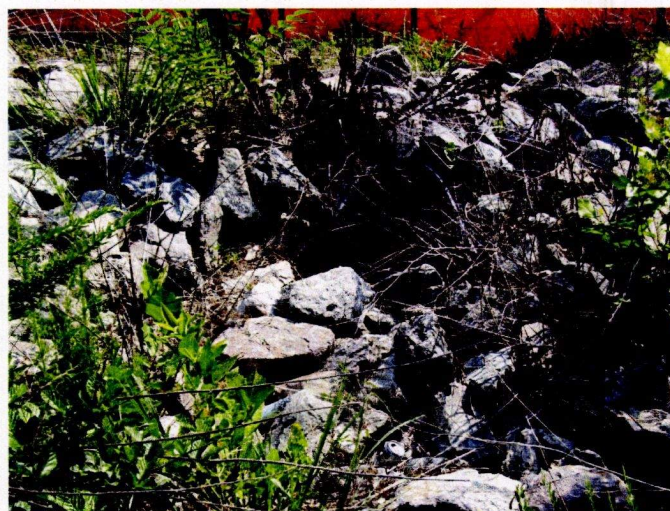
<b>Identifier:</b>	Kristiansand - 34
<b>Location:</b>	Southern edge of Williamsburg Village
<b><u>Existing Conditions:</u></b>	Dry detention basin with timber weir wall and perforated pipe outlet.
<b><u>Potential Improvements:</u></b>	Convert to an infiltration/bioretention basin or shallow marsh facility pending further soil evaluation. Ensure ends of weir wall are fully tied into slopes.

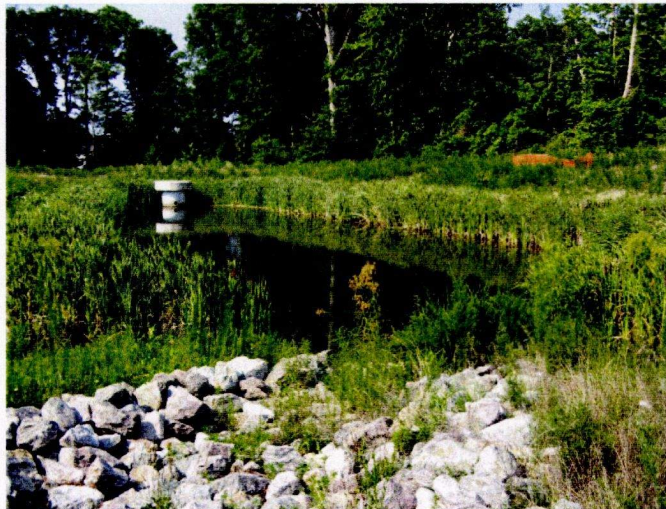
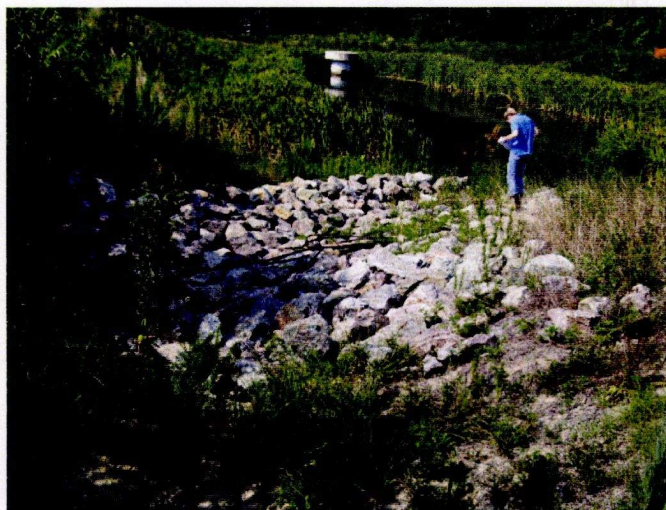
<b>Identifier:</b>	Kristiansand - 35
<b>Location:</b>	Between Williamsburg Village and Williamsburg Dodge
<p><b><u>Existing Conditions:</u></b></p> <p>Existing wet pond and wetland fringe. Low flow orifice does not have a debris rack, but currently not clogged. Large areas of riprap at inflow points. Some barren areas in uplands.</p>	
<p><b><u>Potential Improvements:</u></b></p> <p>Install debris rack over low flow orifice. Provide soil amendments and permanent seeding in any barren areas. Provide joint plantings within riprap areas, where appropriate, or replace with vegetated buffer. Evaluate the potential to expand the pond size (may be some room adjacent to parking lot of Williamsburg Dodge) and/or adjust outlet structure to treat other contributing areas than initially designed for. Should also consider installing submerged gabion wall across inflow points to create sediment forebays.</p>

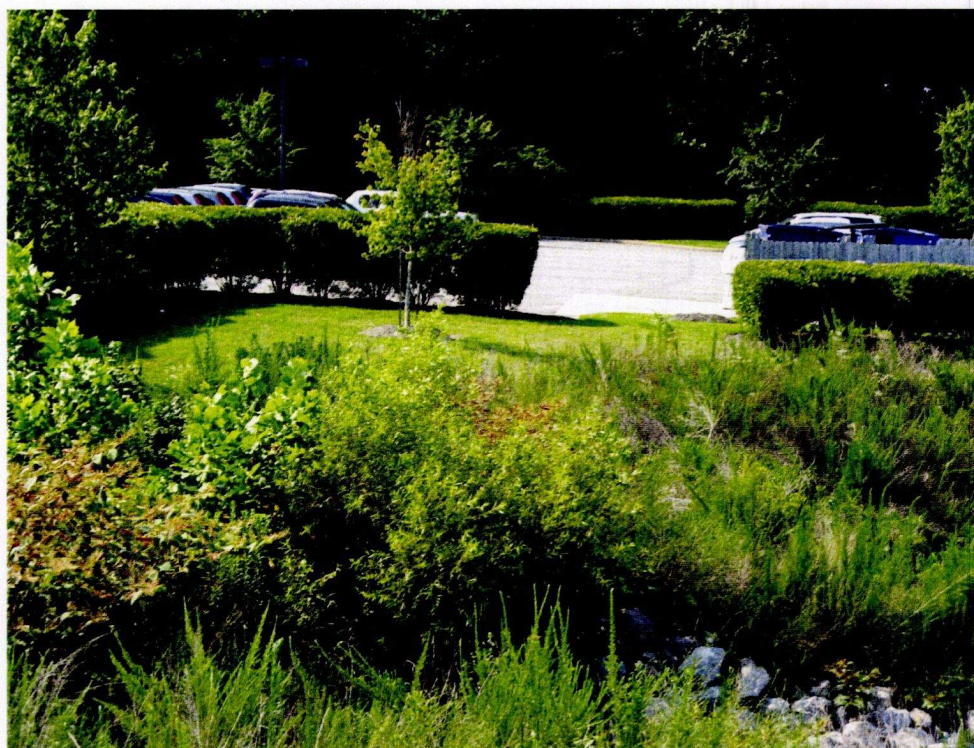
<b>Identifier:</b>	Kristiansand - 36
<b>Location:</b>	Parking lot in rear of Williamsburg Dodge
<b><u>Existing Conditions:</u></b>	Open area adjacent to parking lot near existing curb inlet.
<b><u>Potential Improvements:</u></b>	Construct curb cuts and offline bioretention filter or infiltration trench between parking lot and existing pond.

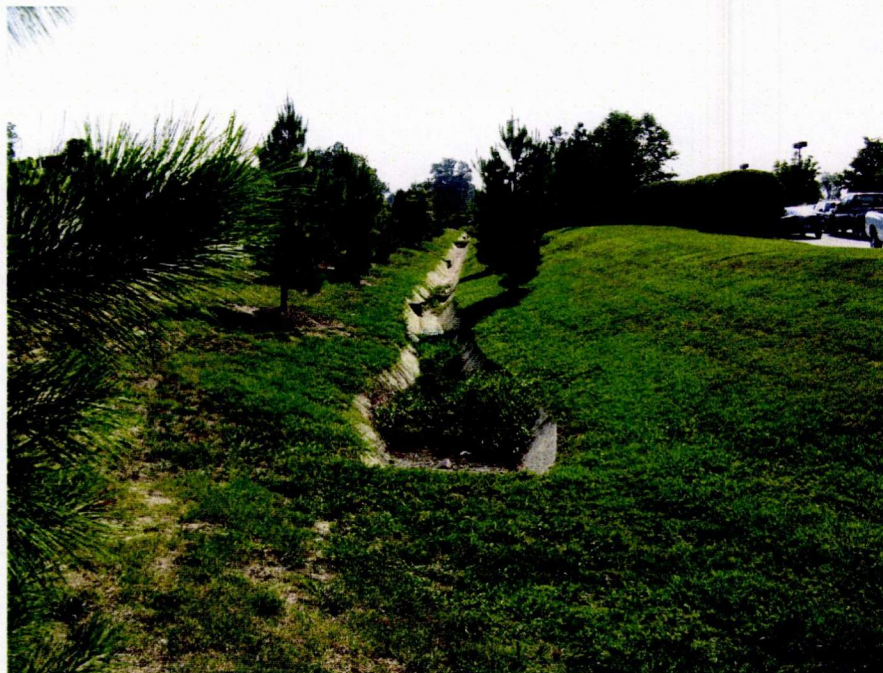
<b>Identifier:</b>	Kristiansand - 37
<b>Location:</b>	Between Williamsburg Village and Williamsburg Dodge
<p><b><u>Existing Conditions:</u></b></p> <p>Concrete channel receiving flow from Rt. 60 and adjacent development. Channel ultimately outfalls to existing pond discussed in Retrofit #35. A large amount of sediment accumulation is present at bottom of channel, burying what is assumed to be a drop inlet connecting to the pond.</p>	
<p><b><u>Potential Improvements:</u></b></p> <p>Remove and dispose of accumulated sediment. Construct an offline bioretention filter at end of channel (downslope of drop inlet). Alternately, a pre-treatment sediment forebay could be constructed at the end of the channel and outfall adjusted accordingly. Further evaluation could also be provided to determine the feasibility of replacing the concrete-lined channel with another which better promotes infiltration. This may consist of a grassed swale with soil amendments and check dams (however the longitudinal slope and number of check dams could be problematic).</p>

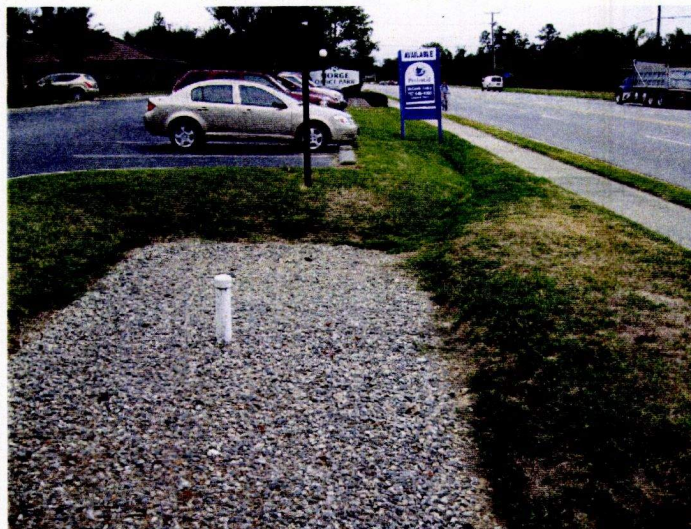
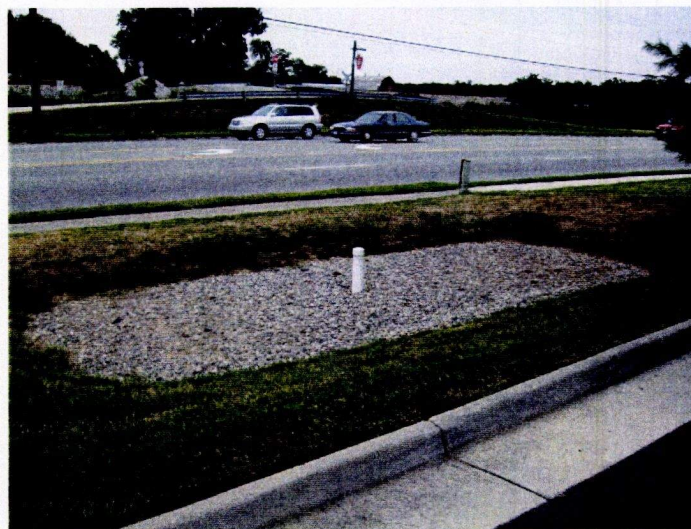
<b>Identifier:</b>	Kristiansand - 39
<b>Location:</b>	Norge Office Park (southeast corner)
<b><u>Existing Conditions:</u></b>	Existing gravel infiltration trench adjacent to parking lot. Appears to be functioning well.
<b><u>Potential Improvements:</u></b>	To improve the aesthetic value of the facility, perimeter landscaping and/or a surface layer of topsoil and vegetative ground cover could be employed. If the basin is to be topdressed, further evaluation of its function should be performed to ensure water quality benefits are not compromised and to determine the new design configuration (may require an overflow structure).

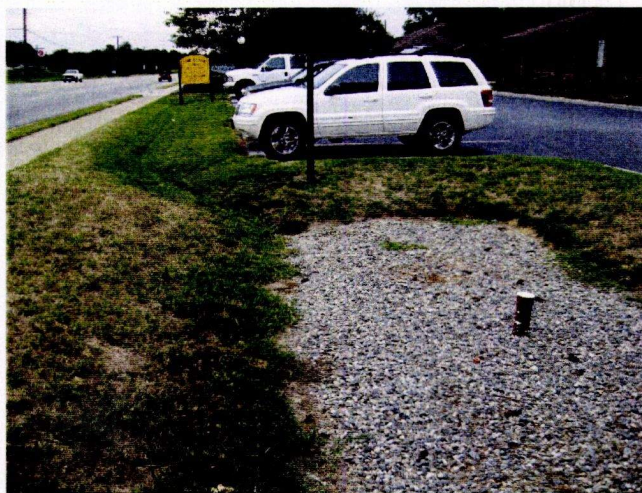
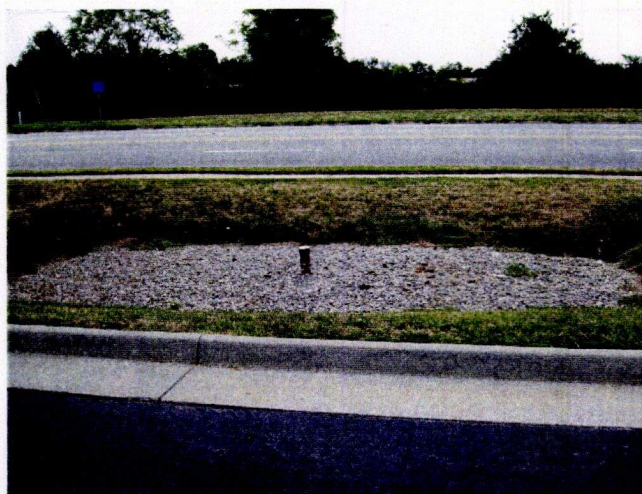
<b>Identifier:</b>	Kristiansand - 40
<b>Location:</b>	Norge Office Park (northeast corner)
<b><u>Existing Conditions:</u></b>	Existing gravel infiltration trench adjacent to parking lot. Appears to be functioning well.
<b><u>Potential Improvements:</u></b>	To improve the aesthetic value of the facility, perimeter landscaping and/or a surface layer of topsoil and vegetative ground cover could be employed. If the basin is to be topdressed, further evaluation of its function should be performed to ensure water quality benefits are not compromised and to determine the new design configuration (may require an overflow structure).

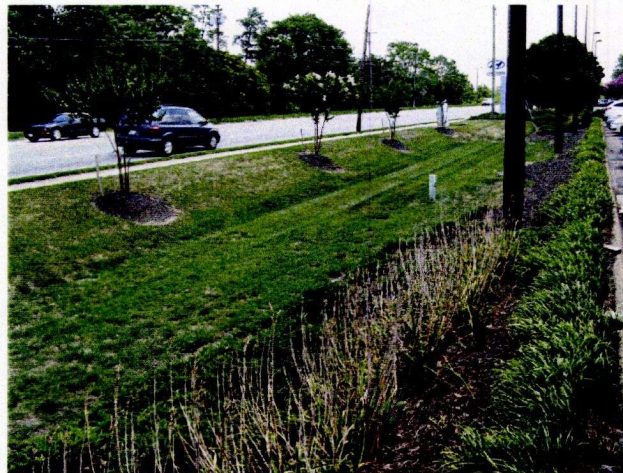
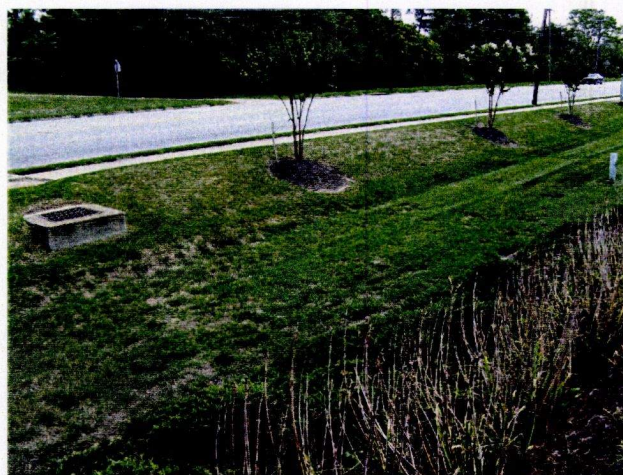
<b>Identifier:</b>	Kristiansand - 42
<b>Location:</b>	Front of Williamsburg Honda
<b><u>Existing Conditions:</u></b>	Existing infiltration basin between Rt. 60 and parking lot of Williamsburg Honda which appears to be functioning well.
<b><u>Potential Improvements:</u></b>	Identified in Yarmouth Creek Watershed Plan (104-R1). Enhance existing basin by adding landscaping and mulch layer to function more like a bioretention facility.

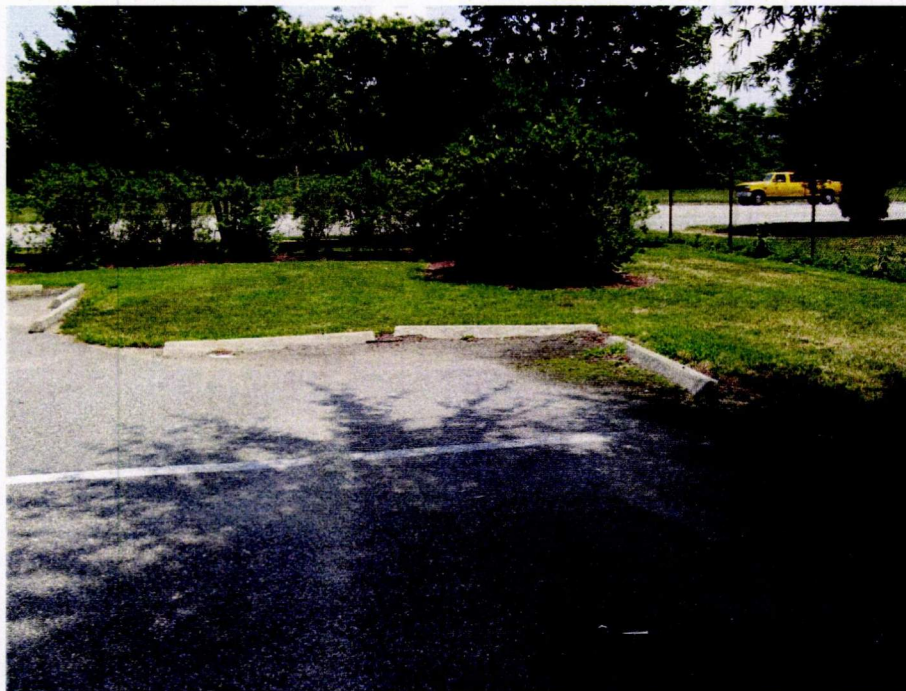
<b>Identifier:</b>	Kristiansand - 43
<b>Location:</b>	Norge Elementary School (southeast corner of parking lot near Rt. 60)
<p><b><u>Existing Conditions:</u></b></p> <p>Open area adjacent to parking lot receiving surface runoff from pavement. Some sediment accumulation at edge of parking lot.</p>	
<p><b><u>Potential Improvements:</u></b></p> <p>Construct a bioretention filter or infiltration trench to treat the parking lot runoff. Remove and dispose of accumulated sediment and configure entrance to biofilter to help prevent future sediment buildup. Stabilized overflow or level spreader needed as biofilter outlet. Cooperation with the school as an educational tool is also recommended. Other retrofits not identified herein may also be feasible at the school pending further evaluation.</p>

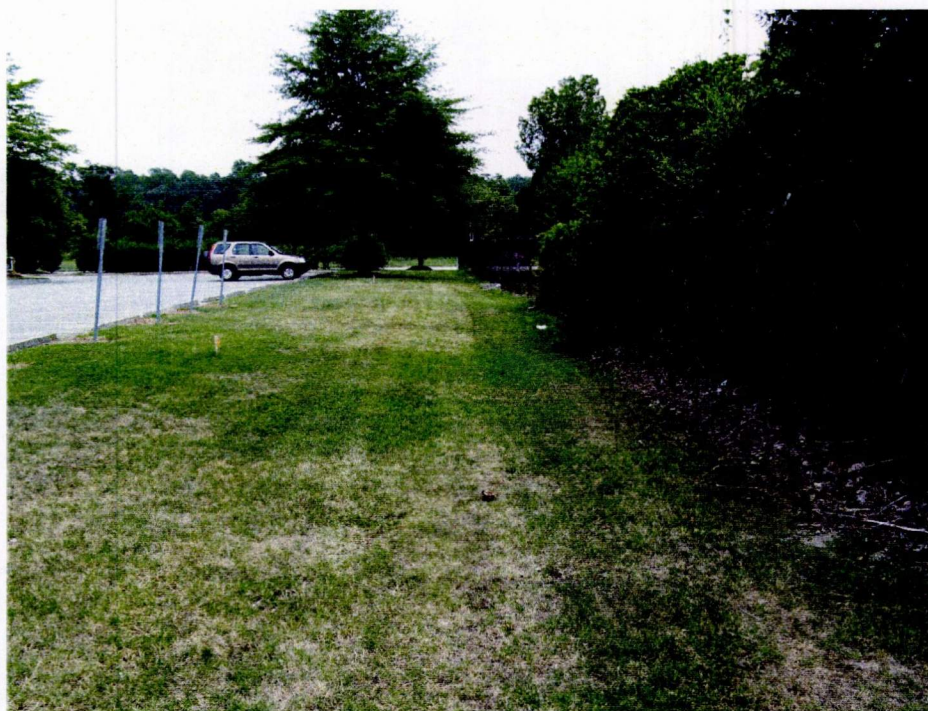
<b>Identifier:</b>	Kristiansand - 44
<b>Location:</b>	Norge Elementary School (southern edge of parking lot)
<b><u>Existing Conditions:</u></b>	
Open area adjacent to parking lot receiving surface runoff from pavement.	
<b><u>Potential Improvements:</u></b>	
Construct bioretention filters, an infiltration trench, or an engineered swale to treat the parking lot runoff. Discharge into proposed Retrofit #43. Cooperation with the school as an educational tool is also recommended. Other retrofits not identified herein may also be feasible at the school pending further evaluation.
