# Kristiansand Subdivision

# STREAM CONDITION SUMMARY MAP JCC - KRISTIANSAND TRIBUTARY JAMES CITY COUNTY, VIRGINIA

WATERSHED EVALUATION  
SUMMARY MAP

JCC - KRISTIANSAND TRIBUTARY  
JAMES CITY COUNTY, VIRGINIA

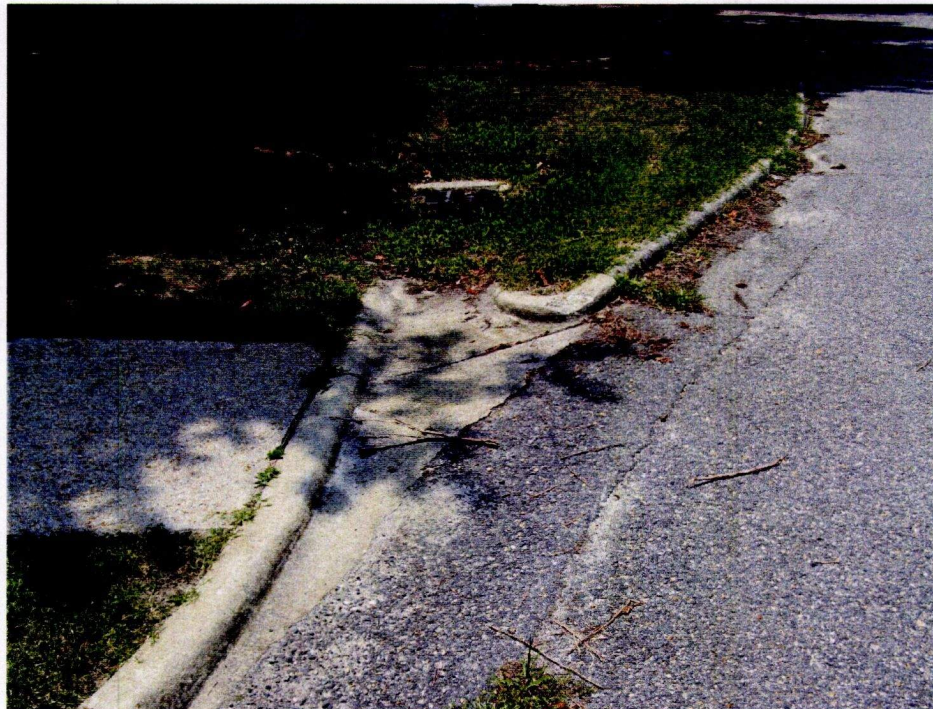
**Identifier:** Kristiansand - 45

**Location:** Norge Elementary School (south behind school, near bend in access road)

Construct a bioretention filter around existing drop inlet. Ensure adequate protection at inflow from flume. Tie underdrains of biofilter into existing inlet. Cooperation with the school as an educational tool is also recommended. Other retrofits not identified herein may also be feasible at the school pending further evaluation.

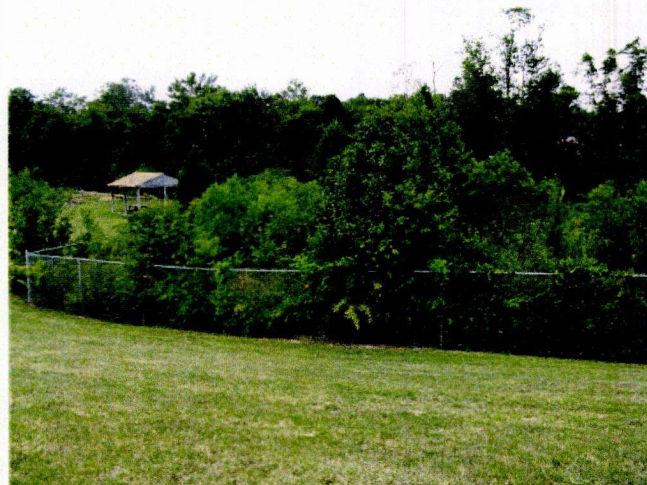
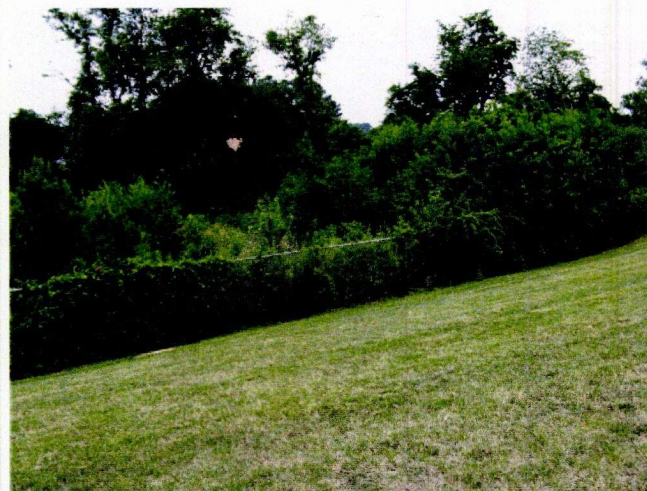
<b>Identifier:</b>	Kristiansand - 47
<b>Location:</b>	Norge Elementary School (behind school to the west)
<p><b><u>Existing Conditions:</u></b></p> <p>Existing wetland area or shallow BMP surrounded by chain link fence. Appears to be outfall from the school storm sewer system.</p>	
<p><b><u>Potential Improvements:</u></b></p> <p>Even though this area drains away from the tributary of concern for this study (as may other portions of Norge Elementary School), it could be evaluated for potential retrofits. This area was not reviewed in great detail in this study, but there may be potential for a shallow marsh BMP retrofit, outlet protection, pre-treatment forebay, and/or existing wetland enhancement pending further evaluation.</p>

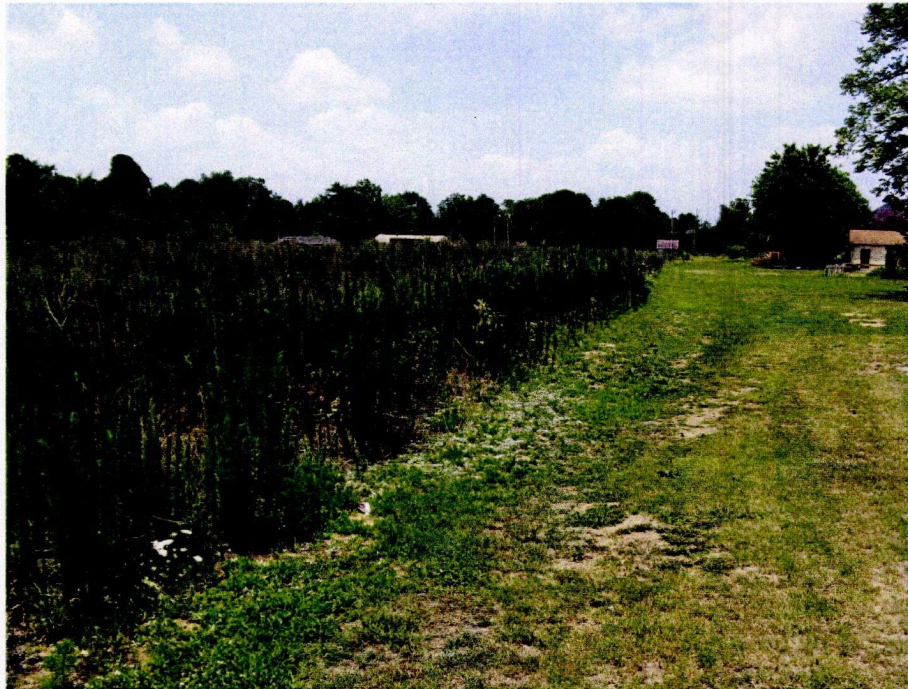
**Identifier:** Kristiansand - 48

**Location:** Open field west of development on Rt. 60, immediately north of school

Construct treatment practices downslope of developed areas. May include practices such as level spreaders, filter strips, engineered swales, bioretention filters, or infiltration basins pending further evaluation.

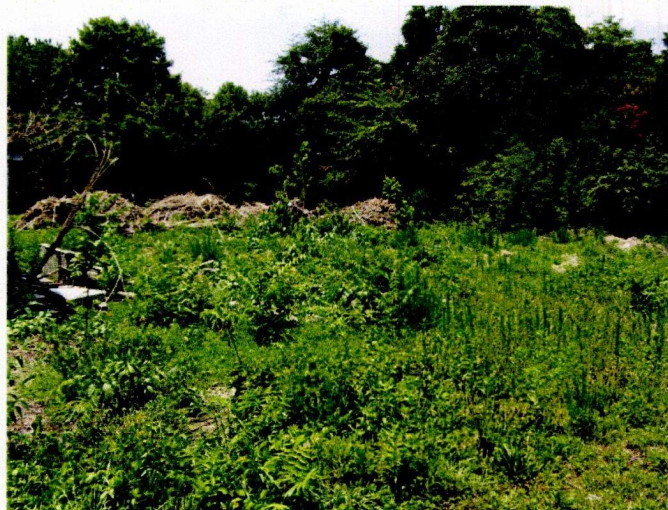
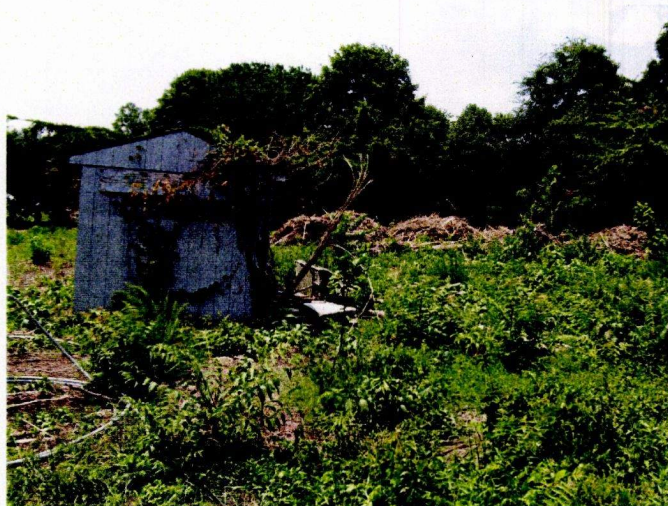
**Identifier:** Kristiansand - 49

**Location:** Open field west of Motor Lodge on Rt. 60

Construct treatment practices downslope of developed areas. May include practices such as level spreaders, filter strips, engineered swales, bioretention filters, or infiltration basins pending further evaluation.
