**A G E N D A**  
**JAMES CITY COUNTY WETLANDS BOARD**  
**REGULAR MEETING**  
**County Government Center, Building F**  
**101 Mounts Bay Road, Williamsburg, Virginia, 23185**  
**January 13, 2021**  
**5:00 PM**

1. Case No. WJPA 20-0038 / VMRC 20-1934 : 8797 Pocahontas Trail

**Breakwaters**  
**WJPA 20-0038**  
**8797 Pocahontas Trail**

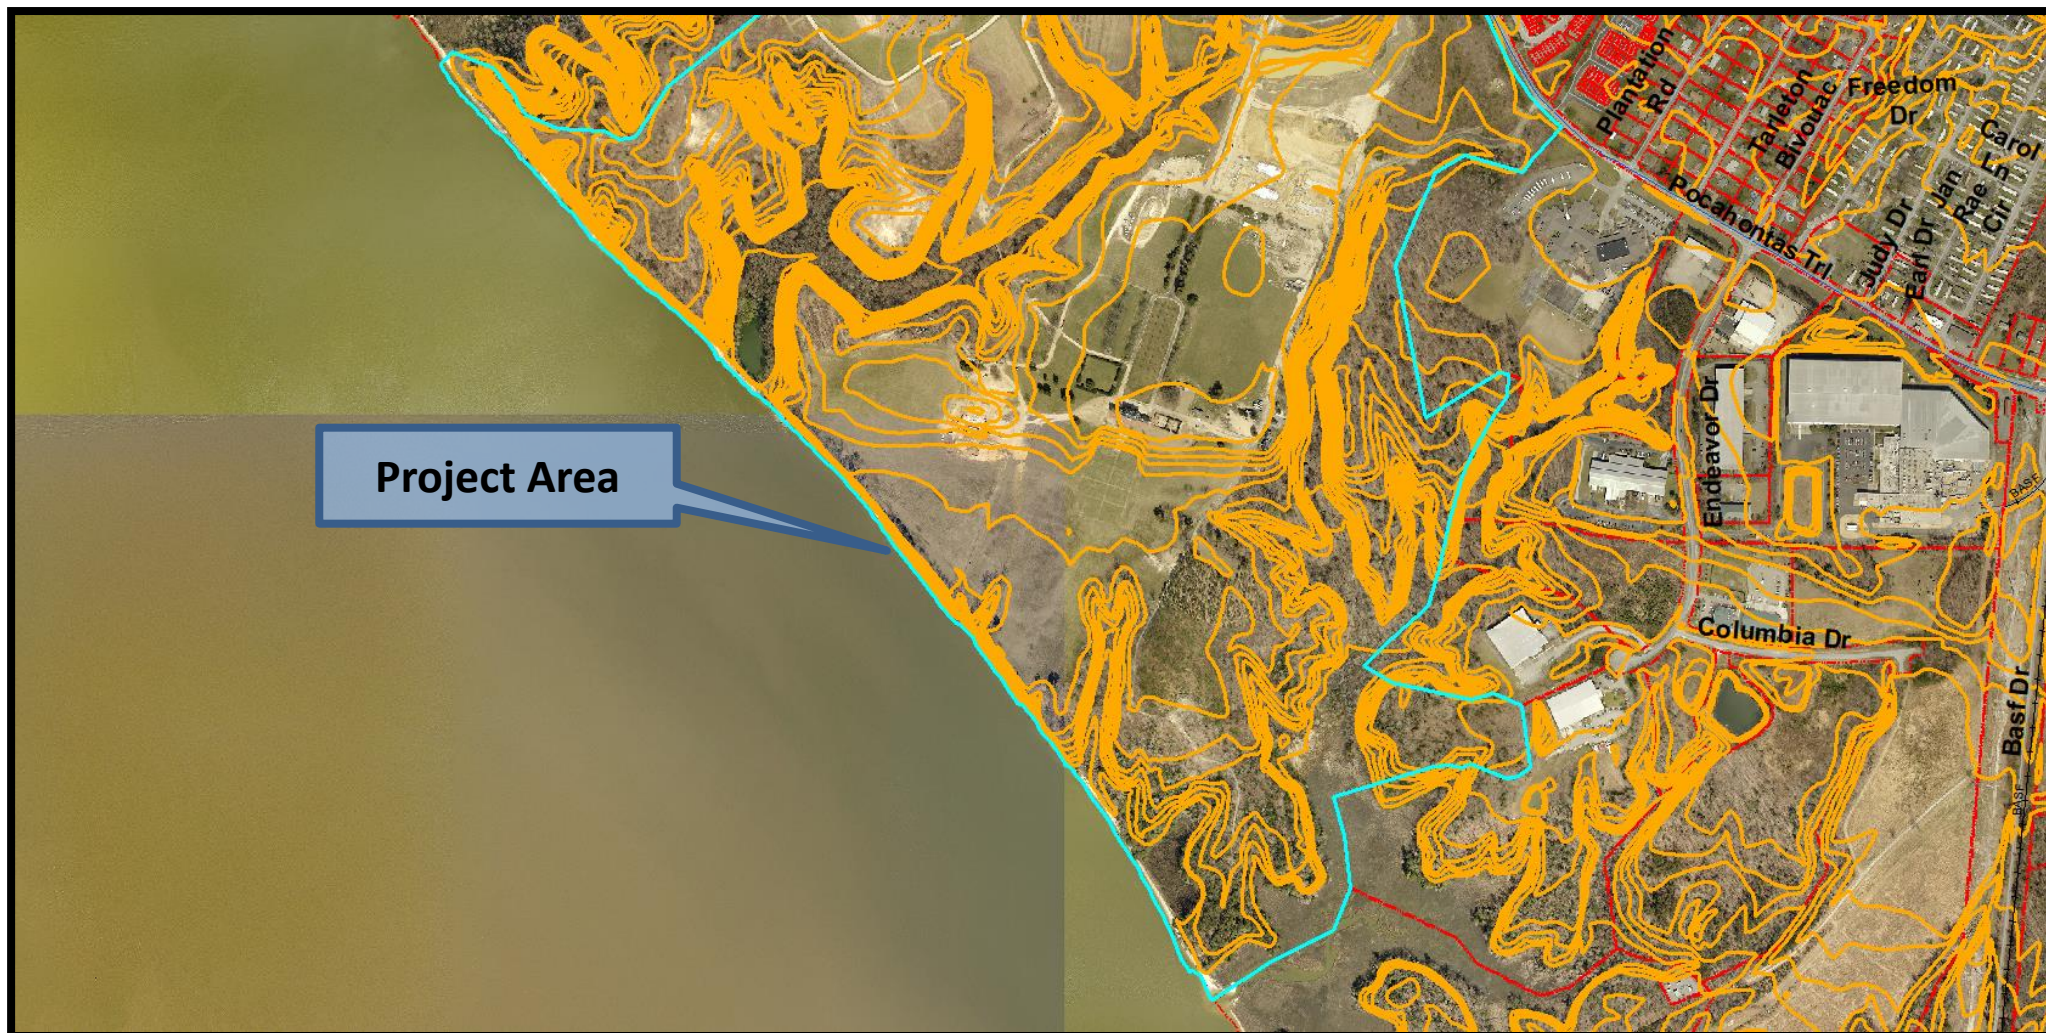
Site Plan showing proposed improvements, submitted October 29, 2020. For representative use only for presentation of case #WJPA 20-0038.

The shoreline is characterized by heavily eroding banks caused by offshore wave action. The height of several of the bluffs are estimated at over 50 feet. Consistent with Senate Bill 776 enacted on July 1, 2020, the applicant is proposing a living shoreline approach to protect and restore the property. The project consists of 12 free-standing, offshore, armor stone breakwaters, and 78,000 cubic yards of sand fill to create 108,754 square feet of sandy, intertidal shoreline and 285,595 square feet of vegetated shoreline. The plantings are *Spartina patens* (saltmeadow hay) planted on 18-inch centers.

In addition, a failed concrete drainage channel located in the center of an existing revetment will be replaced with a pipe outfall and a failing spillway from a freshwater pond adjacent to the shoreline will be replaced with a spill box and emergency spillway.

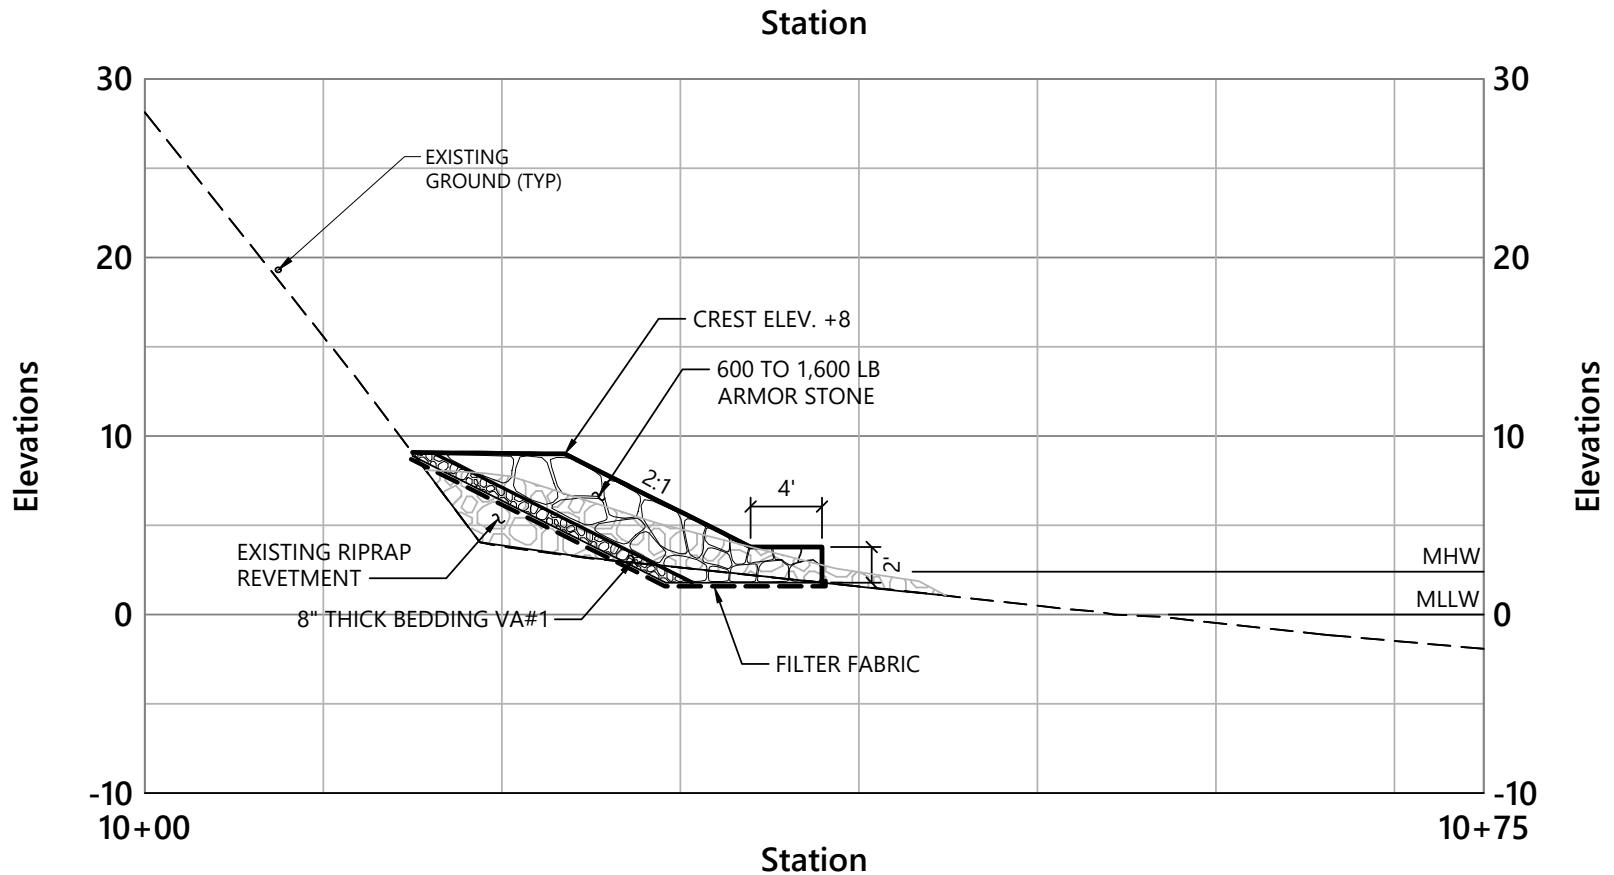
## Revetment Over Existing Revetment

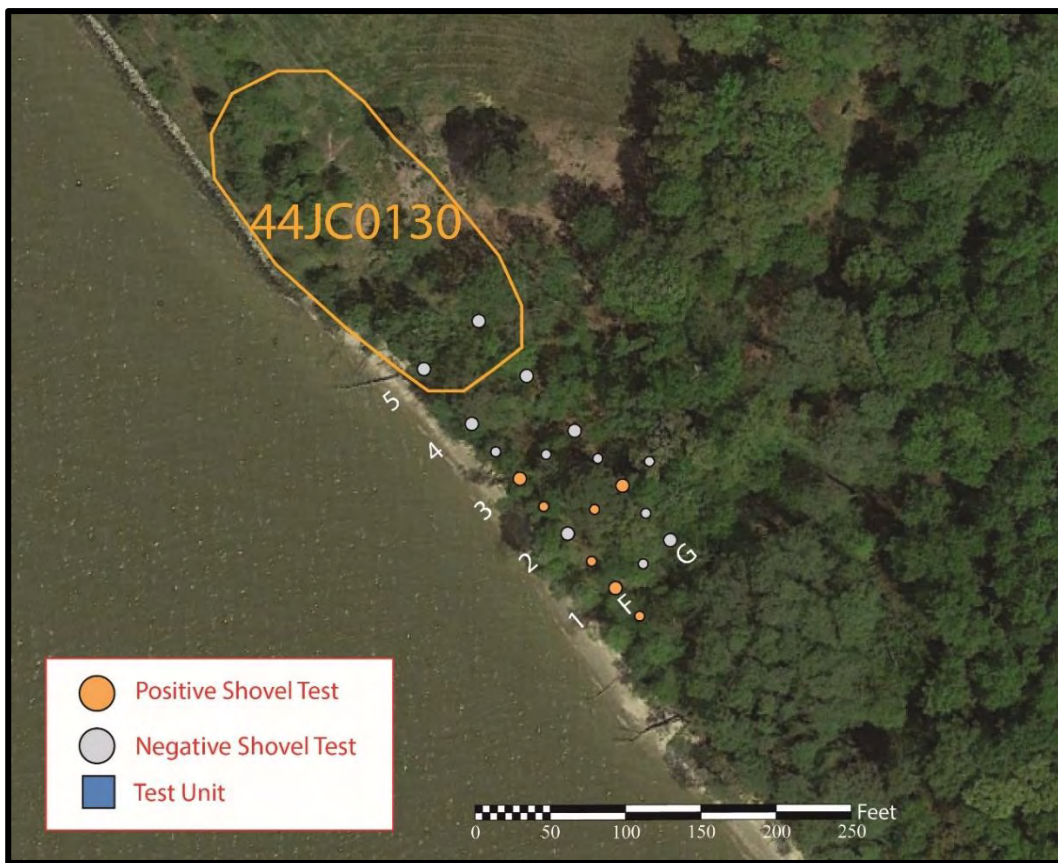
**Figure 5.** Shovel test locations at Area 1.

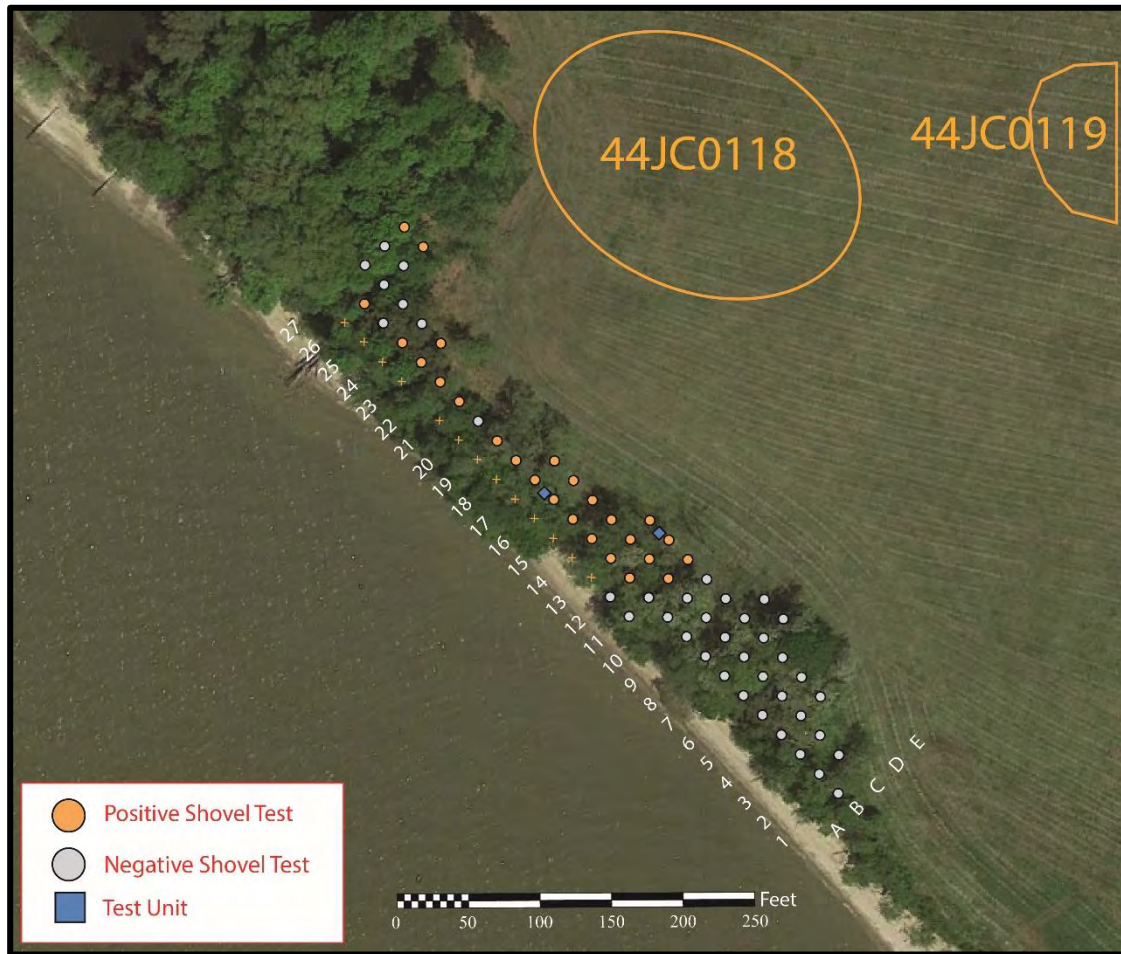
**Figure 8.** Shovel test locations at Area 2.

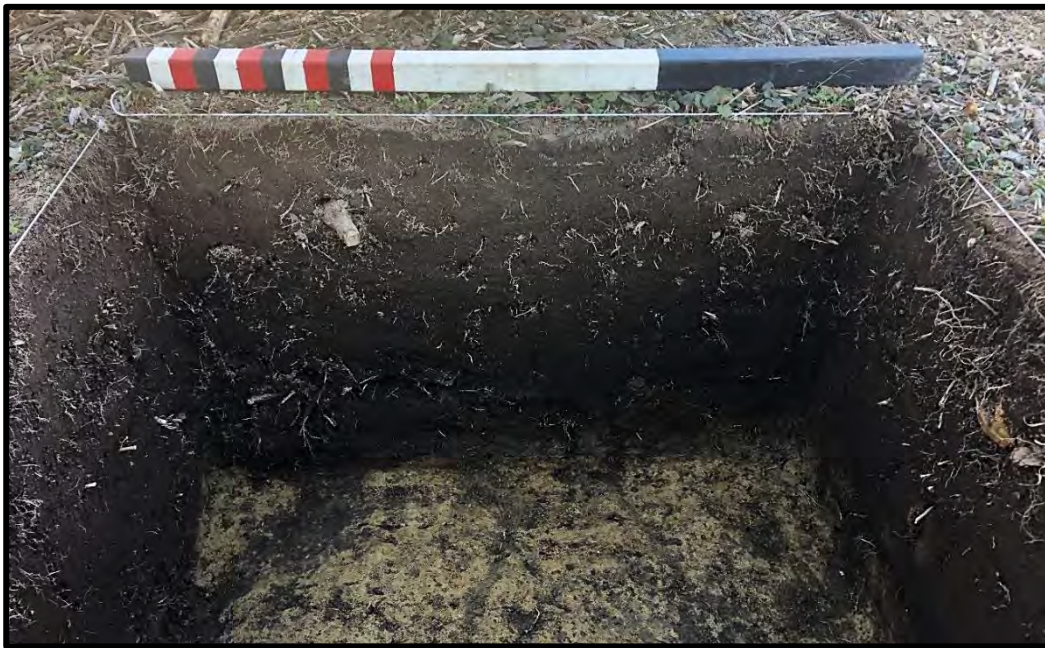
**Figure 14.** North profile of Test Unit 2.

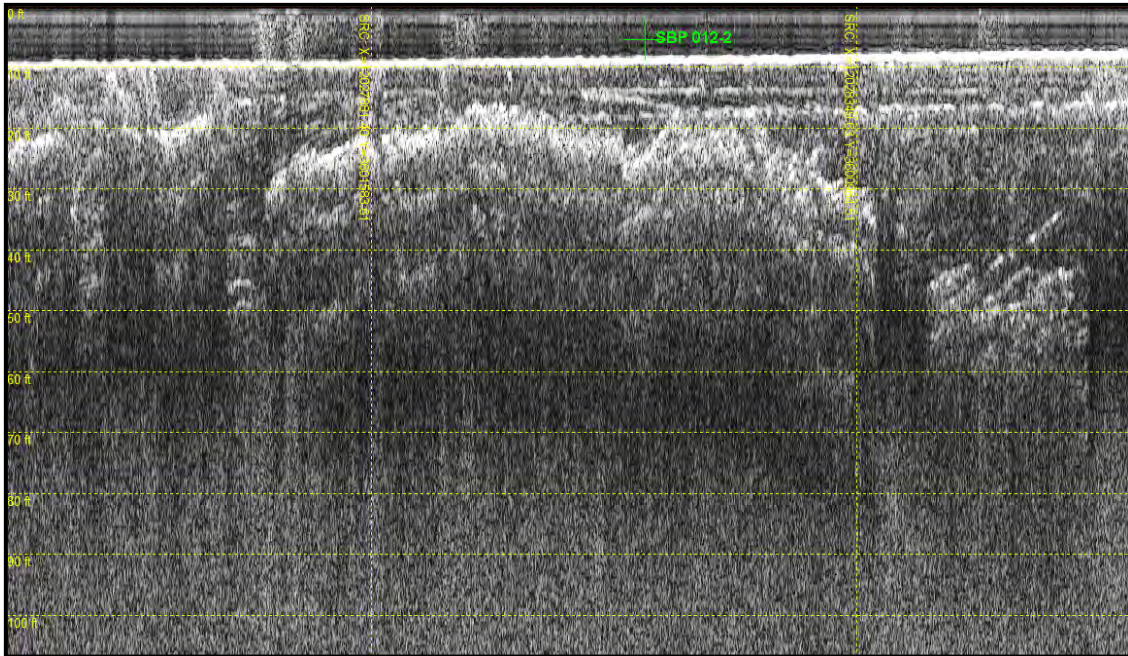
**Figure 24. Sub-bottom profiler data image of feature representing infilling with organic debris or dense material cap.**
