BMP NUMBER: **PC033**

Subdivision, Tract, Business or Owner Name (if known): Longhill Gate Homeowners Association

Upper wet pond located on the north side of the main entrance road; Combined folder with PC033

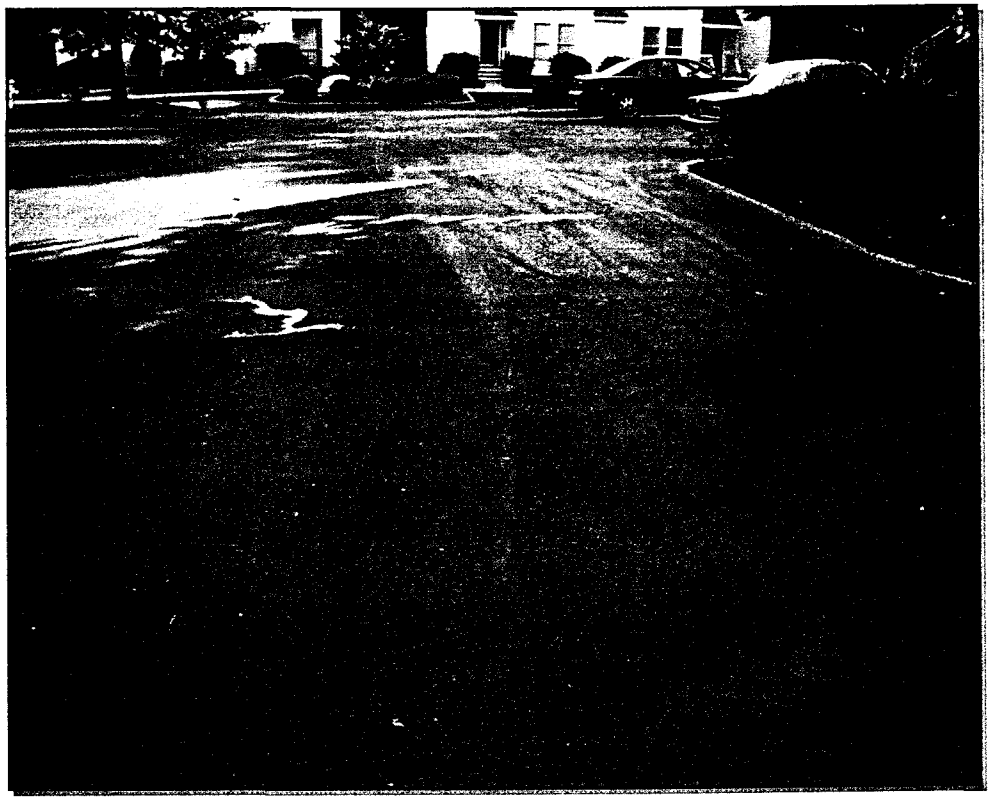
Areas of subgrade failure characterized by irregular cracking will sometimes weep trapped moisture contained in underlying aggregate or subgrade soils. Referencing Photo 3, the area located in the *Tower Hill* section represents the trapped moisture weeping from the subgrade, and also beneath the asphalt surface. Although the pavement has not completely failed in the area, future pavement failure can be expected, as the trapped moisture is weakening subgrade.

Photo 3 – Tower Hill
Evidence of trapped moisture weeping through cracks in the asphalt surface.

Again, AES Consulting Engineers recommends that areas of substantial subgrade failure be repaired. A French drain system will help prevent pavement failure by eliminating trapped moisture, but this is a very costly, "after the fact", repair. Due to the isolated areas of failure, it is recommended that the areas of subgrade failures be excavated to suitable and stable subgrade soil conditions; the depth of excavation could be as deep as 18-inches, or more. The subgrade must be compacted and tested to reveal any weakness of the soil. A layer of aggregate, 21-A stone or cement treated aggregate (CTA) with a minimum thickness of 8-inches should be placed over the subgrade, capped with a minimum 4-inch asphalt surface layer, asphalt type SM-2A. Asphalt joints should be sealed with liquid A-C prior to asphalt surface placement. Such repair efforts have demonstrated good results, with a minimum chance of a reoccurring failure.

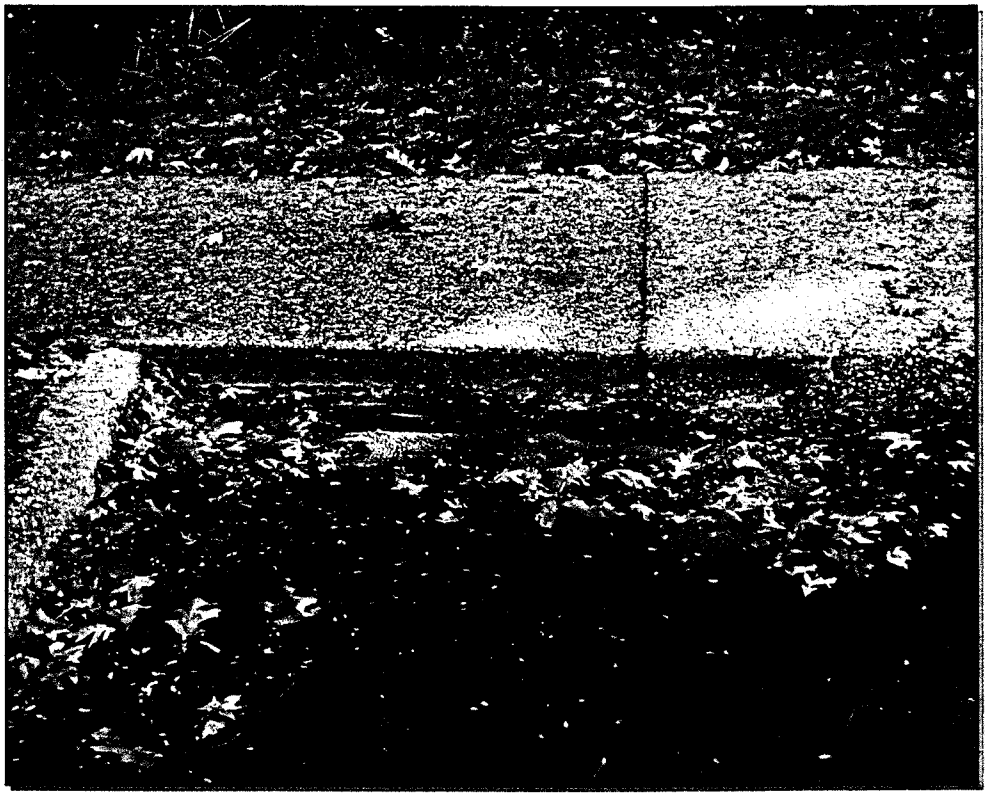
The curbing and sidewalks in *Longhill Gate* are rated to be in fair to good condition. Since AES report dated February 1997, it appears some of the damaged concrete sidewalks and curb sections have been repaired or replaced. AES believes the original poor condition of the curbs and sidewalks is due, in some degree, to substandard workmanship, as this is still evidence in some areas. (See Photo 8)

Photo 8 – Tower Hill
Note voids in the bottom of the sidewalk, which demonstrate poor construction workmanship.

With respect to the sidewalks, AES recommends that all cracked and broken sidewalks, and areas of the sidewalk where poor workmanship is observable, continue to be replaced to minimize pedestrian hazards. During replacement, the soils under the sidewalk should be compacted and the replacement sidewalk should be installed using fiber reinforced concrete, 4-inches thick.

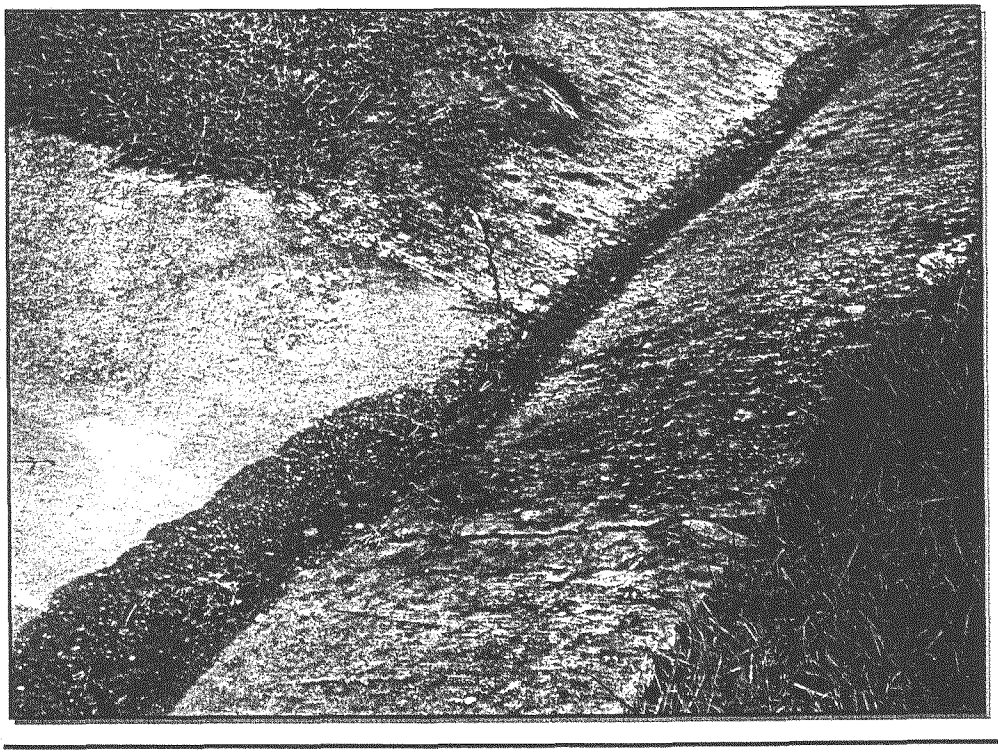
Photo 10 – Highgate Green
Note the cracks in the paved ditch section; there is also evidence of large voids beneath the paved channel in several locations.

pumped into the void regions. All paved ditches, which have become broken and misaligned due to lack of proper support must be repaired or replaced. AES suggests the damaged section of the ditch be removed between the crack control joints, the voids in the earth filled with compacted fill material, and a replacement paved ditch be constructed using fiber reinforced concrete.

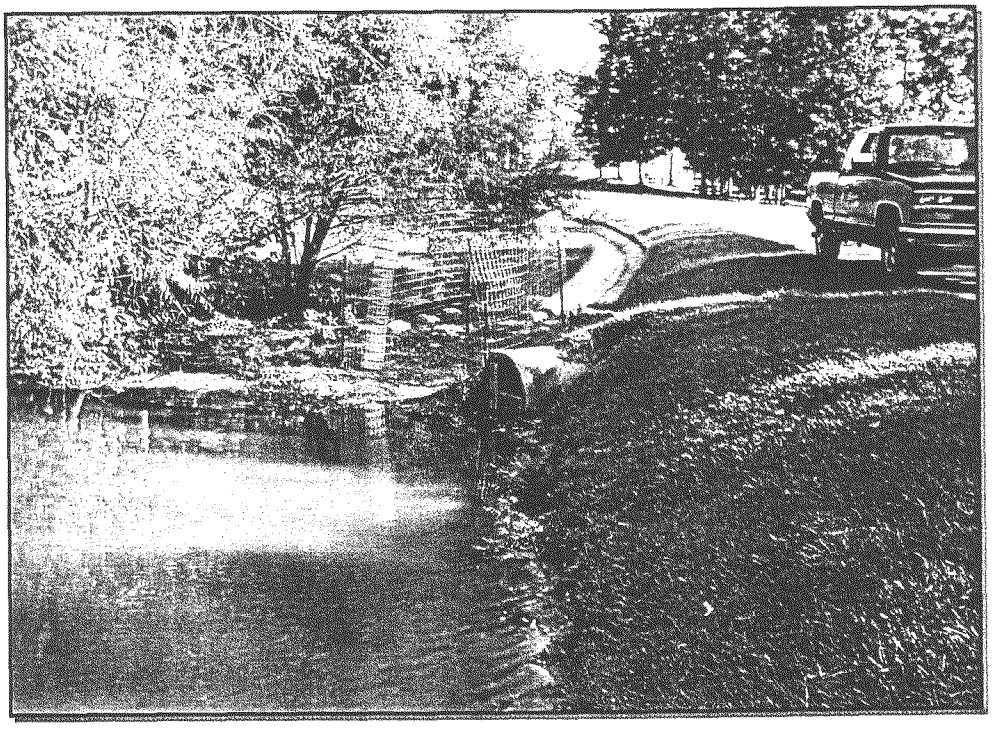
Just to the left of *Longhill Gate* (entrance road), a small pond is found. Dewatered by a culvert under *Longhill Gate*, an obstruction to the inlet of the culvert pipe was noted (See Photo 14). As this obstruction prevents the culvert functioning efficiently, AES recommends that this item be removed.

Photo 14 – Longhill Gate Entrance Road Causeway
Obstruction of cross-culvert preventing free-flow of stormwater to other pond.

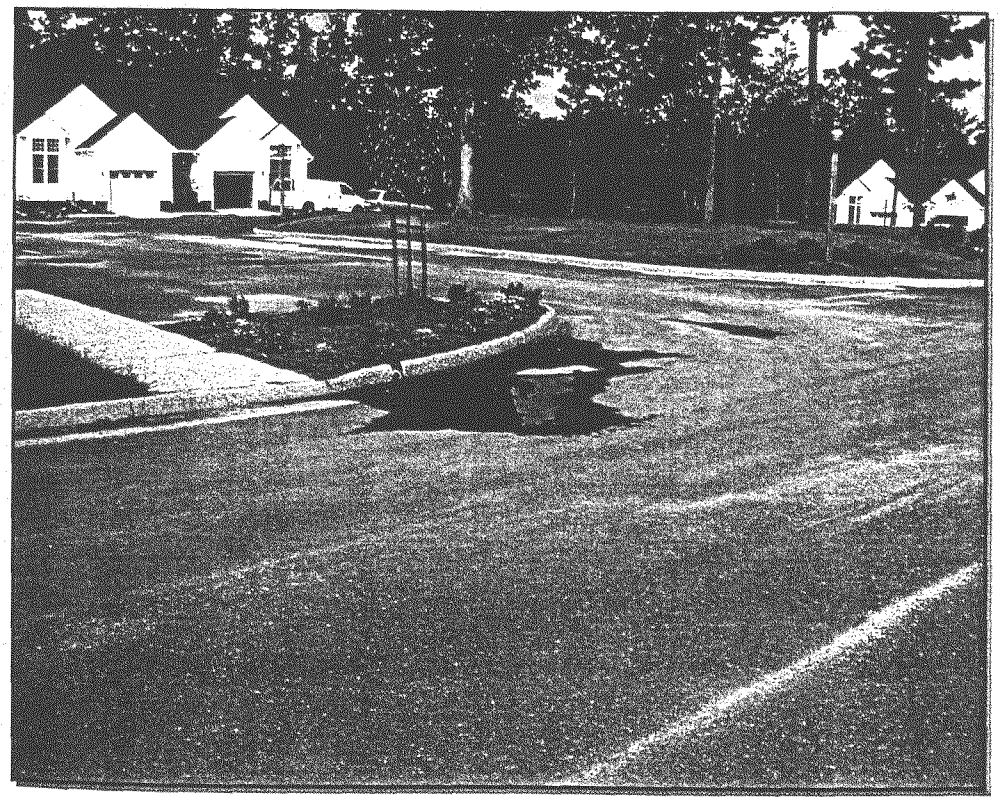
Photo 18 – Baron's Court
Drainage problem. Water is accumulating on the downstream side of the drainage pipe in the landscape island indicating a low spot in the asphalt surface at this point.

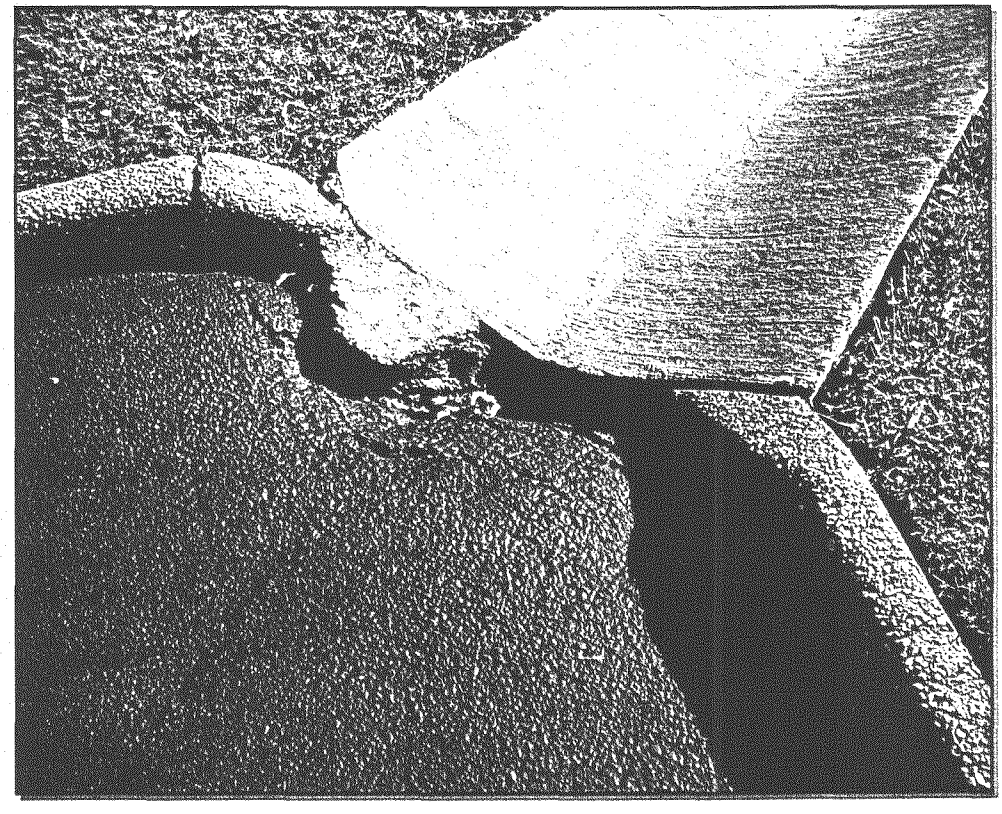
A pedestrian hazard was noted in the Tower Hill section (see Photo 19), this should be alleviated by a smooth transition of asphalt to the concrete swale. This will prevent the undermining of the drainage way as well.

Photo 19 – Tower Hill
Maintenance potential and pedestrian hazard. A smooth transition should be provided to the concrete ditch section.

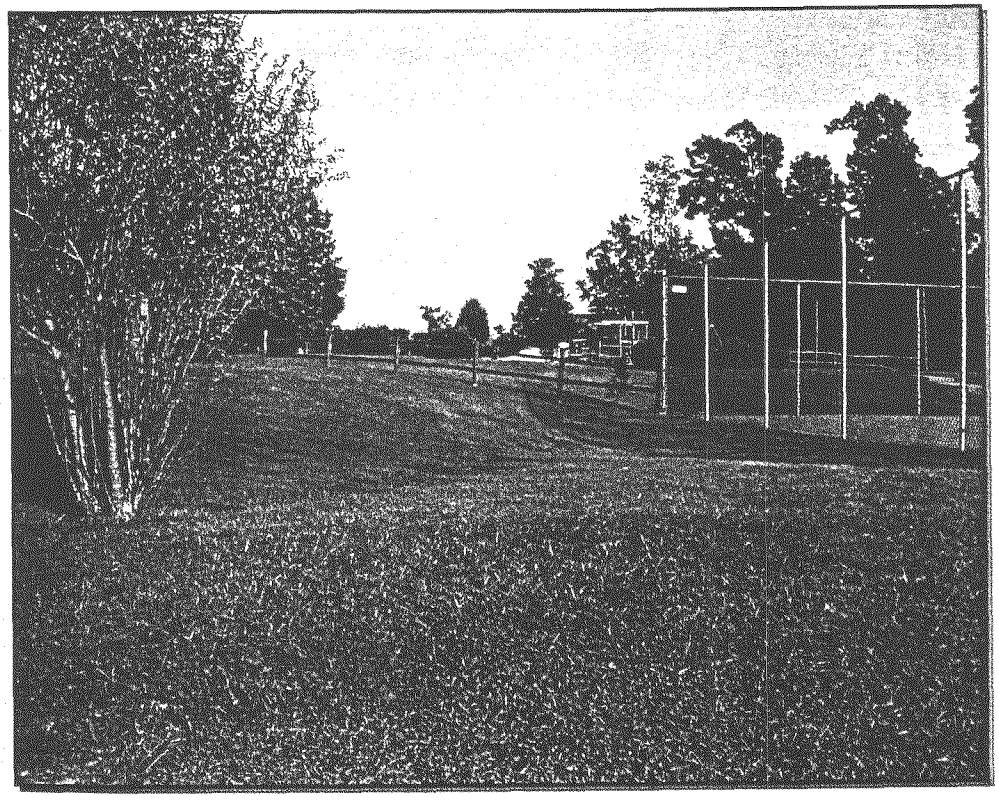
Photo 21 – Recreation Area
Standing water between the tennis courts and pool. Swa should be regraded to provic positive drainage and seedec

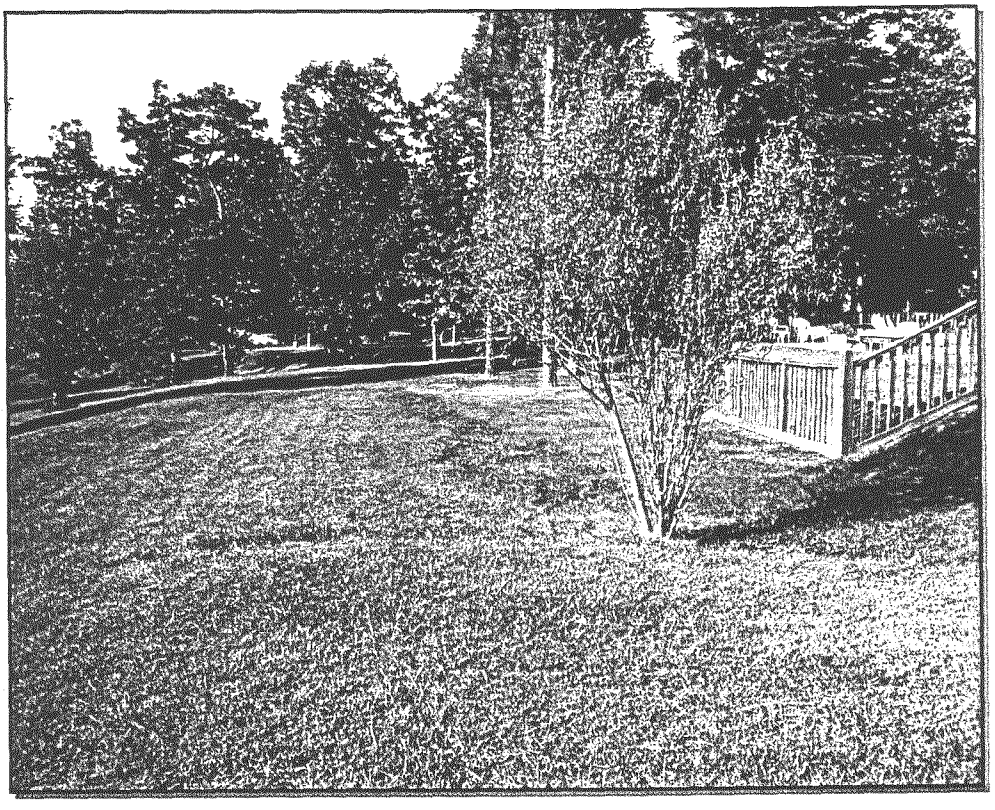
Another area of concern is located nearby between the pool and the pond. (See Photo 22) This area should also be repaired in a similar manner as the above-mentioned area.

Photo 22 – Recreation Area
Evidence of standing water behind the pool. Area should be regraded to provide positive drainage and seeded.

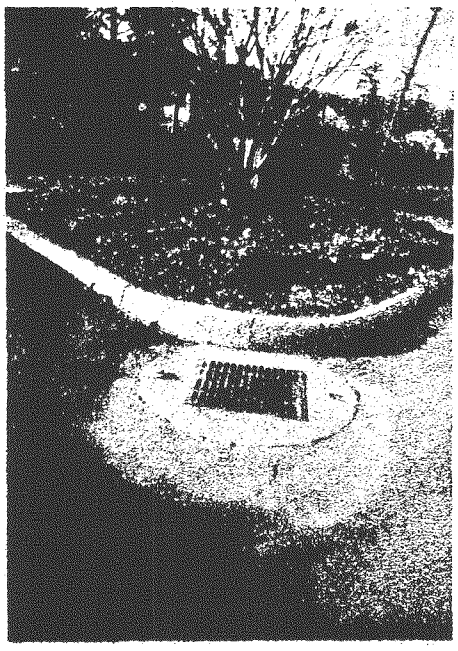
Photo 5 - Highgate Greer
Surrounding asphalt surfac
slightly lower than deck of
storm inlet. Note evidence
standing water adjacent to
storm water inlet.

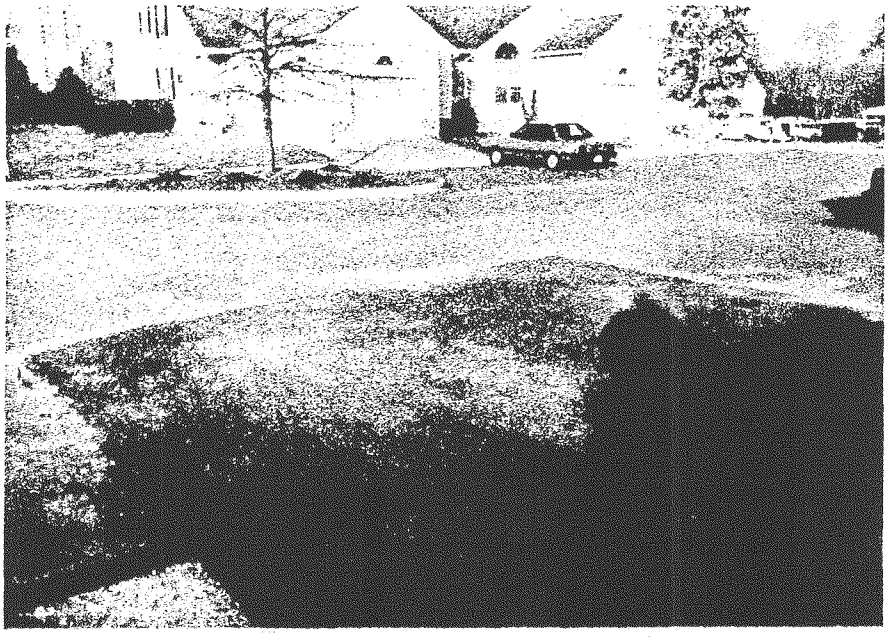
Photo 3 - Chiswick Park
Additional asphalt layer placed to improve surface flow. Utility access cover should be adjusted to be flush with surrounding surface.

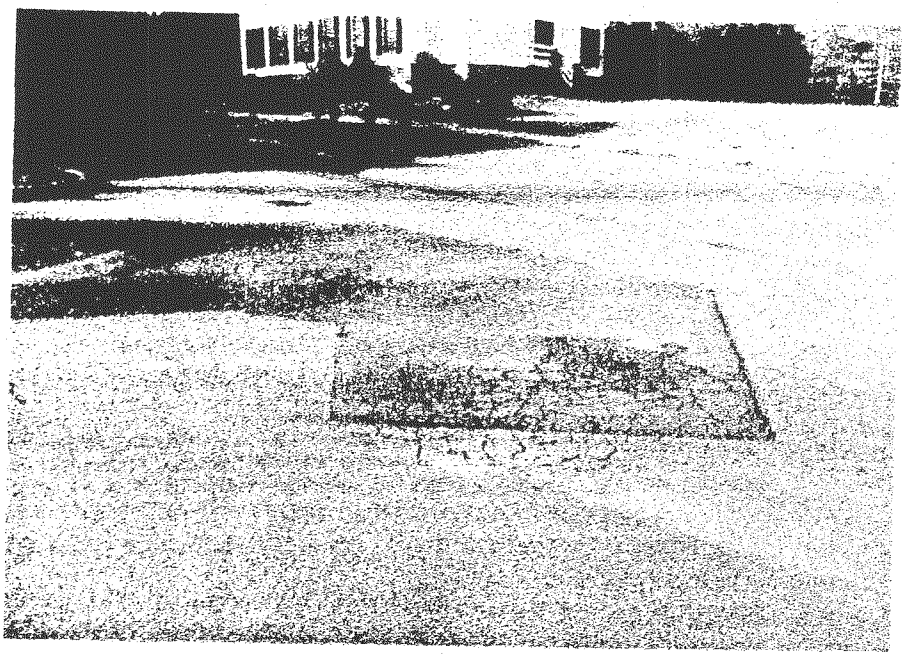
Photo 1 - Tower Hill
Subgrade failure. Note "alligator" texture of asphalt surface. This area has bee repaired several times.

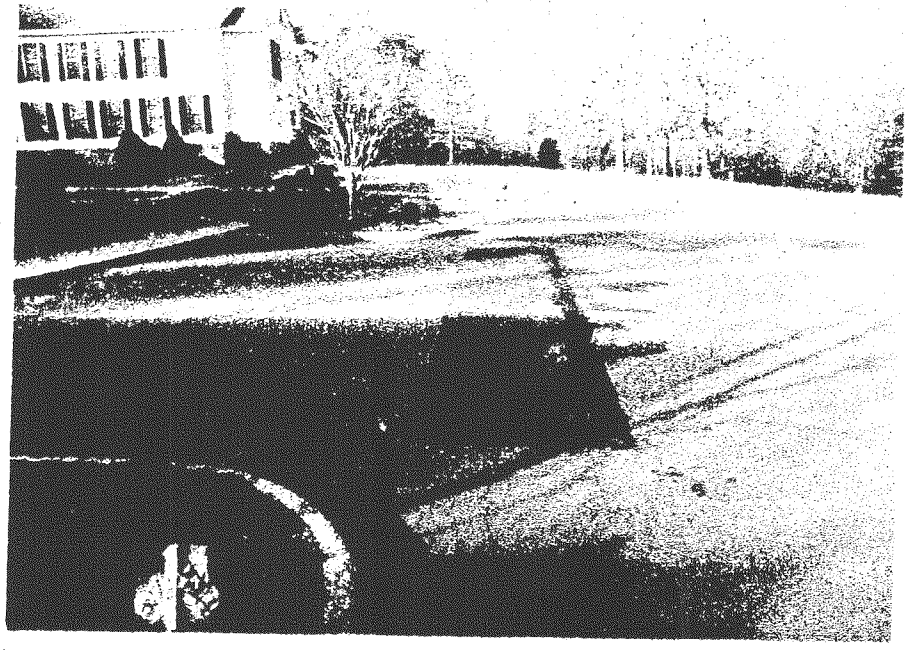
Photo 2 - Tower Hill
Normal surface wear and utility repair. Accumulated underground moisture weeps from joints and cracks.

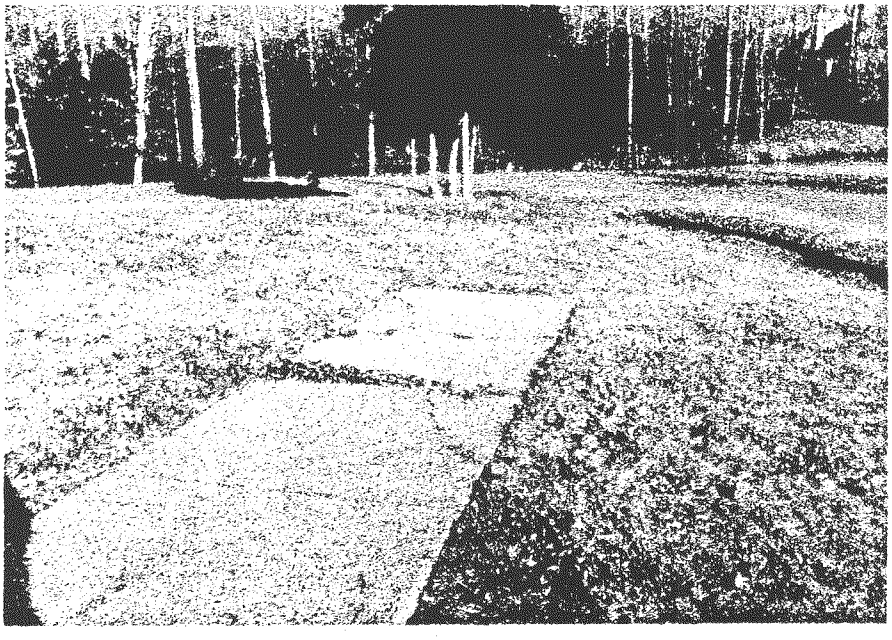
Photo 8
Typical example of broken sidewalk.

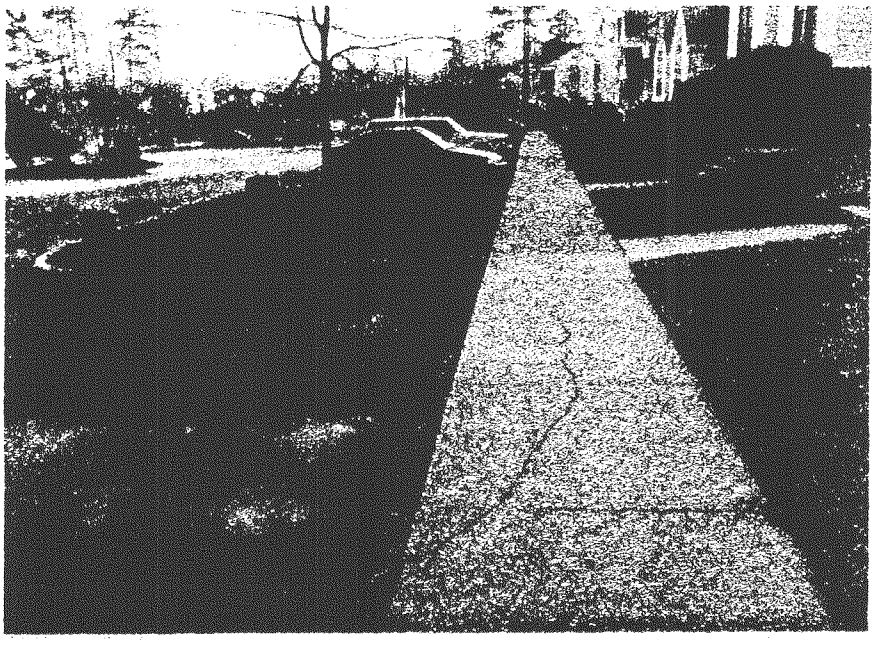
Photo 9 - Tower Hill
Typical example of cracked and broken sidewalks and curbing.

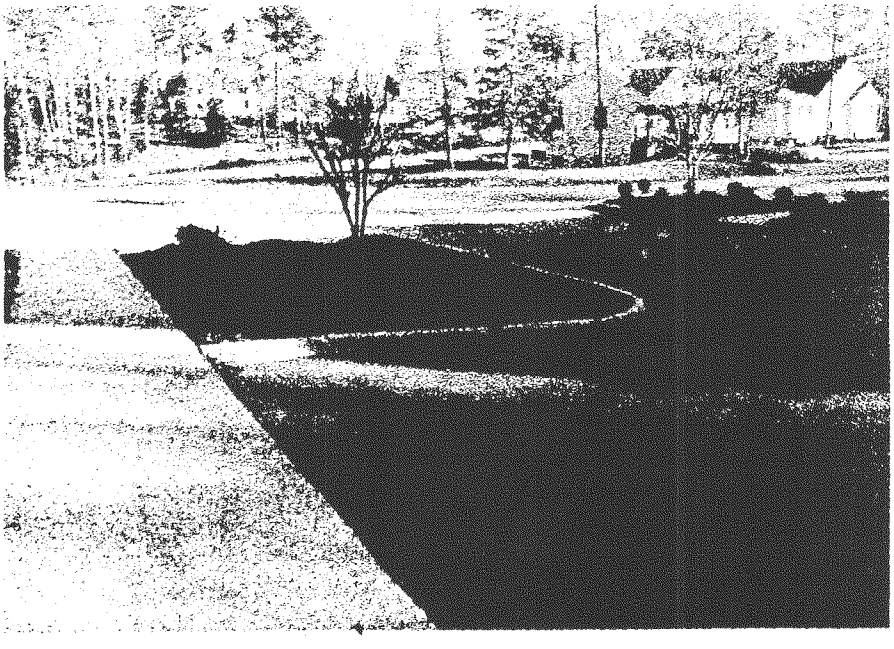
Photo 10 - Tower Hill
Typical example of broken and cracked curbs. Curb is skewed and is recommende for repair.

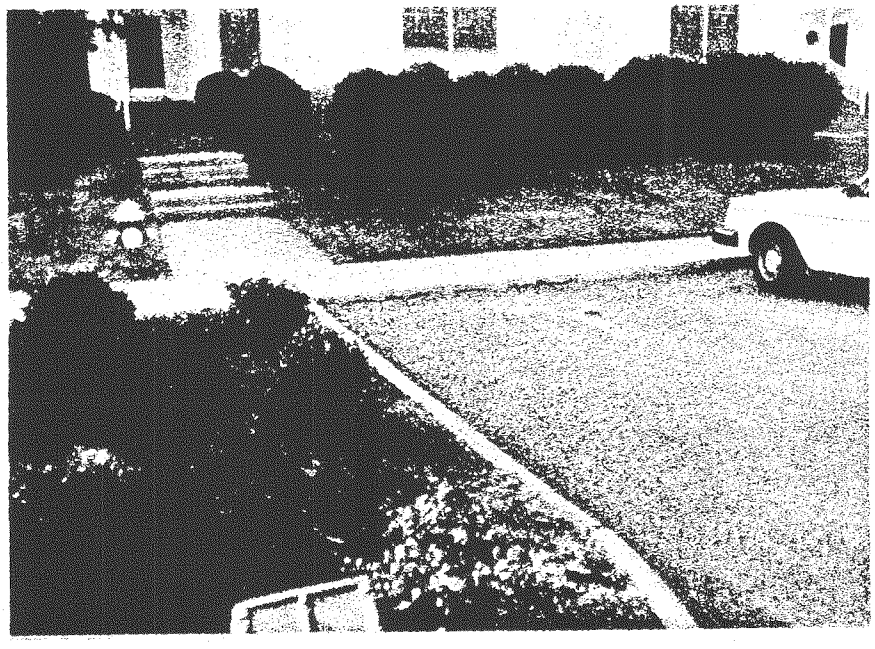
Photo 11 - Tower Hill
Evidence of substandard workmanship. Note voids in concrete at line with asphalt surface.

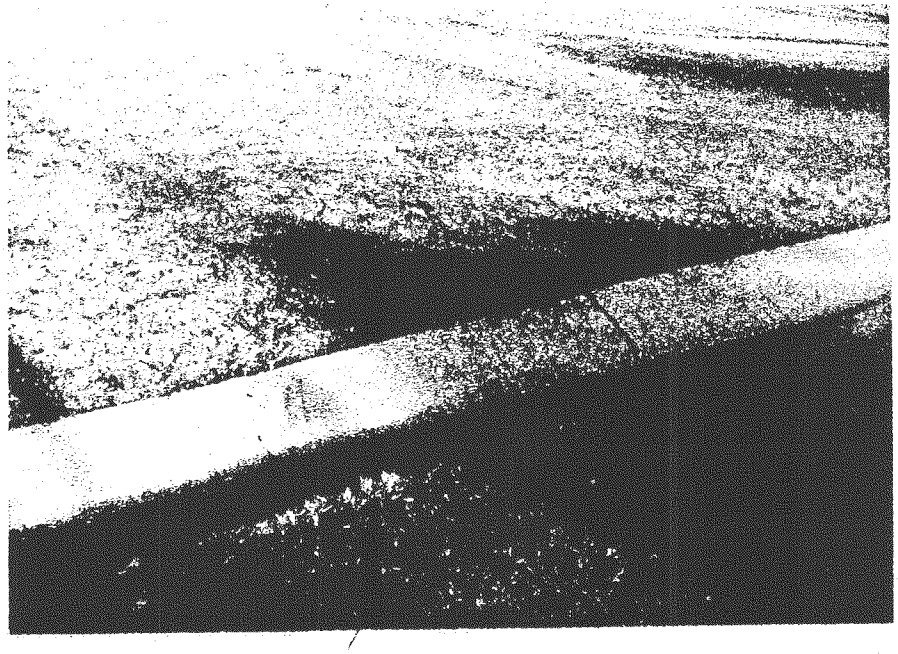
Photo 12 - Recreation Are
Broken concrete paved ditch due to little or no soil suppor

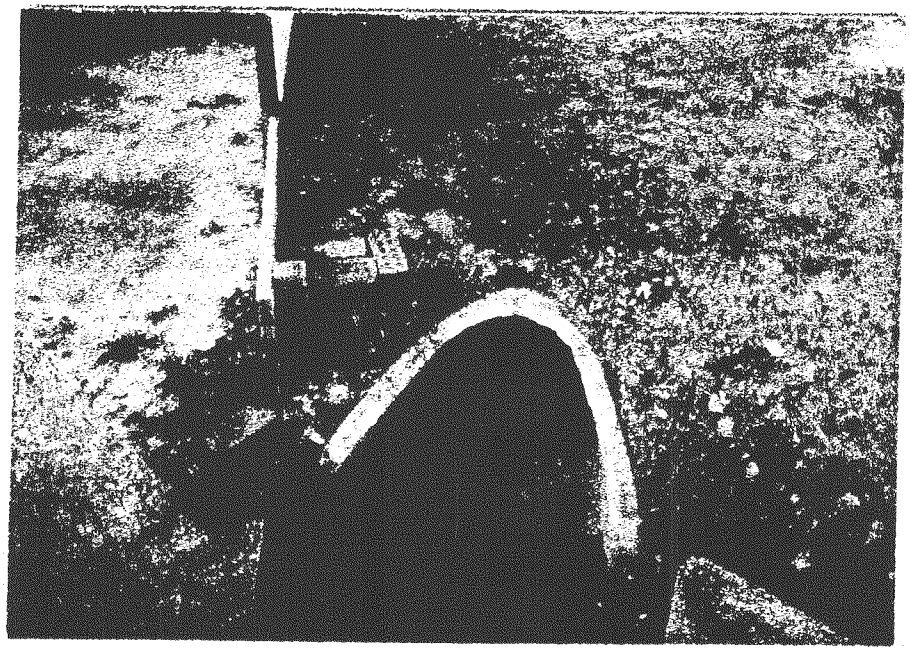
Photo 13 - Recreation Area
Roof drain not properly routed to culvert. Roof drain is currently located among bricks, but should be directly connected to culvert.
