BMP NUMBER: JR016

MEMORANDUM

Name (if known): Governors Land

Located behind 3001 Travis Close

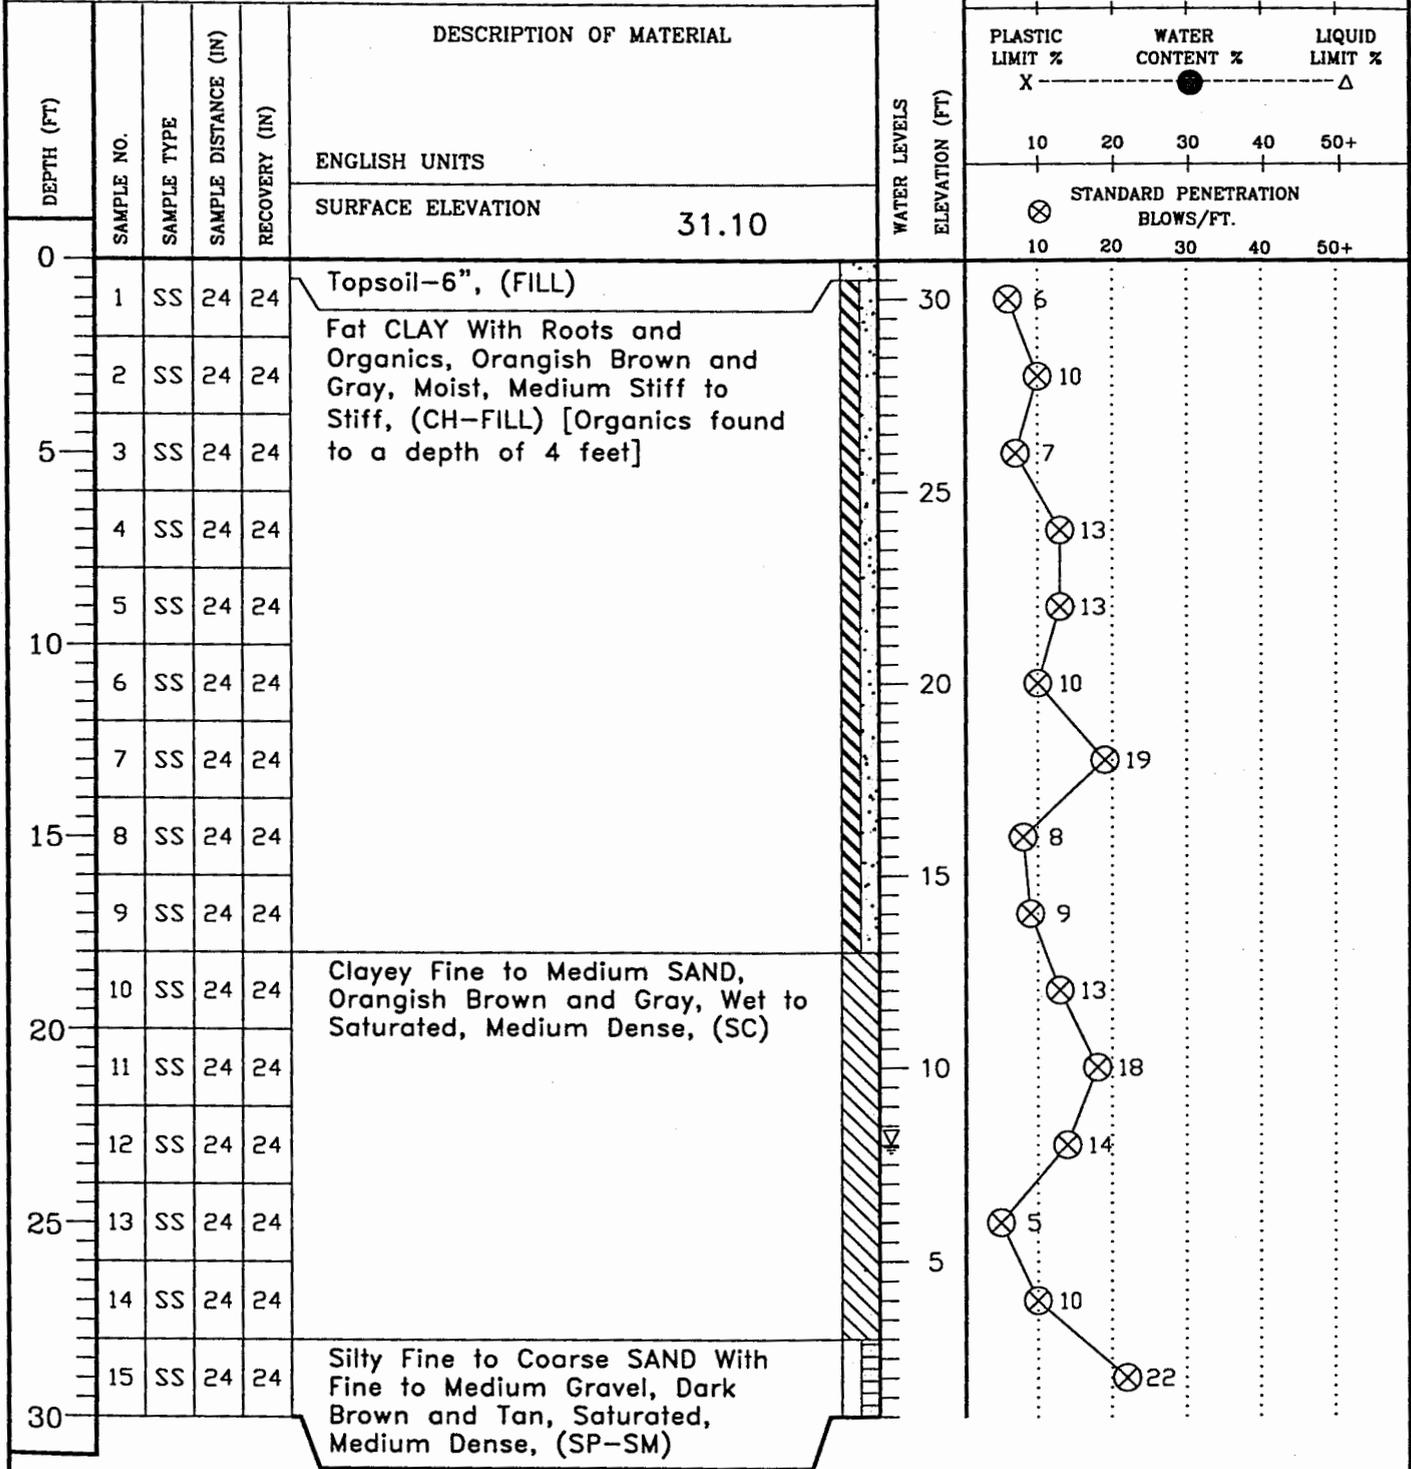
CLIENT DOMINION LAND MANAGEMENT CO.	JOB # 6221	BORING # B-2	SHEET 1 OF 1	ECS LTD
PROJECT NAME GOVERNOR'S LAND DAMS (EMBANKMENT EVAL.)	ARCHITECT-ENGINEER AES, INC.

Significant moisture was not observed within the dam fill material. Groundwater was encountered in boring B-2 at a depth of about 23 feet below top of the dam surface. The presence of water at this depth does not present a problem with the stability of the dam.
