**BMP NUMBER: PC130**

Longhill Gate Homeowners Association

Upper wet pond located on the north side of the main entrance road; Combined folder with PC033

# LONGHILL GATE SITE ASSESSMENT

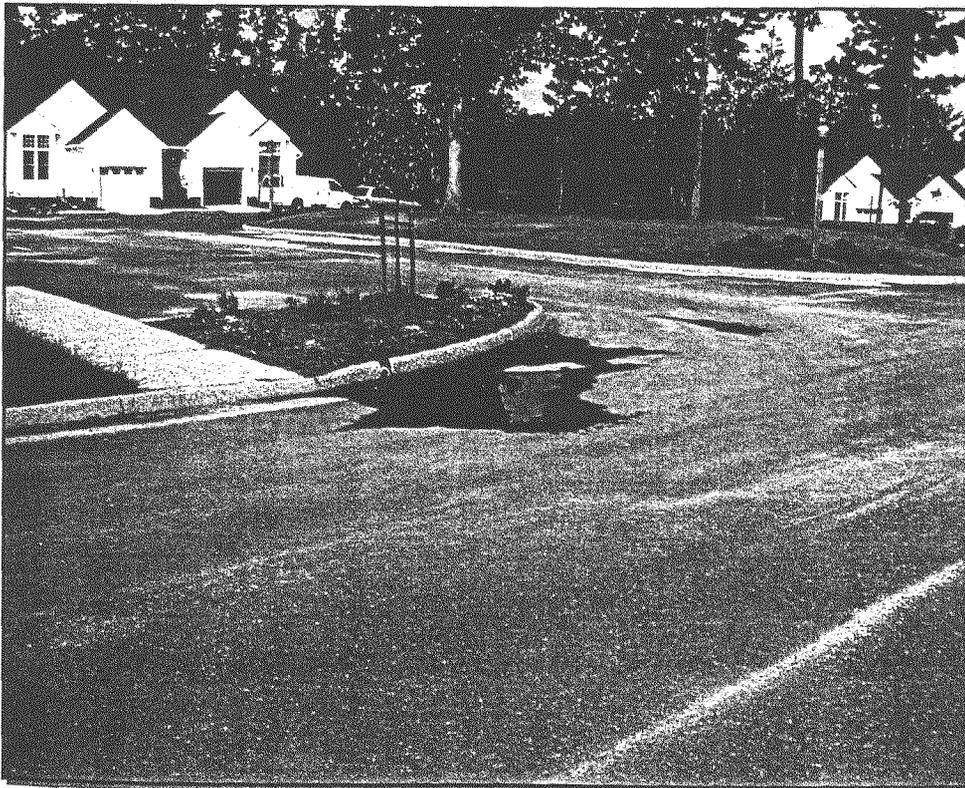
**Photo 18 – Baron’s Court**

Other area of concern includes *Baron's Court*. A drainage pipe in a parking island appears to be inadequate. Sediment-bearing runoff deposits sediment in the corner of the parking lot because the runoff is unable to quickly flow from this point, thus allowing material to settle out on the uphill side of the pipe. During the winter, it is very likely for this area to pond water, allowing it to freeze, creating a pedestrian hazard. (See Photo 17) A low spot can be evidenced at the downstream side of the island by the standing water. (See Photo 18) AES recommends that a paved gutter be constructed through the parking island to allow the drainage to flow through the island and prevent any obstruction of the sediment-laden stormwater, or the accumulation of runoff.

Drainage problem. Water is accumulating on the downstream side of the drainage pipe in the landscape island indicating a low spot in the asphalt surface at this point.
