**Stormwater Management/BMP Facilities
Record Drawing/Construction Certification
*Review Tracking Form***

County Plan No.: 5-30-97
 Project Name: STONEHOUSE SEC 4A Leather Leaf ~~Basin B~~
 Stormwater Management Facility: BASIN B DRY DET 9815 LEXINGTON LEX
 Phase: I II III

RECORD DRAWING
 OF
BASIN B
SECTION IVA
AT STONEHOUSE

Re: Stonehouse Section 4A Leather Leaf, Basin B
Dry Pond near 9815 Turning Leaf
County BMP ID Code: WC 038

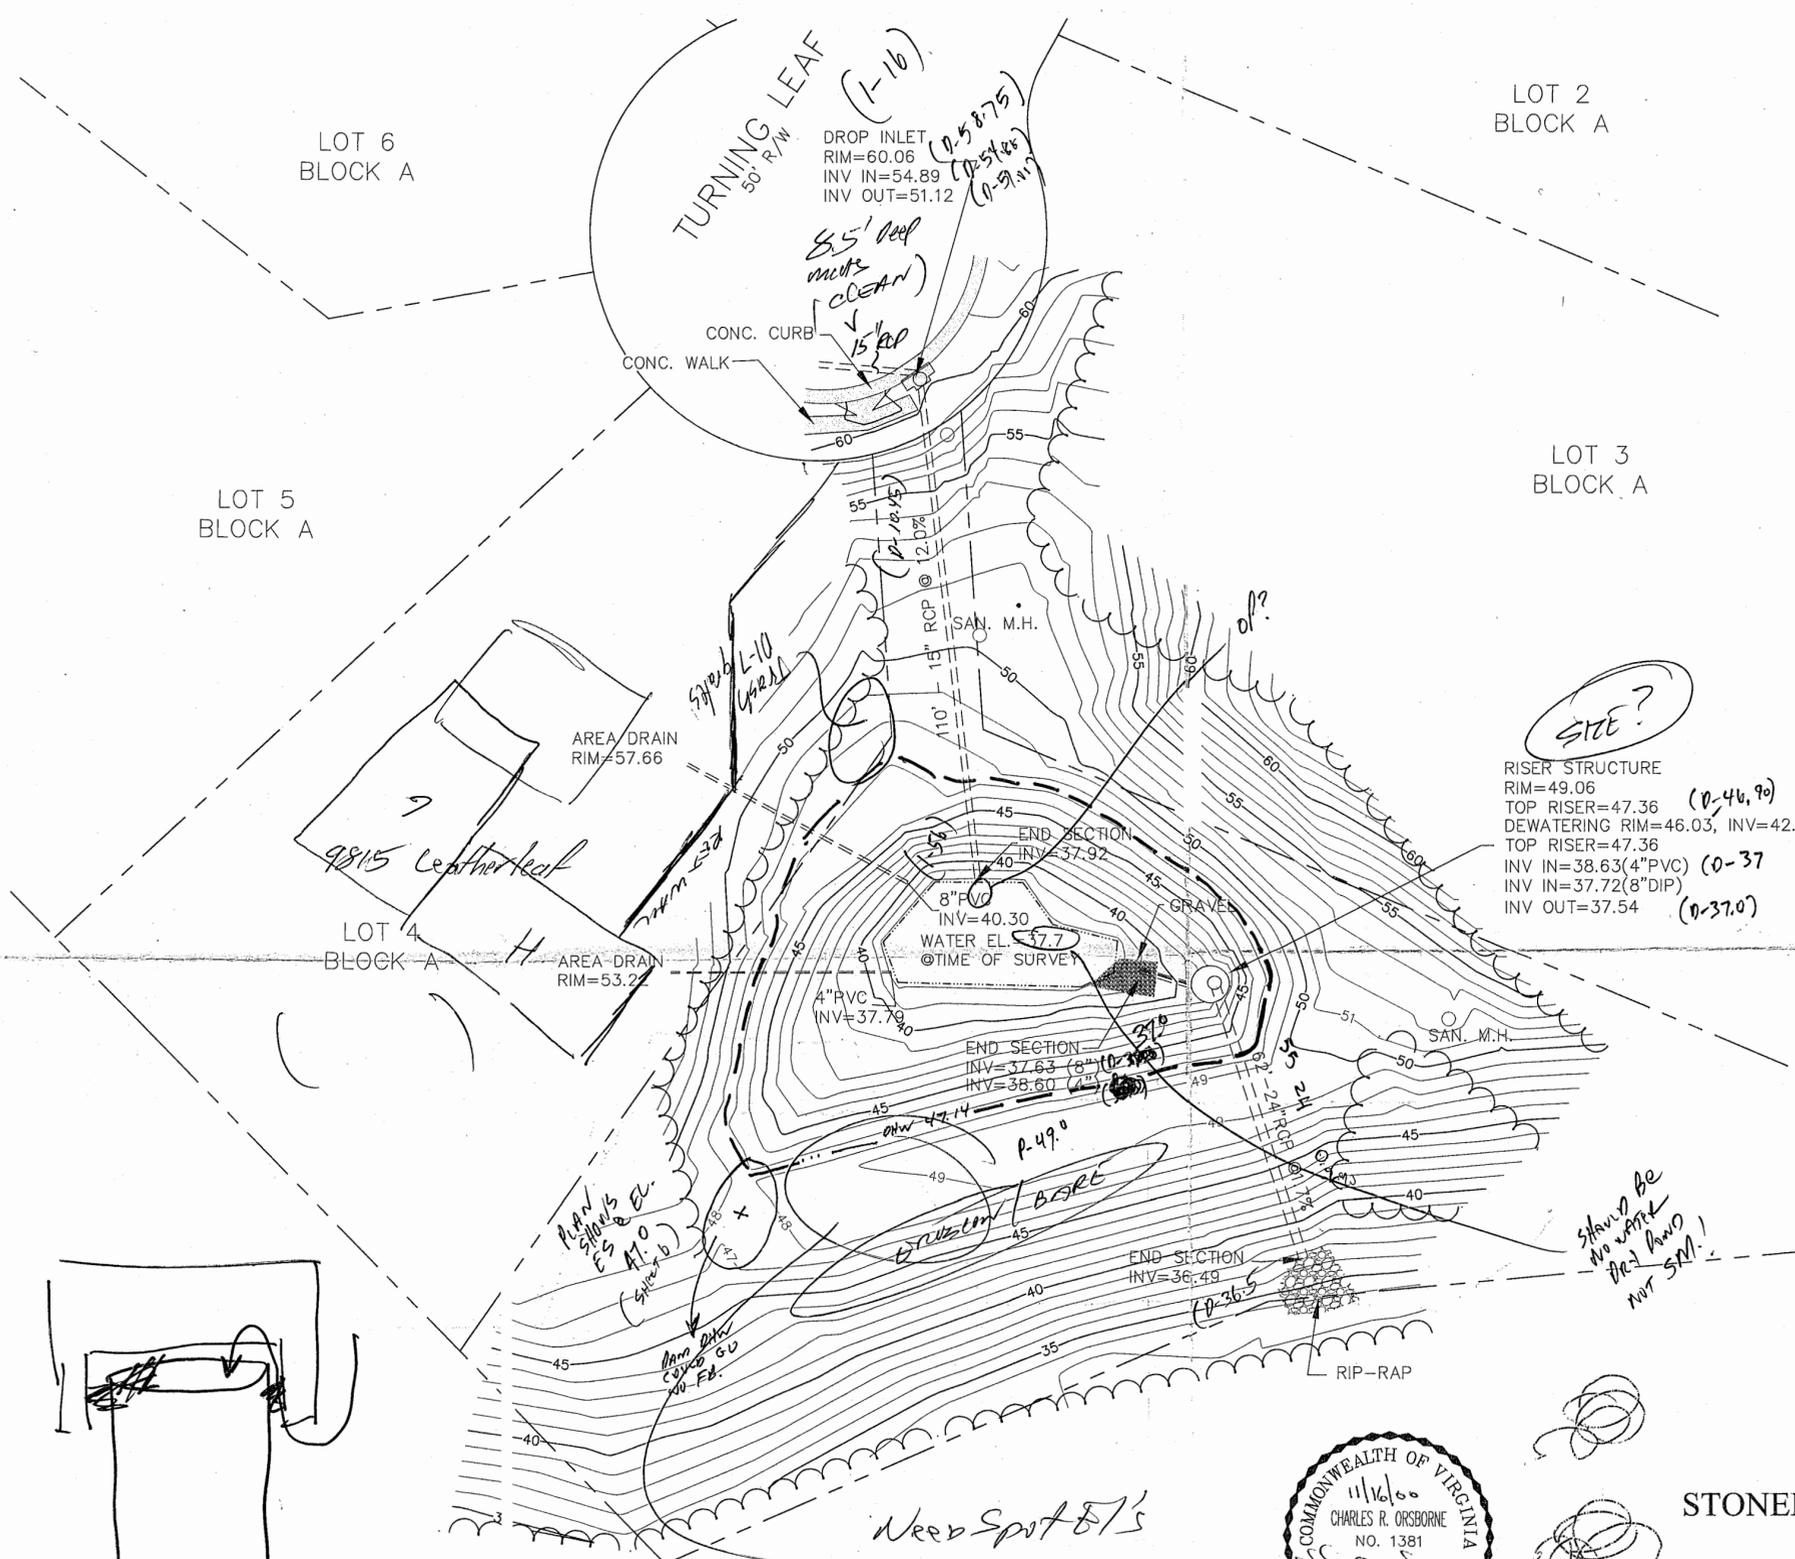
Show
 Plan view
 MR
 No Bench
 Present.
 Ave.?
 ES?

RISER STRUCTURE
 RIM=49.06
 TOP RISER=47.36 (0-46.90)
 DEWATERING RIM=46.03, INV=42.79 (0-42.5)
 TOP RISER=47.36
 INV IN=38.63 (4\"/>

Need Spot E/Ls
 Contours
 not right
 TW=12' and 20'
