# Kristiansand Subdivision

# STREAM CONDITION SUMMARY MAP JCC - KRISTIANSAND TRIBUTARY JAMES CITY COUNTY, VIRGINIA

WATERSHED EVALUATION  
SUMMARY MAP

JCC - KRISTIANSAND TRIBUTARY  
JAMES CITY COUNTY, VIRGINIA

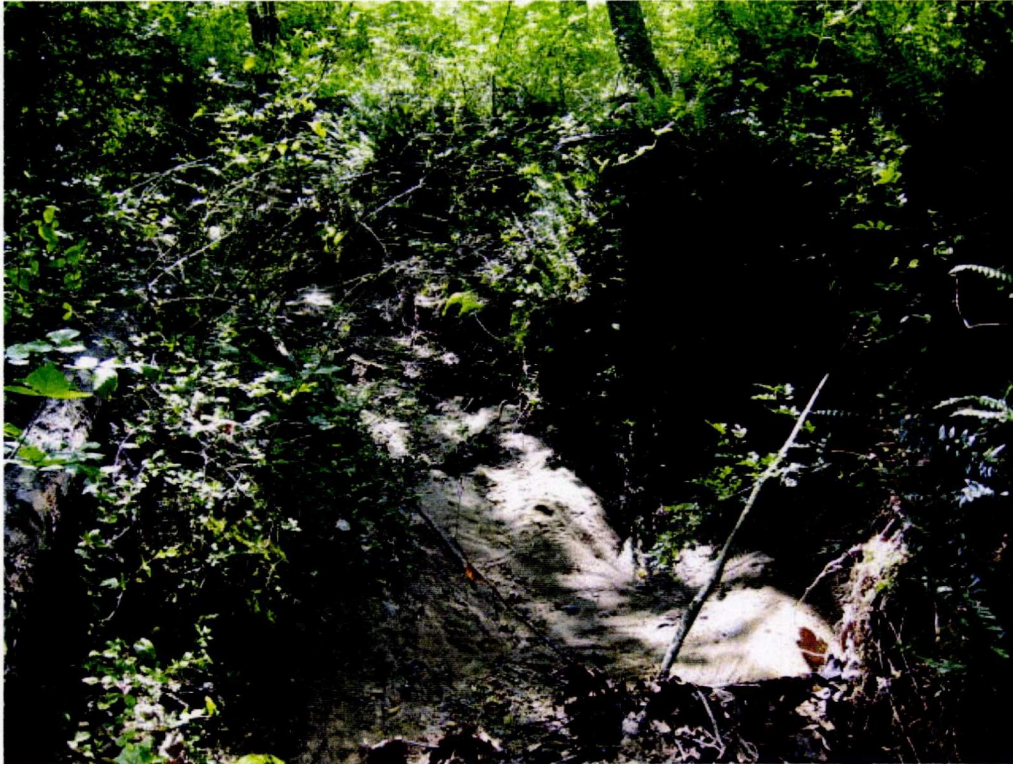
Photograph 1: Reach 1 – Looking upstream (potential stream enhancement).

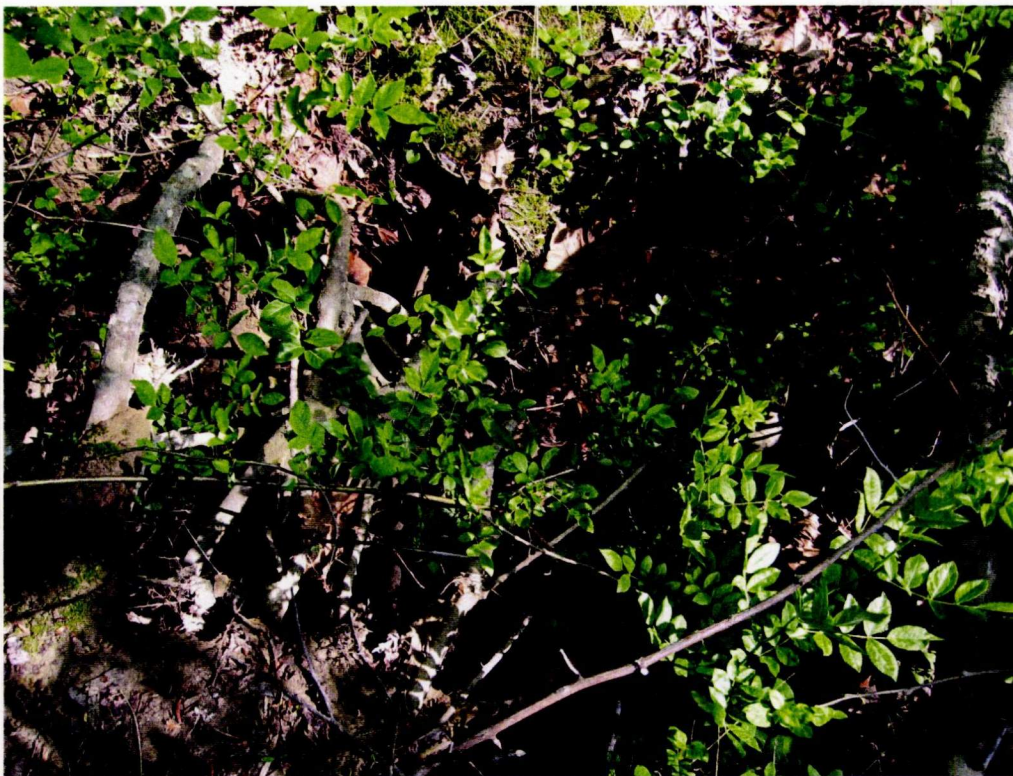
Photograph 2: Reach 2 – Incision below effective rooting depth (potential stream restoration).

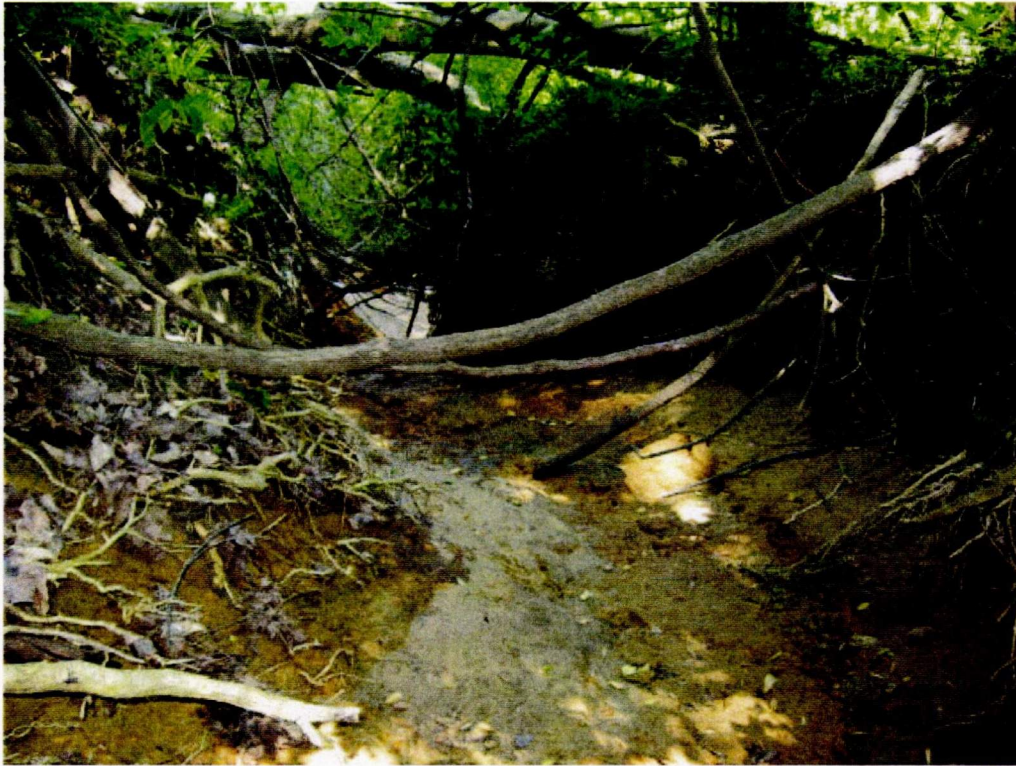
Photograph 3: Reach 3 – Looking downstream (potential stream enhancement).

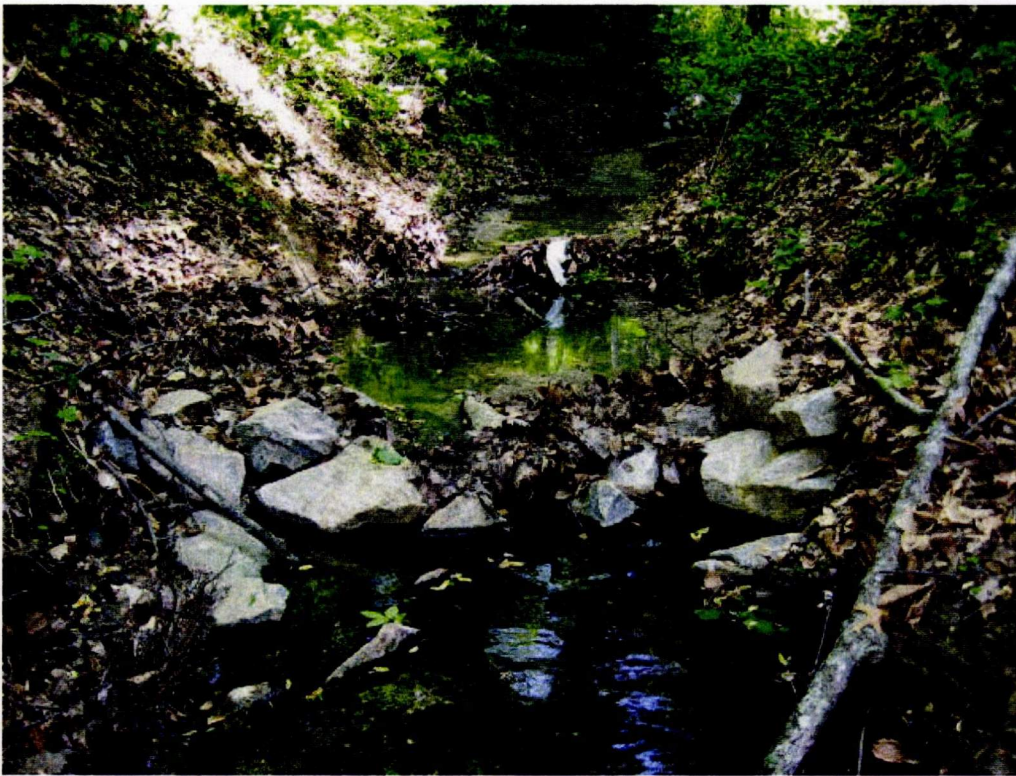
Photograph 4: Reach 4 – Within currently enhanced area.

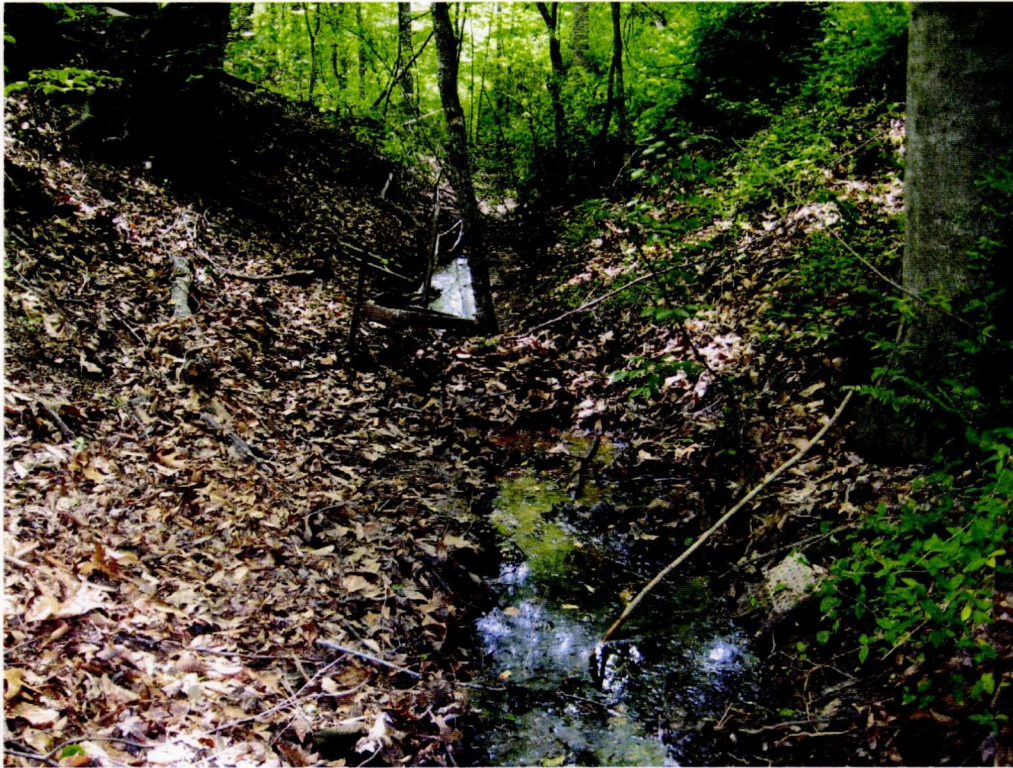
Photograph 5: Reach 5 – Looking upstream.

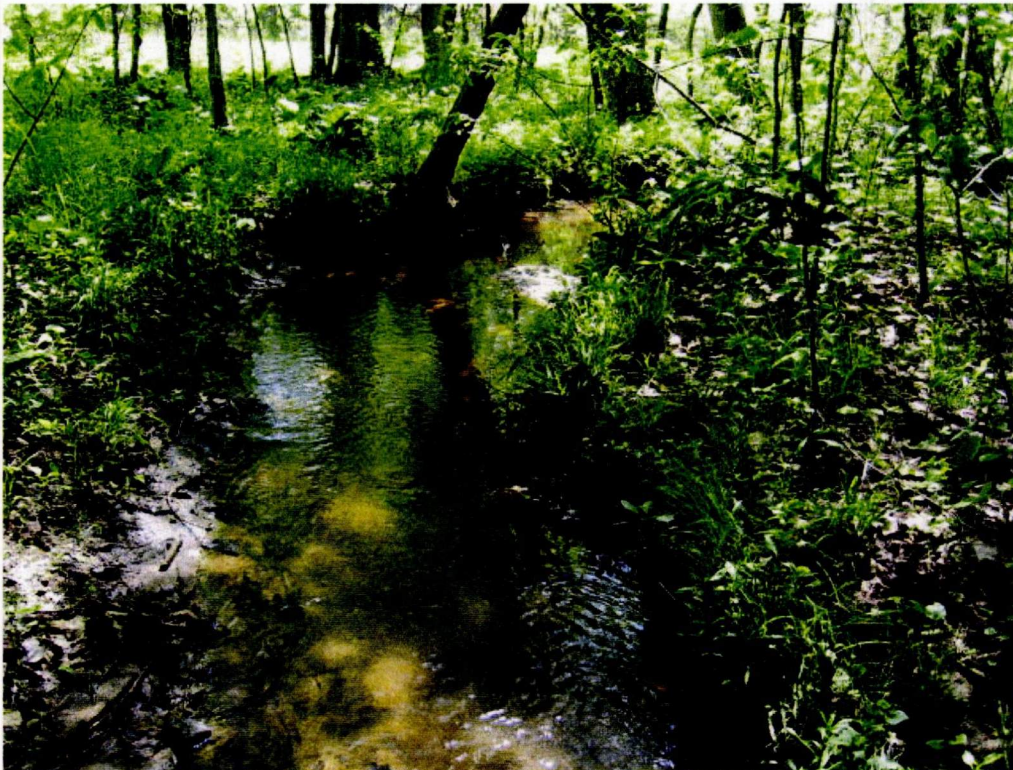
Photograph 6: Reach 6 – Looking downstream.

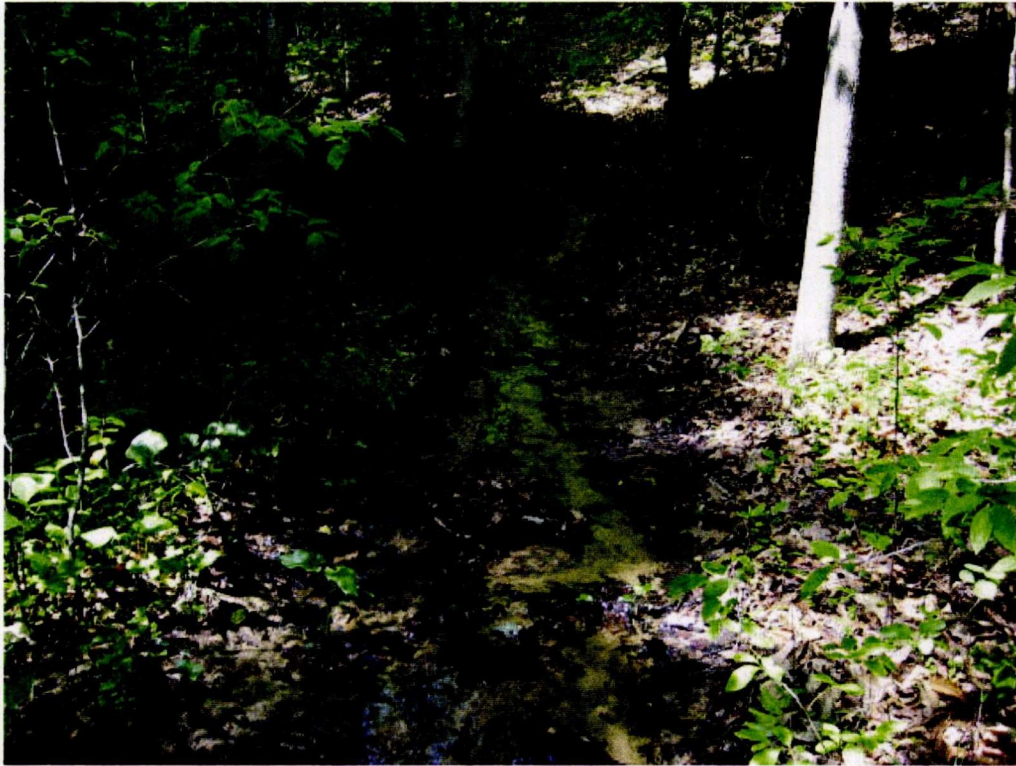
Photograph 7: Reach 7 – Looking upstream.

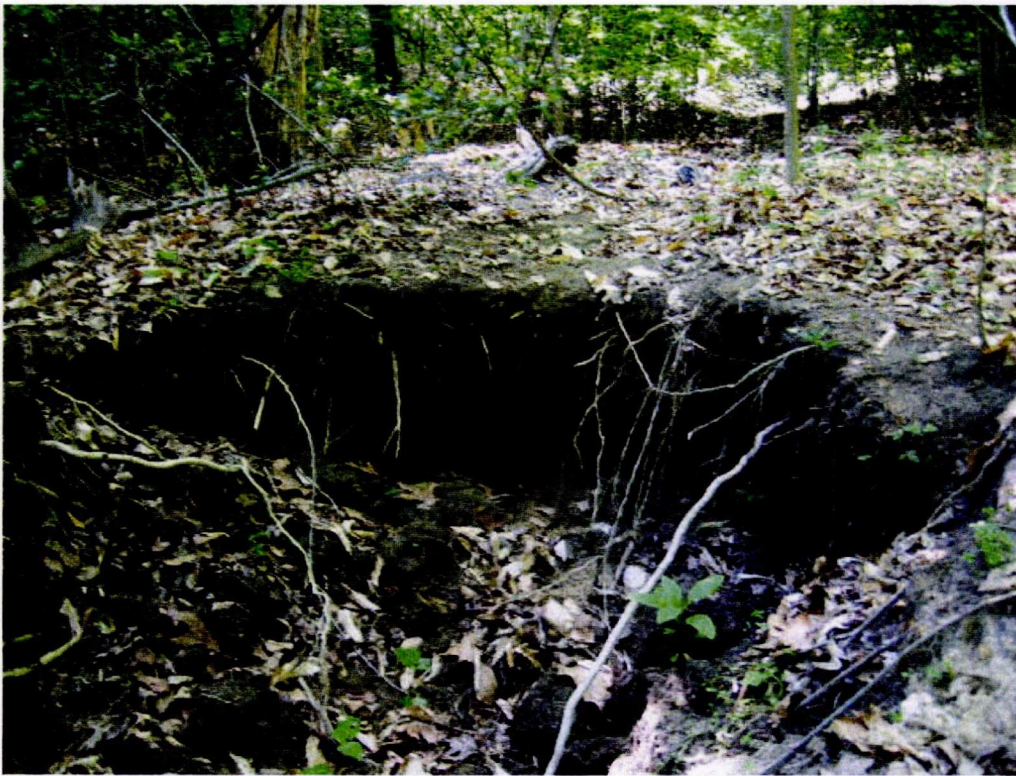
Photograph 8: Reach 7 – Headcut area (potential stream restoration).

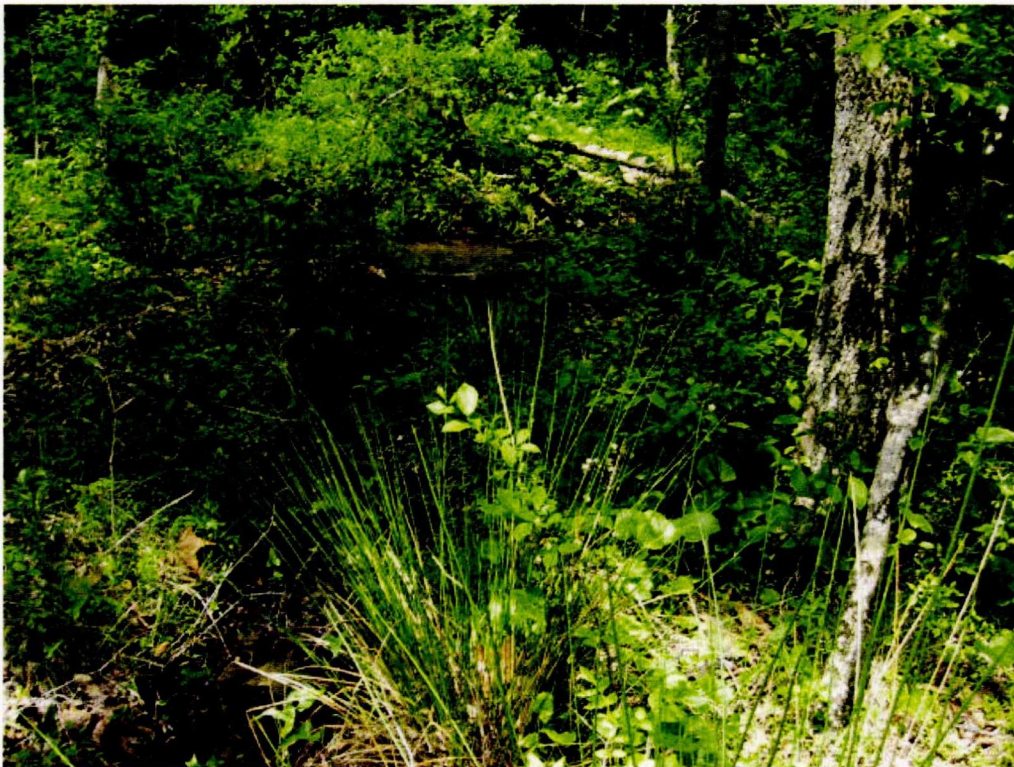
Photograph 9: Reach 8 – Looking downstream.

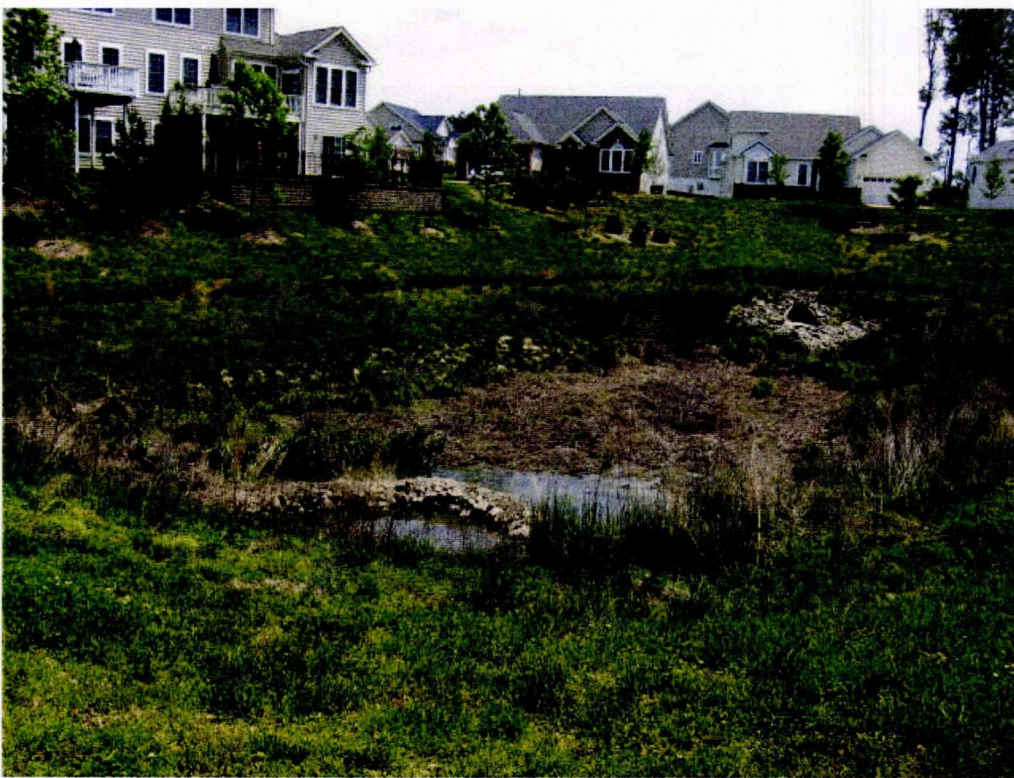
Photograph 10: Reach 8 – Representative existing BMP.

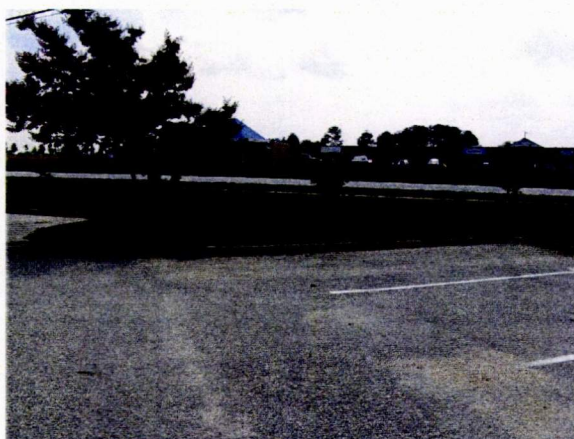
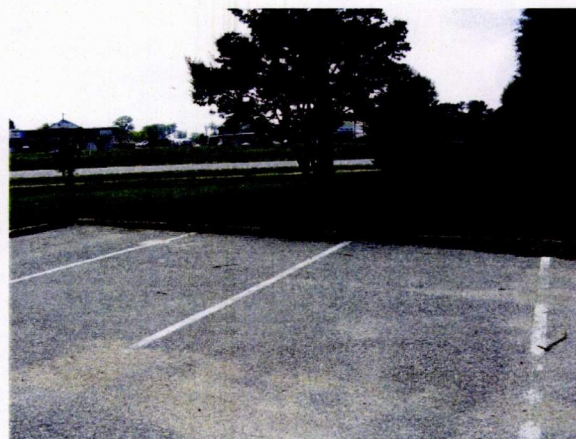
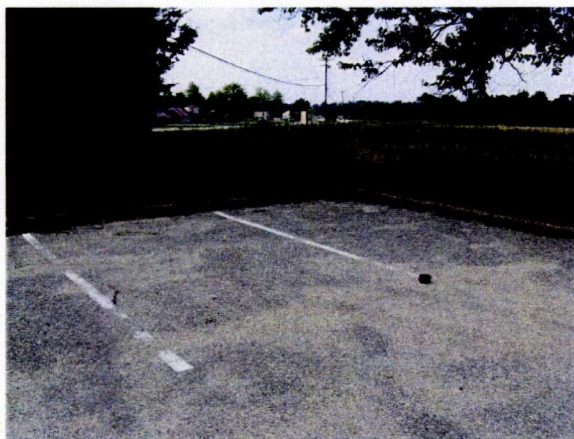
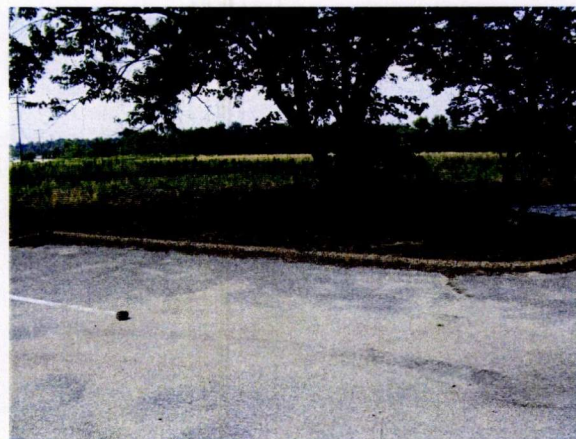
<b>Identifier:</b>	Kristiansand - 4
<b>Location:</b>	Go-Karts Plus (northern edge of parking lot)
<b><u>Existing Conditions:</u></b>	Open areas adjacent to curb and gutter along parking lot.
<b><u>Potential Improvements:</u></b>	Install curb cuts and offline bioretention filters treating parking lot. May be difficult to daylight underdrains.

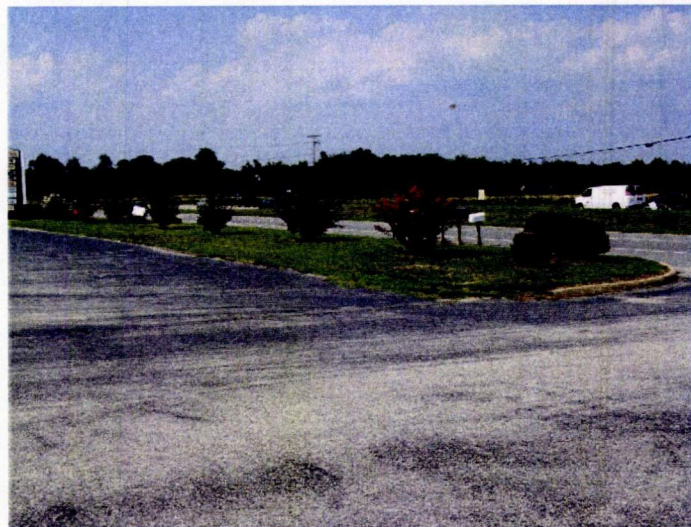
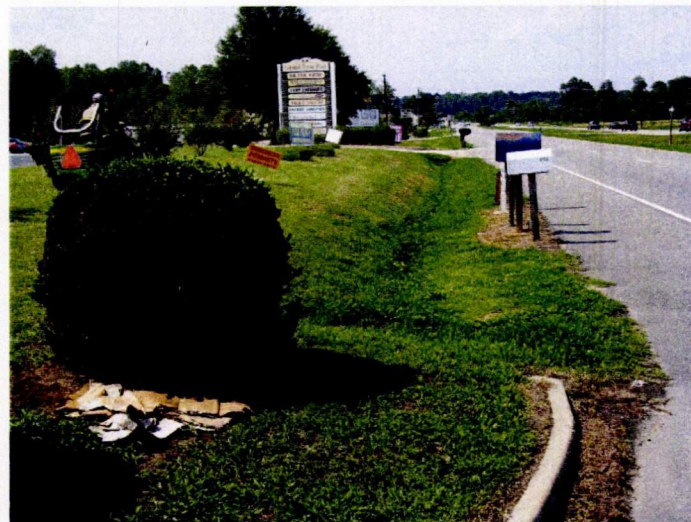
**Identifier:** Kristiansand - 5

**Location:** Colonial Towne Plaza (southeast of shopping center near Tequila Rose)

**Potential Improvements:**

Construct **bioretention filter** to treat parking lot runoff immediately north of the entrance near Tequila Rose. Biofilter could be installed within the open space adjacent to the Rt. 60 right-of-way. Removal of excess pavement could be considered to increase biofilter size. Likely, a trench drain will need to be installed across the entrance to capture the parking lot runoff. Underdrains could daylight into Rt. 60 ditch. Remove existing trash.

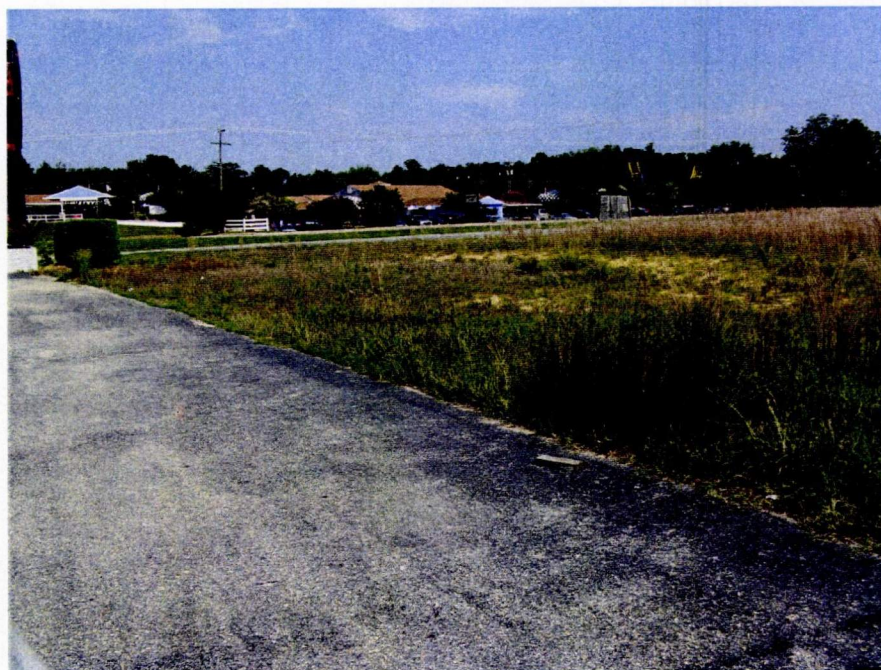
**Identifier:** Kristiansand - 6

**Location:** Colonial Towne Plaza (southeast of Shopping Center behind Tequila Rose)

Treat runoff with bioretention filter or level spreader/filter strip. Stabilize any barren areas with permanent seeding and soil amendments (as needed).

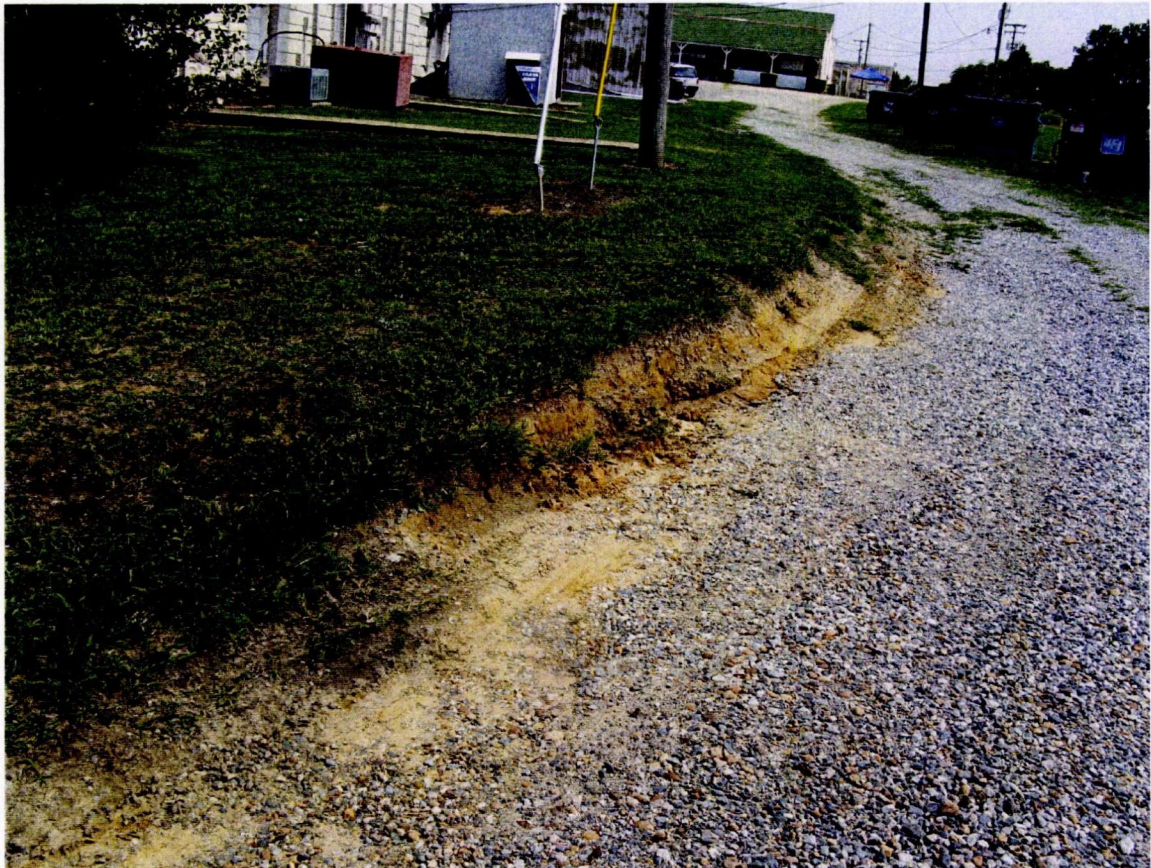
**Identifier:** Kristiansand - 7

Bare soils resulting in noticeable sediment discharge during storm events (as observed on 7/8/08) as surface runoff flows across this area.

Provide sufficient erosion stabilization in barren areas (such as minor grading, soil amendments, and matting). Evaluate the need for a conveyance channel adjacent to the existing gravel access road.

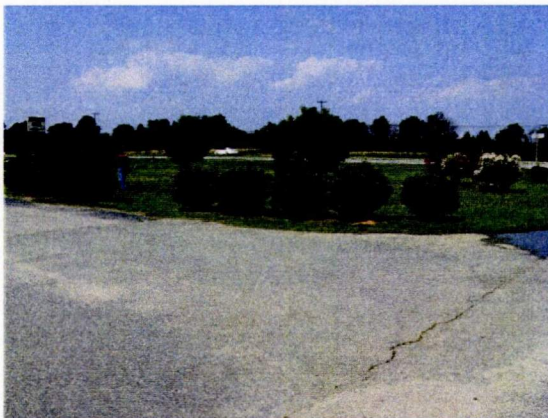
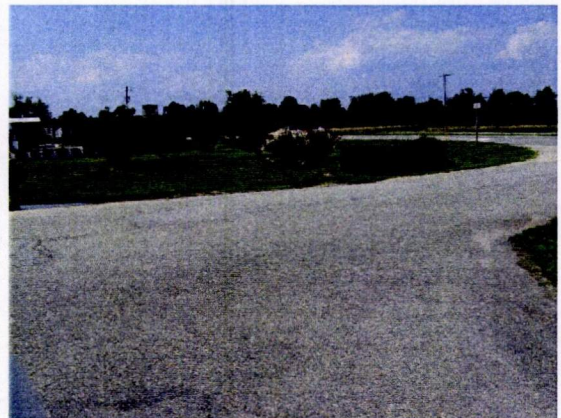
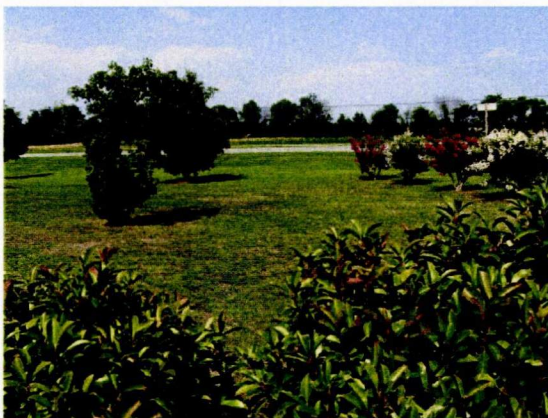
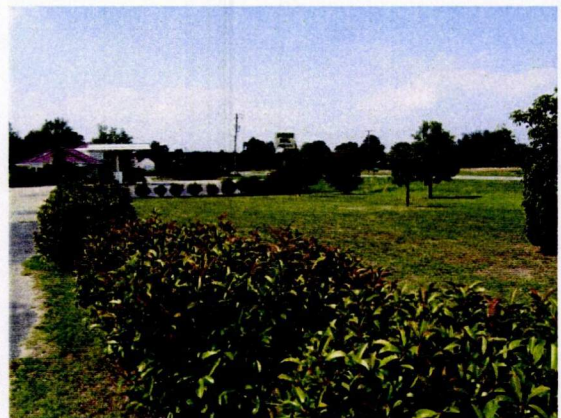
**Identifier:** Kristiansand - 8

Uncontrolled runoff from much of the parking lot draining into an open area near Rt. 60. There are multiple drop inlets located near Rt. 60 receiving the runoff, one covered with debris and damaged.

Construct a stormwater management basin within the open area between the Shopping Center and the Antique Mall. Repair the existing storm sewer system and modify to accommodate the basin outlet structure. The use of an enhanced extended-detention basin (shallow marsh) or an infiltration/bioretention facility should be explored pending further soil evaluation.

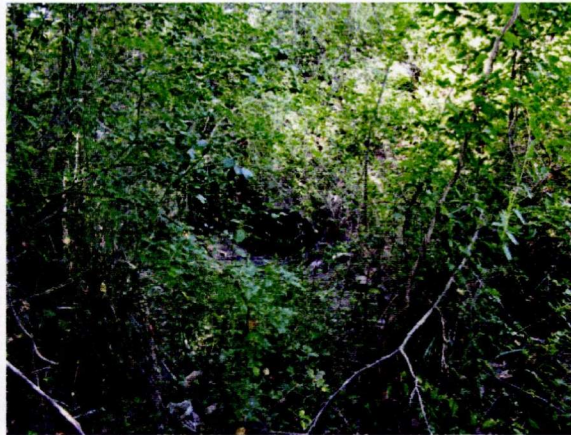
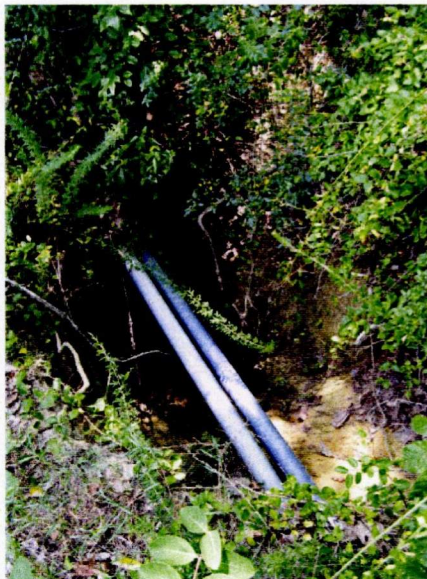
<b>Identifier:</b>	Kristiansand - 10
<b>Location:</b>	Between Econo Lodge and BayLands Federal Credit Union
<b><u>Existing Conditions:</u></b>	Uncontrolled runoff from Rt. 60 causing major erosion downstream of outfall, exposed utilities, and incised channel.
<b><u>Potential Improvements:</u></b>	Pending intended use of barren lot adjacent to Econo Lodge, a stormwater management basin could be constructed upstream of existing stream channel. Proposed BMP may be a retention pond or enhanced extended-detention facility, pending detailed design considerations. New BMP construction would require significant grading and adjustment of storm sewer outfall. Stabilize downstream headcut and restore incised portions of stream channel. At a minimum, proper energy dissipation and headcut stabilization required at outfall.

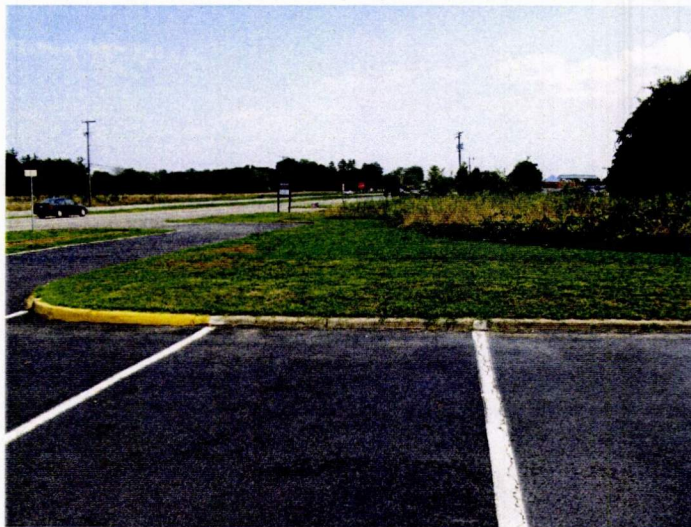
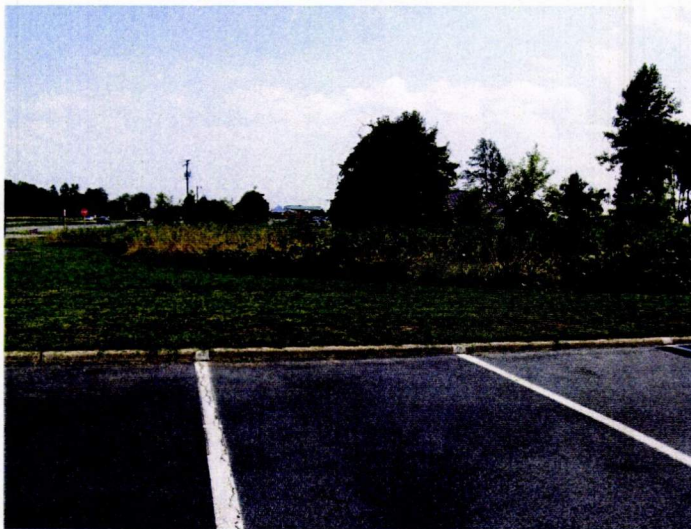
**Identifier:** Kristiansand - 11

**Location:** Econo Lodge (southeast of parking lot near entrance)

Install curb cuts and offline bioretention filter within adjacent open area.

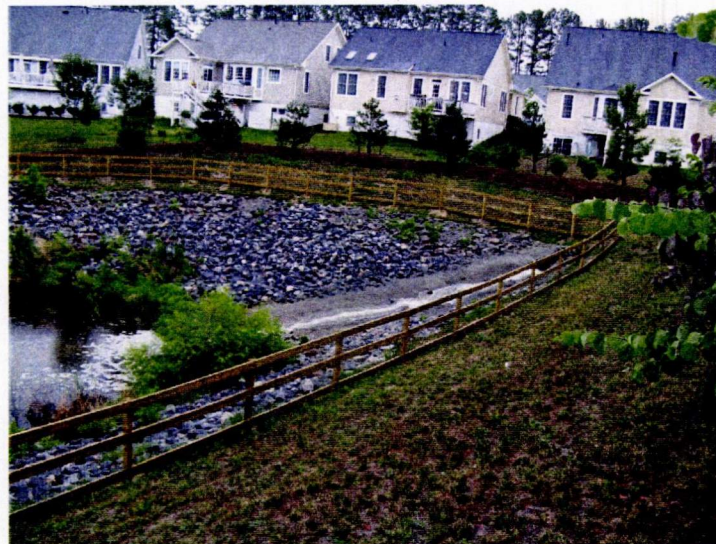
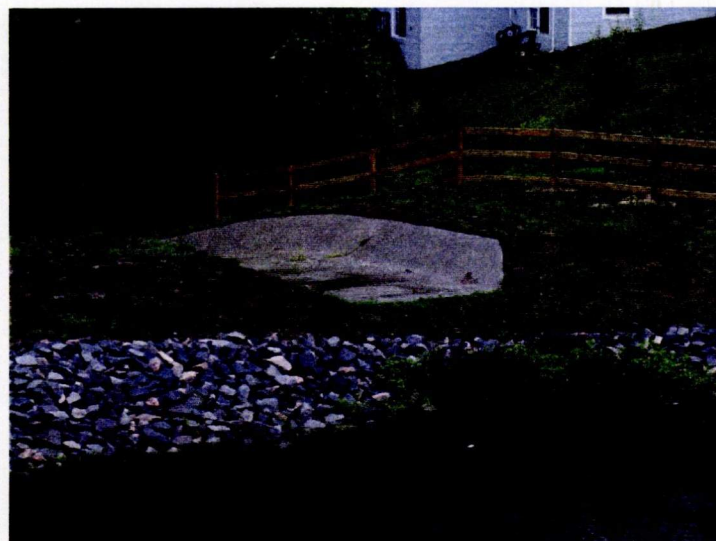
**Identifier:** Kristiansand - 16

**Location:** At end of Pinebrook Rd, north of Winterberry Ct

Replace riprap slopes with natural buffer enhancement and aquatic bench. May also consider extending natural buffer zone beyond perimeter fence rather than maintained turf pending authorization from Colonial Heritage. At a minimum, consider the use of additional joint planting throughout riprap if replacement is not feasible. Further review of outlet structure design may also identify potential optimization for enhanced water quality treatment and/or channel protection.

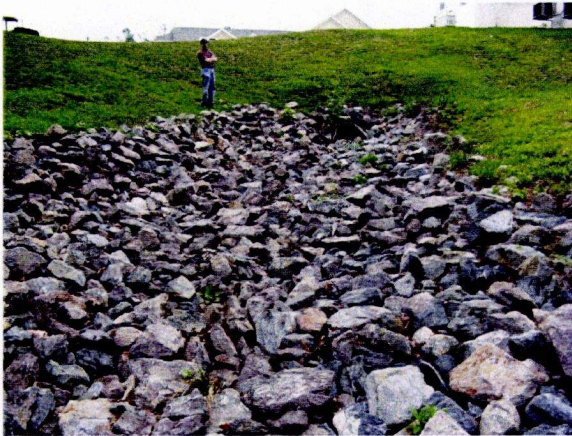
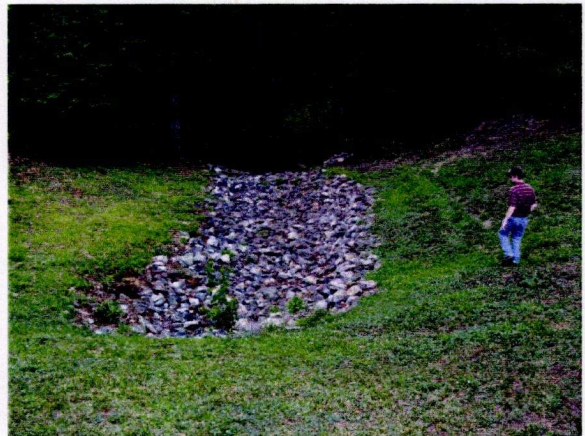
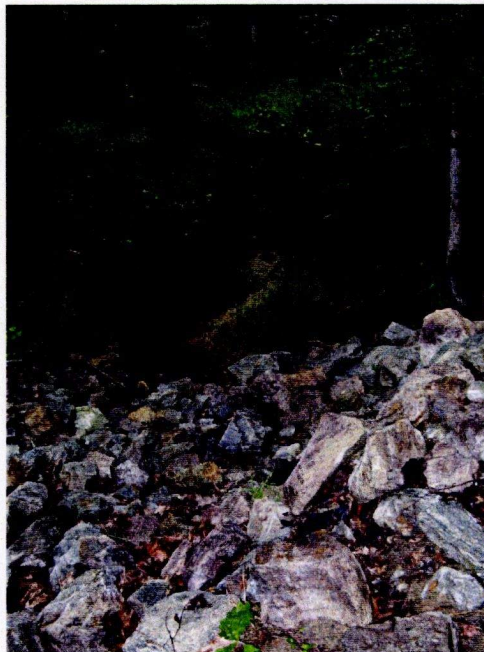
**Identifier:** Kristiansand - 23

**Location:** North of Valley Green

Construct small stormwater basin (such as a shallow marsh) within apron area for improved water quality treatment.

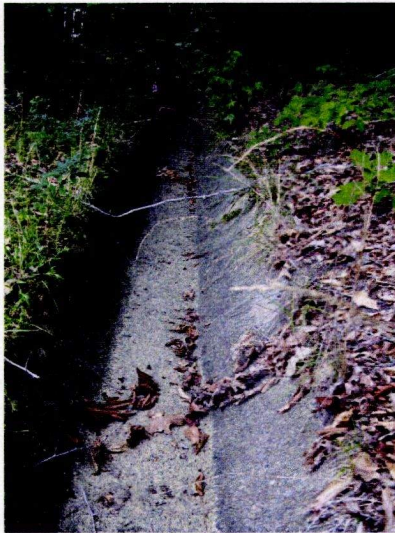
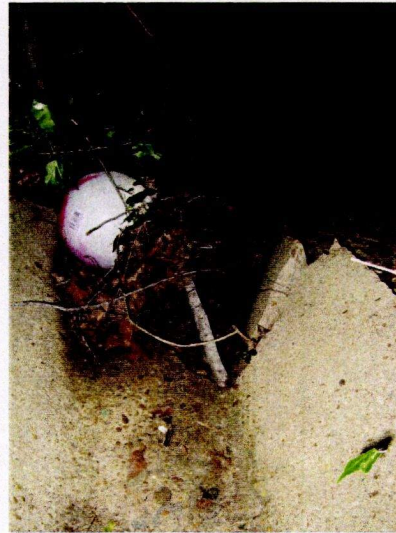
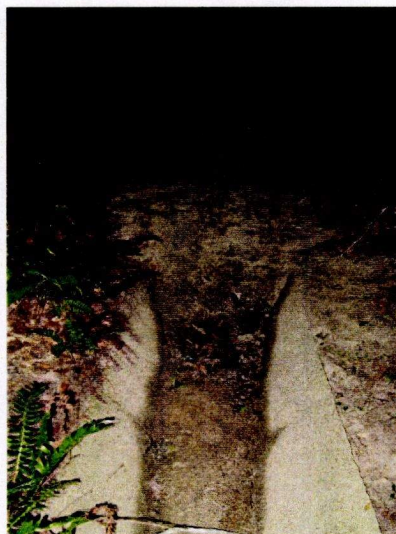
Existing concrete channel conveying stormwater from roadway to stream. Segments of the channel are damaged and clogged with debris. The ultimate outfall has a significant amount of sediment accumulation upstream of an apparent riprap check dam. Some erosion occurring between riprap and stream channel.

Repair damaged segments of channel and remove debris. Remove and dispose of sediment at channel outfall. Modify outfall and/or extend riprap protection as needed to ensure stable transition to stream channel.

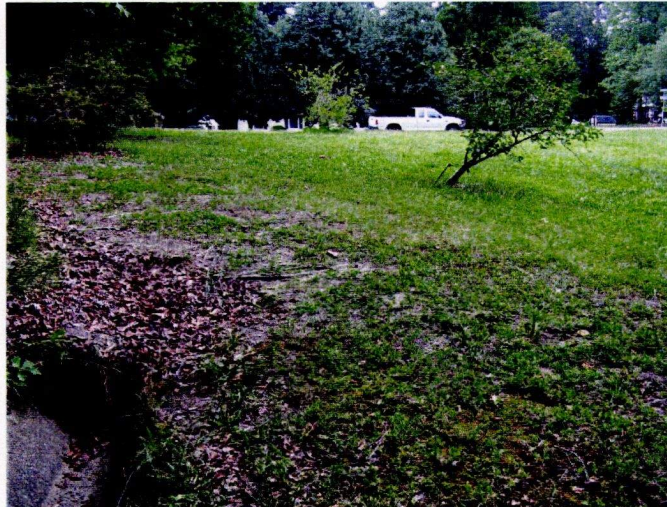
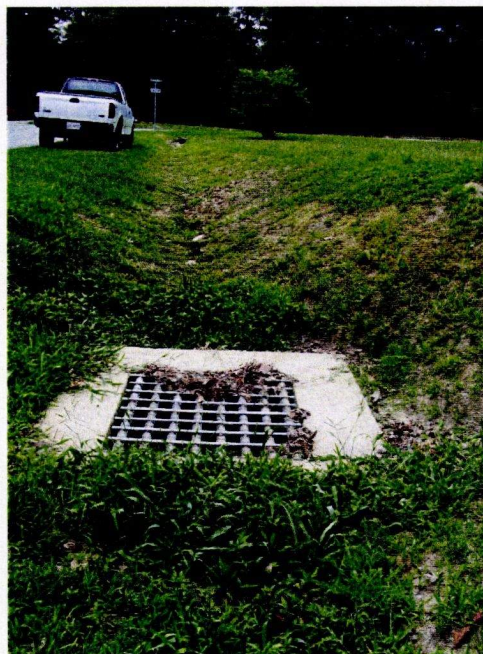
**Identifier:** Kristiansand - 26

**Location:** South of Nina Lane, between Drammon Ct and Sandstad Ct

Install a bioretention filter in the location of the drop inlet which may require a moderate amount of earthwork to construct, but there is ample space. Coordination with the homeowner will be critical.

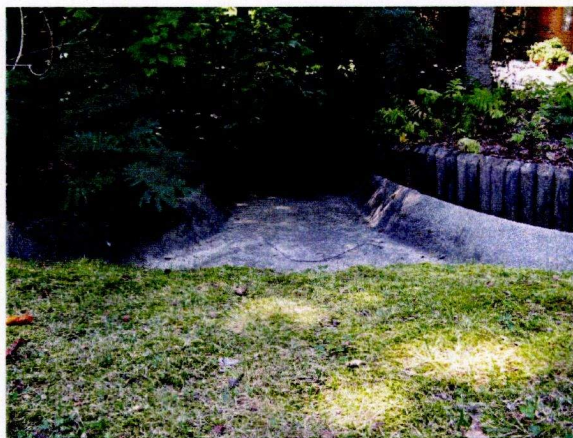
<b>Identifier:</b>	Kristiansand - 27
<b>Location:</b>	Herstad Ct Cul-de-sac
<b><u>Existing Conditions:</u></b>	Stormwater runoff from existing roadways is collected in concrete ditches and transported to this outfall culvert which connects to a manhole in the adjacent property owner's backyard and ultimately to the stream channel.
<b><u>Potential Improvements:</u></b>	Remove and dispose of sediment and debris from downstream invert. Modify outfall and/or provide outlet protection as needed to ensure stable transition to stream channel.

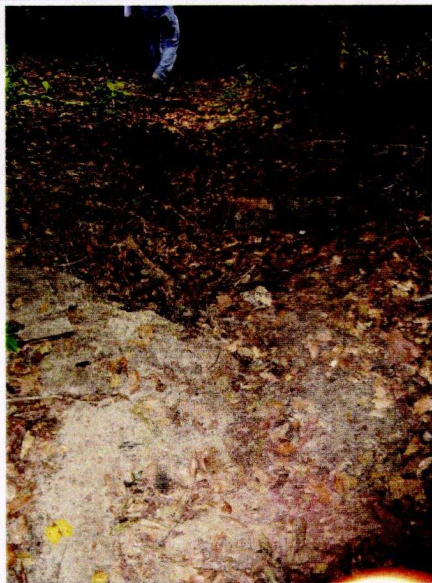
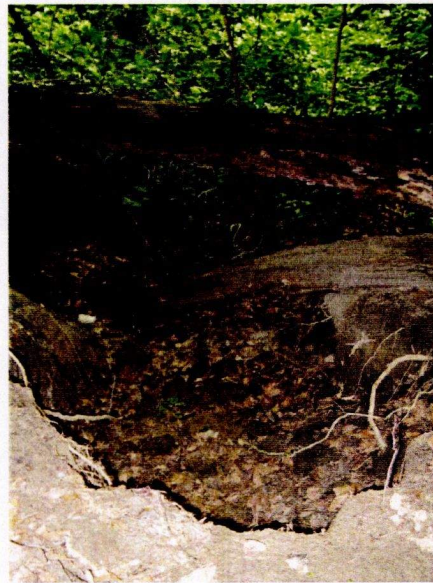
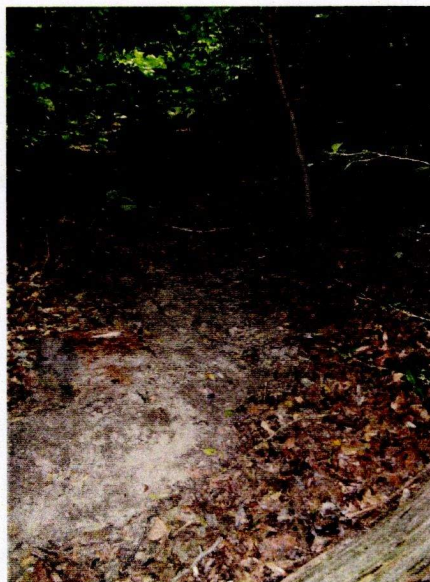
<b>Identifier:</b>	Kristiansand - 28
<b>Location:</b>	West of Torea Court, downstream of Retrofit # 29
<b><u>Existing Conditions:</u></b> Shallow swale conveying stormwater runoff through existing woods. Not well defined flowpath and some erosion present within the swale. Headcut formed at confluence with stream channel.	
<b><u>Potential Improvements:</u></b> Improve existing swale to better promote infiltration. Improvements may include minor grading, soil amendments, and/or installation of check dams. Repair and stabilize all eroded areas. Provide headcut stabilization.

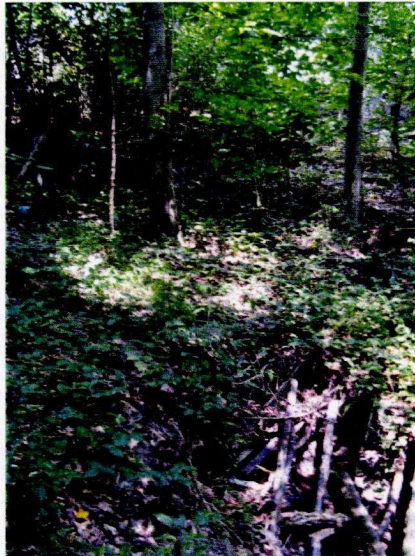
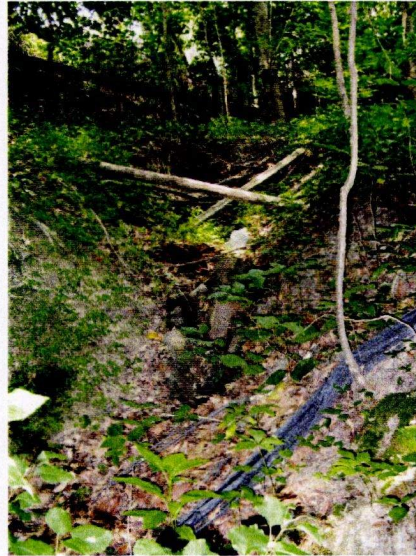
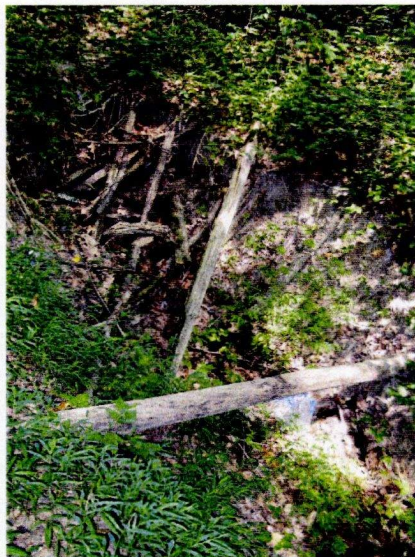
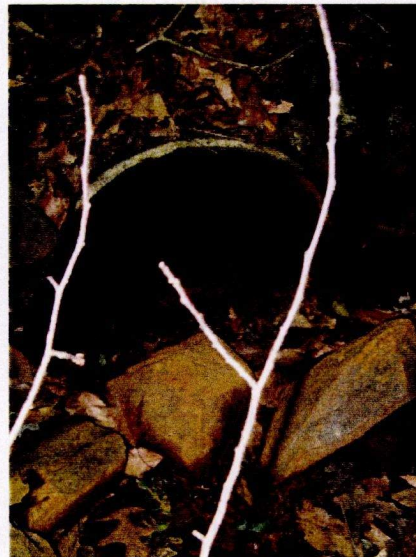
<b>Identifier:</b>	Kristiansand - 33
<b>Location:</b>	Western edge of Williamsburg Village
<b><u>Existing Conditions:</u></b>	<p>Appears to be a large, shallow dry detention/infiltration facility, but currently under construction. Some sediment accumulation and rill erosion present. Pretreatment swales direct runoff from condos to basin. Drop inlet structure uncovered and clogged with debris. Standing water within riser, and outfall pipe could not be located.</p>
<b><u>Potential Improvements:</u></b>	<p>Remove and dispose of accumulated sediment. Install nested bioretention filter within basin area. Potential for compost amended soils and enhanced vegetative cover for improved water quality treatment. Remove debris from drop inlet, locate and remove blockage, replace top of inlet structure, and ensure outfall pipe is properly daylighted. Additional review may yield potential to optimize outlet structure for improved water quality treatment and channel protection.</p>

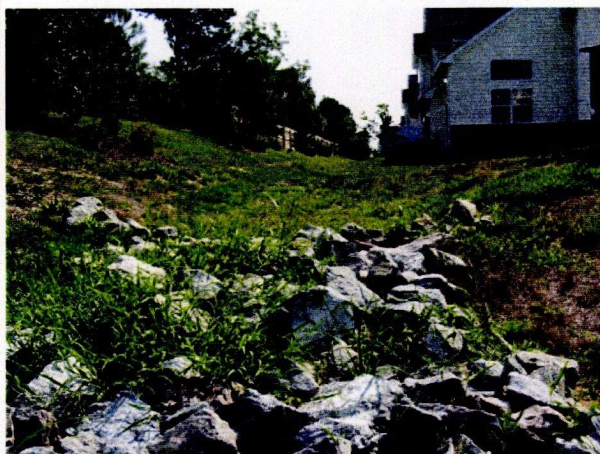
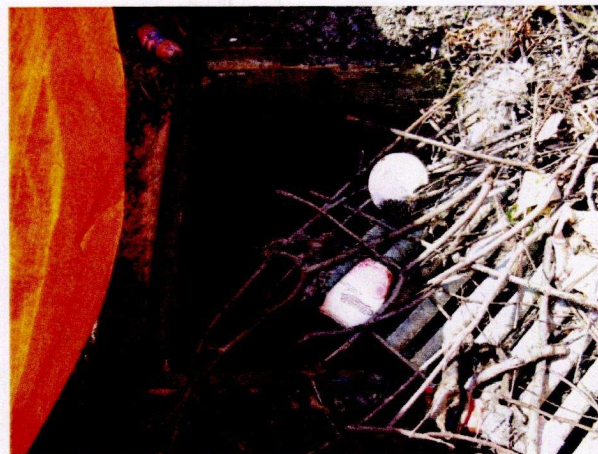
<b>Identifier:</b>	Kristiansand - 34
<b>Location:</b>	Southern edge of Williamsburg Village
<b><u>Existing Conditions:</u></b>	Dry detention basin with timber weir wall and perforated pipe outlet.
<b><u>Potential Improvements:</u></b>	Convert to an infiltration/bioretention basin or shallow marsh facility pending further soil evaluation. Ensure ends of weir wall are fully tied into slopes.

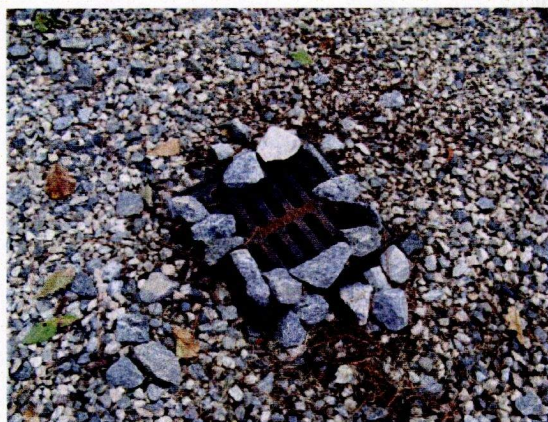
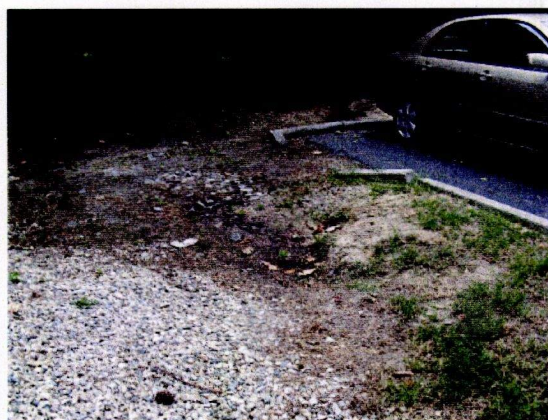
<b>Identifier:</b>	Kristiansand - 39
<b>Location:</b>	Norge Office Park (southeast corner)
<b><u>Existing Conditions:</u></b>	Existing gravel infiltration trench adjacent to parking lot. Appears to be functioning well.
<b><u>Potential Improvements:</u></b>	To improve the aesthetic value of the facility, perimeter landscaping and/or a surface layer of topsoil and vegetative ground cover could be employed. If the basin is to be topdressed, further evaluation of its function should be performed to ensure water quality benefits are not compromised and to determine the new design configuration (may require an overflow structure).

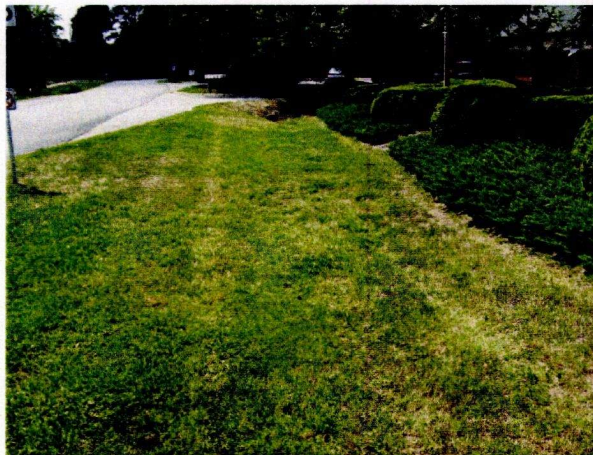
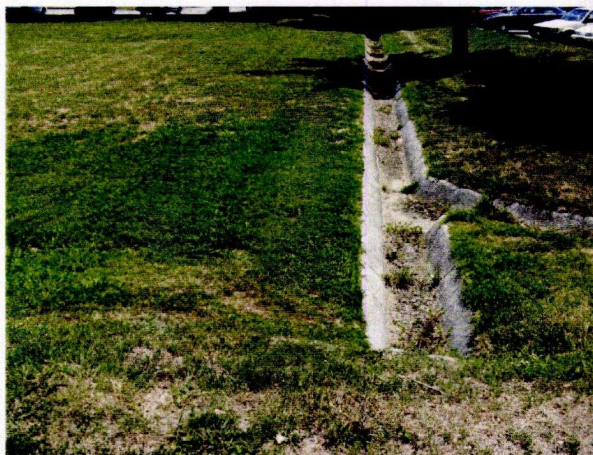
<b>Identifier:</b>	Kristiansand - 42
<b>Location:</b>	Front of Williamsburg Honda
<b><u>Existing Conditions:</u></b>	Existing infiltration basin between Rt. 60 and parking lot of Williamsburg Honda which appears to be functioning well.
<b><u>Potential Improvements:</u></b>	Identified in Yarmouth Creek Watershed Plan (104-R1). Enhance existing basin by adding landscaping and mulch layer to function more like a bioretention facility.
