# Kristiansand Subdivision

# STREAM CONDITION SUMMARY MAP JCC - KRISTIANSAND TRIBUTARY JAMES CITY COUNTY, VIRGINIA

WATERSHED EVALUATION  
SUMMARY MAP

JCC - KRISTIANSAND TRIBUTARY  
JAMES CITY COUNTY, VIRGINIA

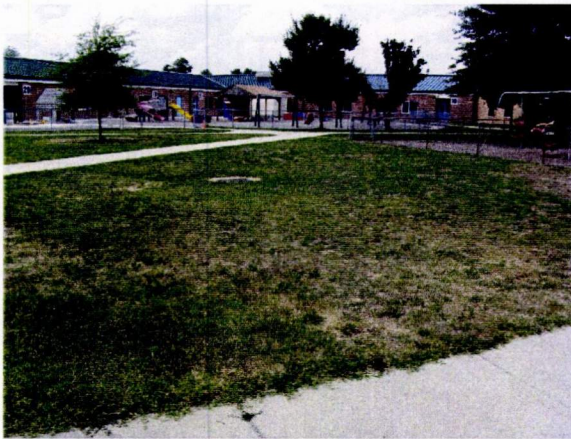
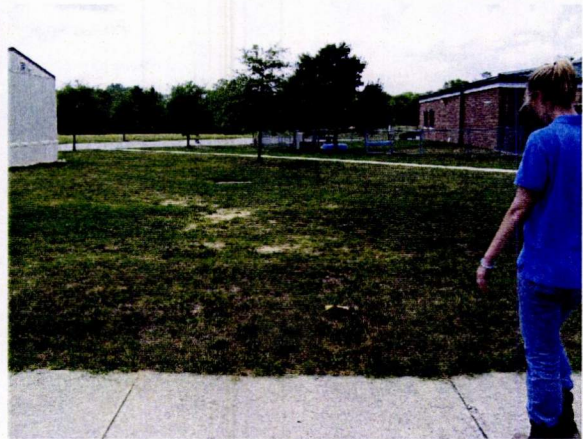
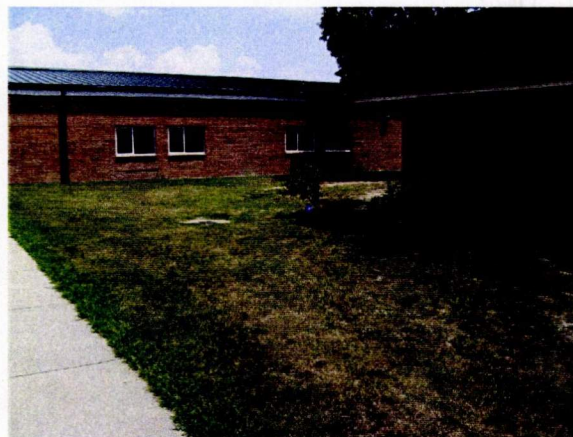
<b>Identifier:</b>	Kristiansand - 47
<b>Location:</b>	Norge Elementary School (behind school to the west)
<p><b><u>Existing Conditions:</u></b></p> <p>Existing wetland area or shallow BMP surrounded by chain link fence. Appears to be outfall from the school storm sewer system.</p>	
<p><b><u>Potential Improvements:</u></b></p> <p>Even though this area drains away from the tributary of concern for this study (as may other portions of Norge Elementary School), it could be evaluated for potential retrofits. This area was not reviewed in great detail in this study, but there may be potential for a shallow marsh BMP retrofit, outlet protection, pre-treatment forebay, and/or existing wetland enhancement pending further evaluation.</p>
