September 5, 2008

**Re: Site Assessment and Conceptual Plan
 Kristiansand Tributary Project, James City County, Virginia
 WEG Project #3935**

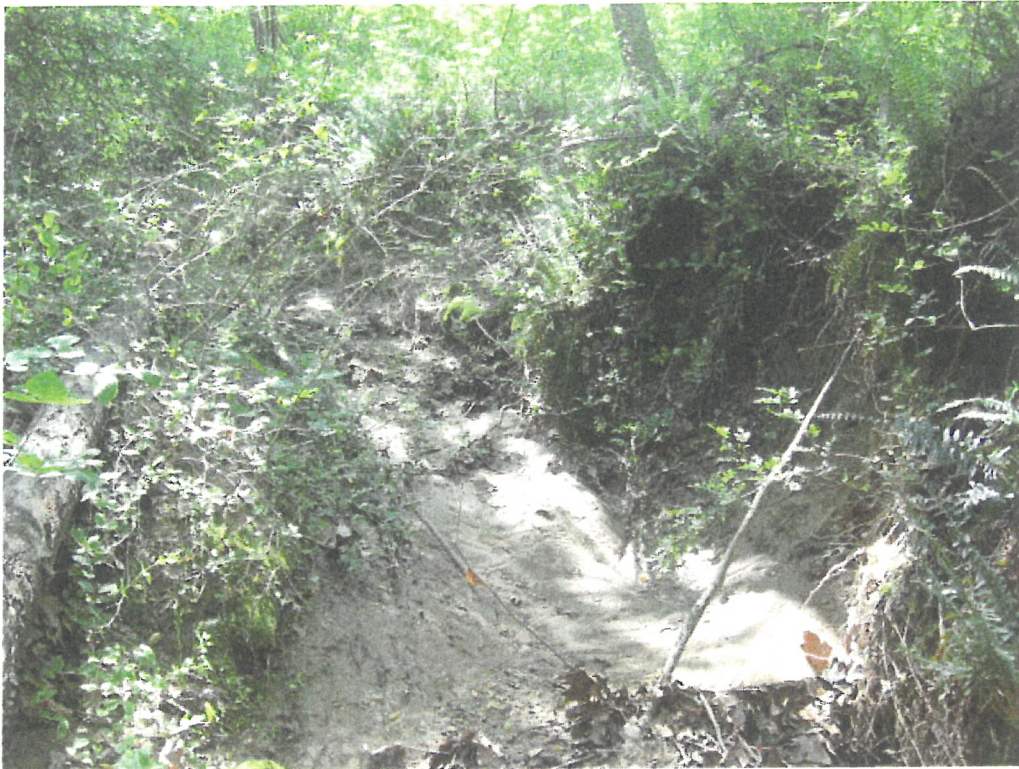
Photograph 1: Reach 1 – Looking upstream (potential stream enhancement).

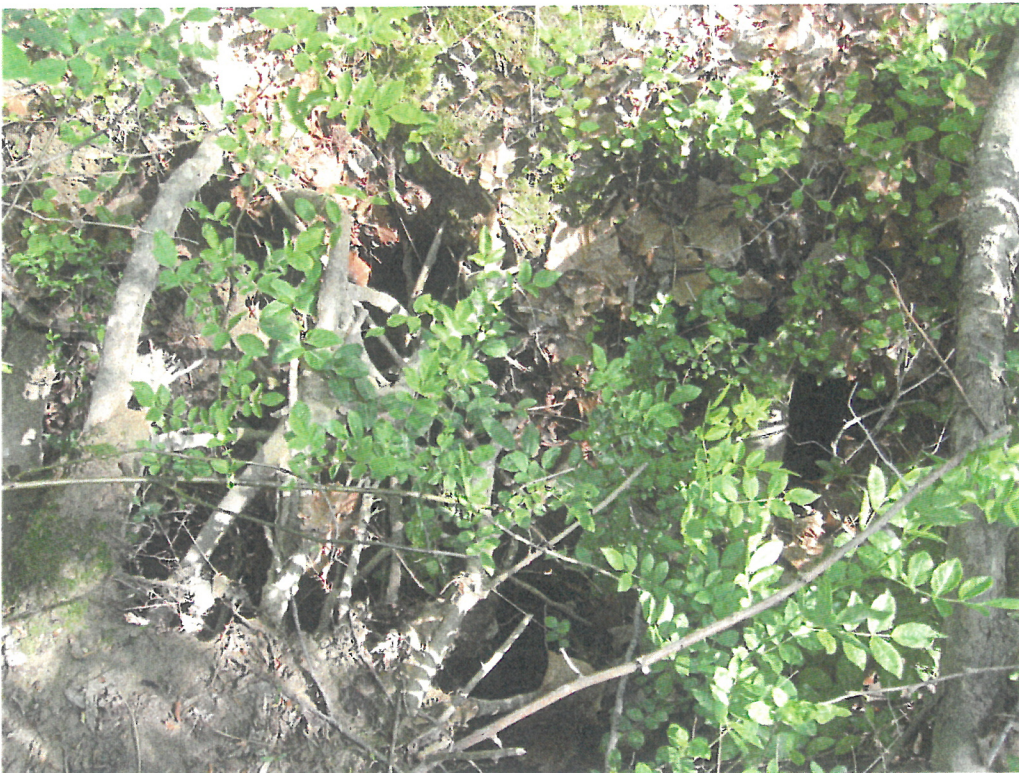
Photograph 2: Reach 2 – Incision below effective rooting depth (potential stream restoration).

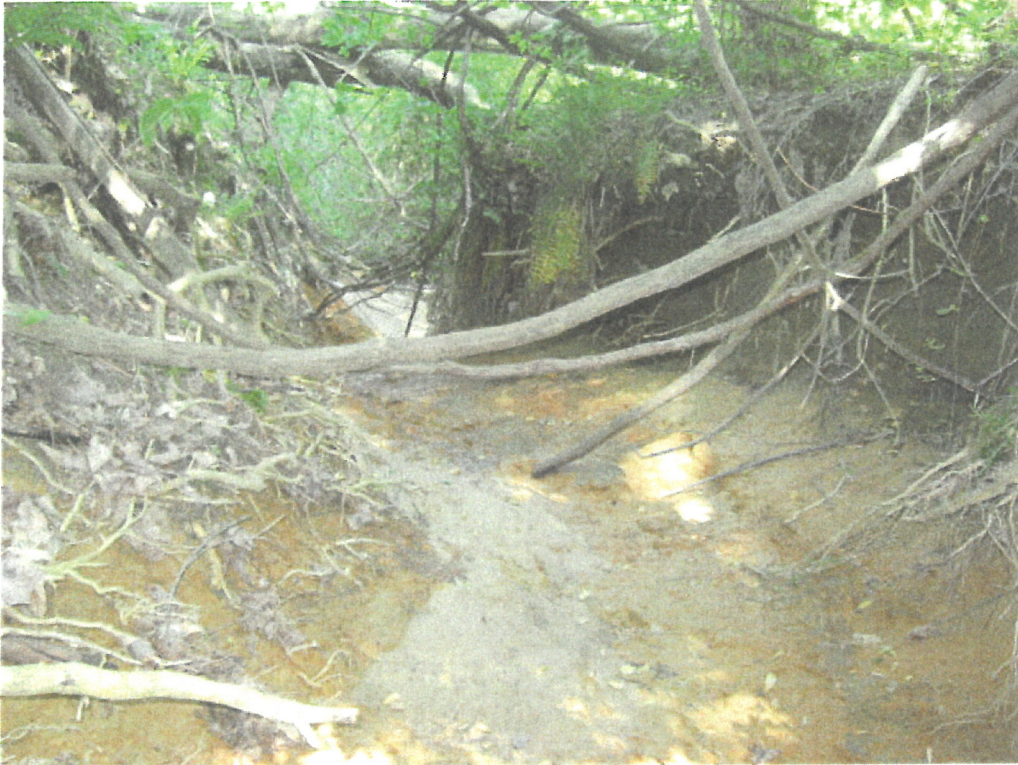
Photograph 3: Reach 3 – Looking downstream (potential stream enhancement).

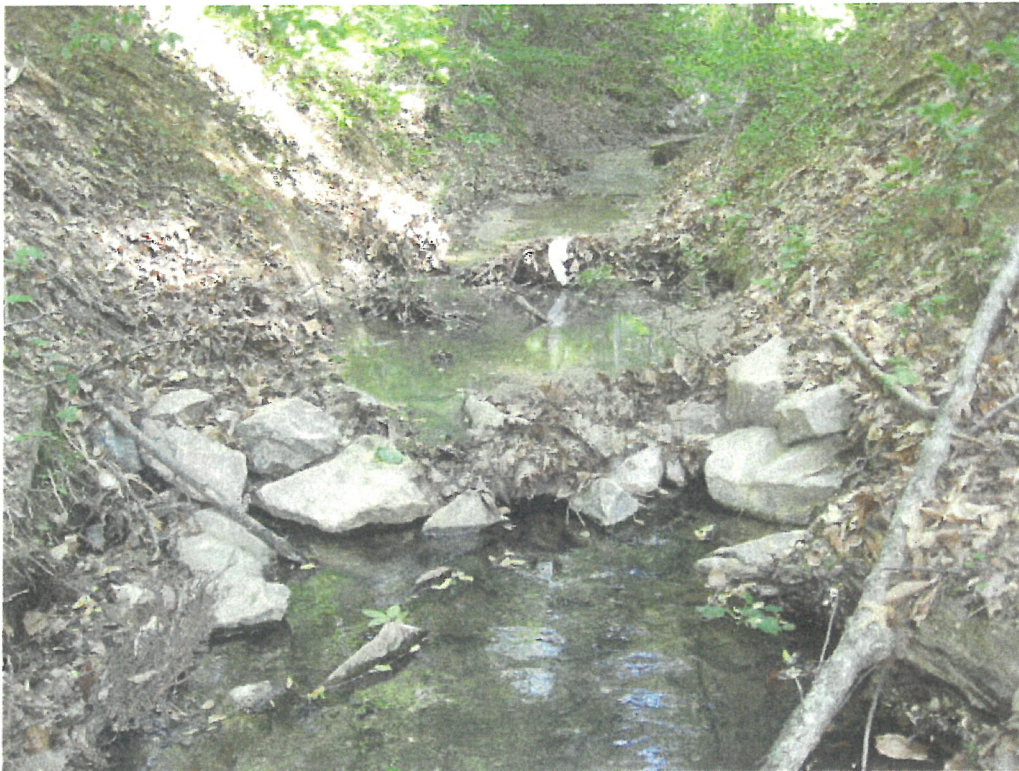
Photograph 4: Reach 4 – Within currently enhanced area.

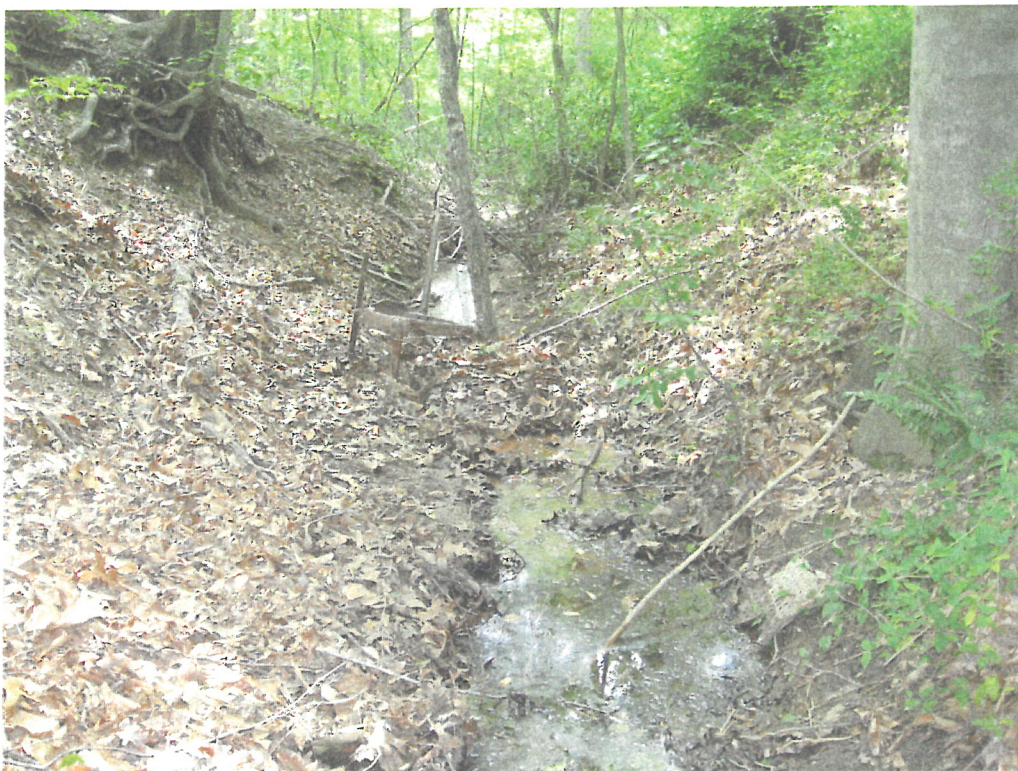
Photograph 5: Reach 5 – Looking upstream.

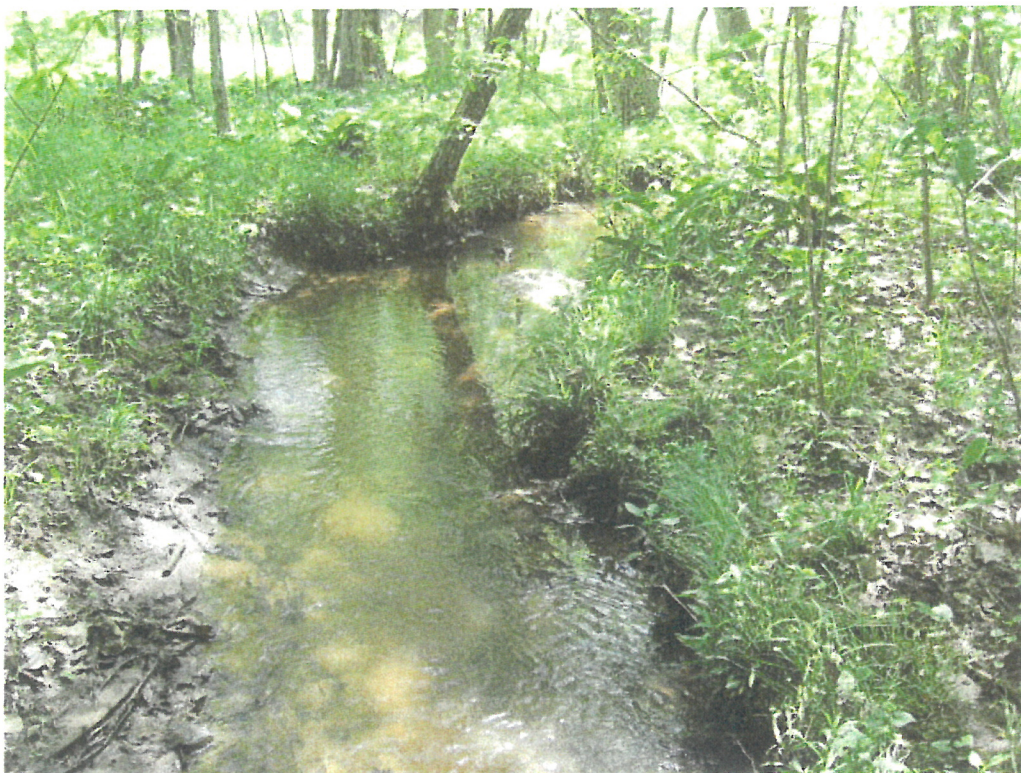
Photograph 6: Reach 6 – Looking downstream.

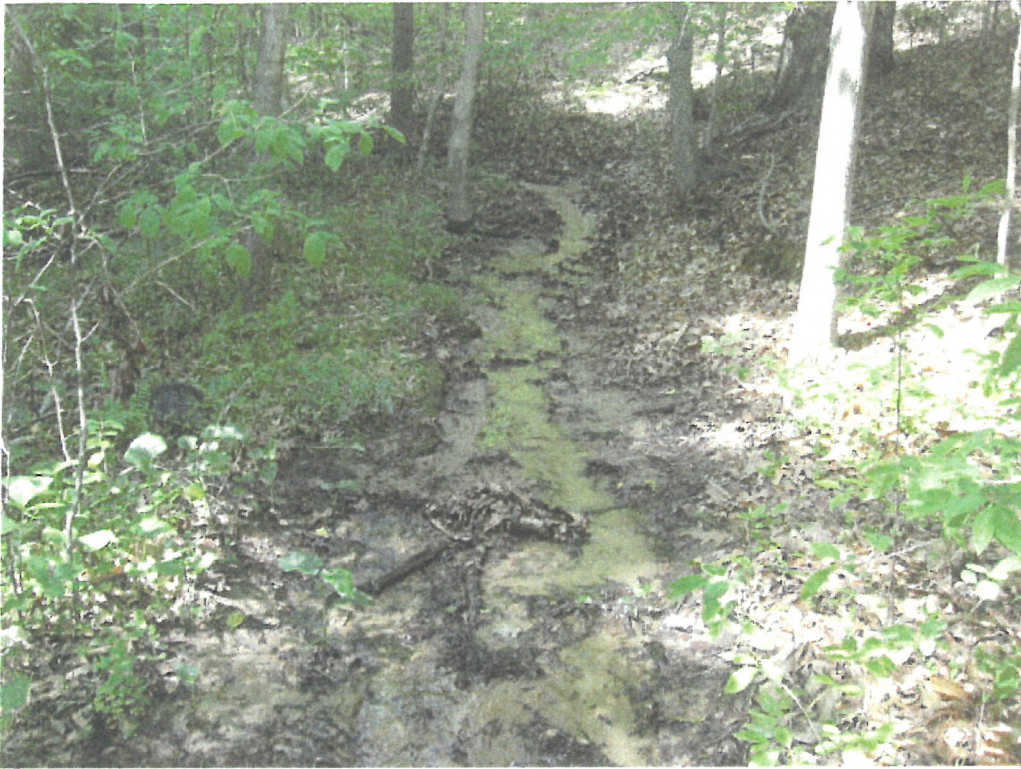
Photograph 7: Reach 7 – Looking upstream.

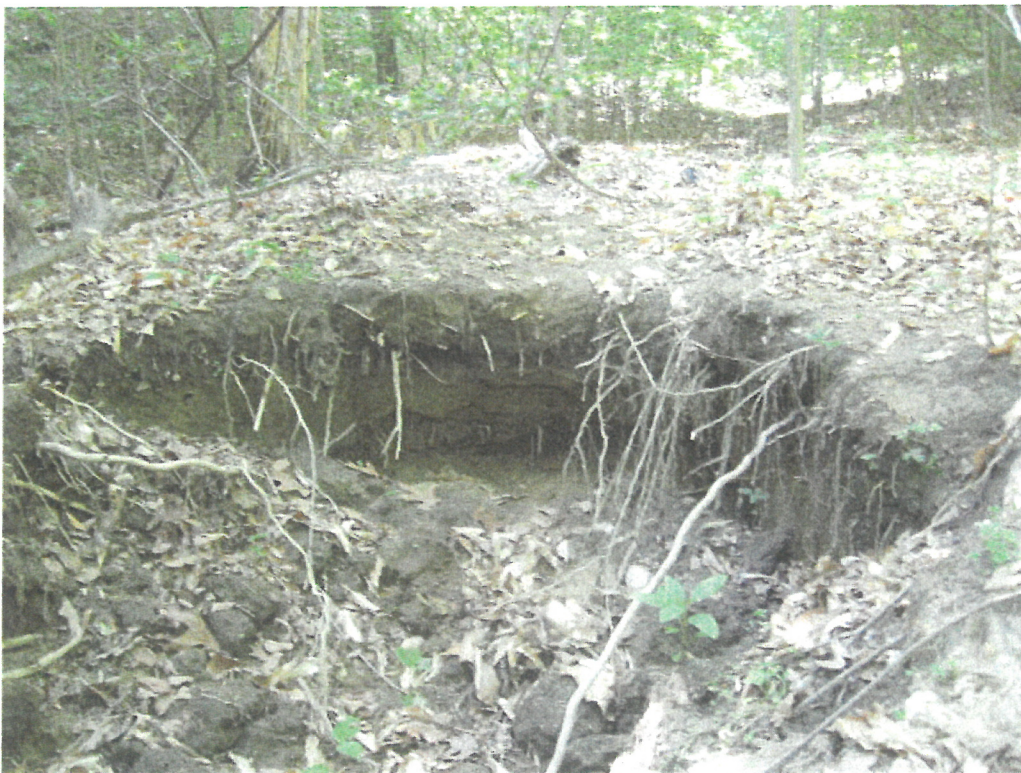
Photograph 8: Reach 7 – Headcut area (potential stream restoration).

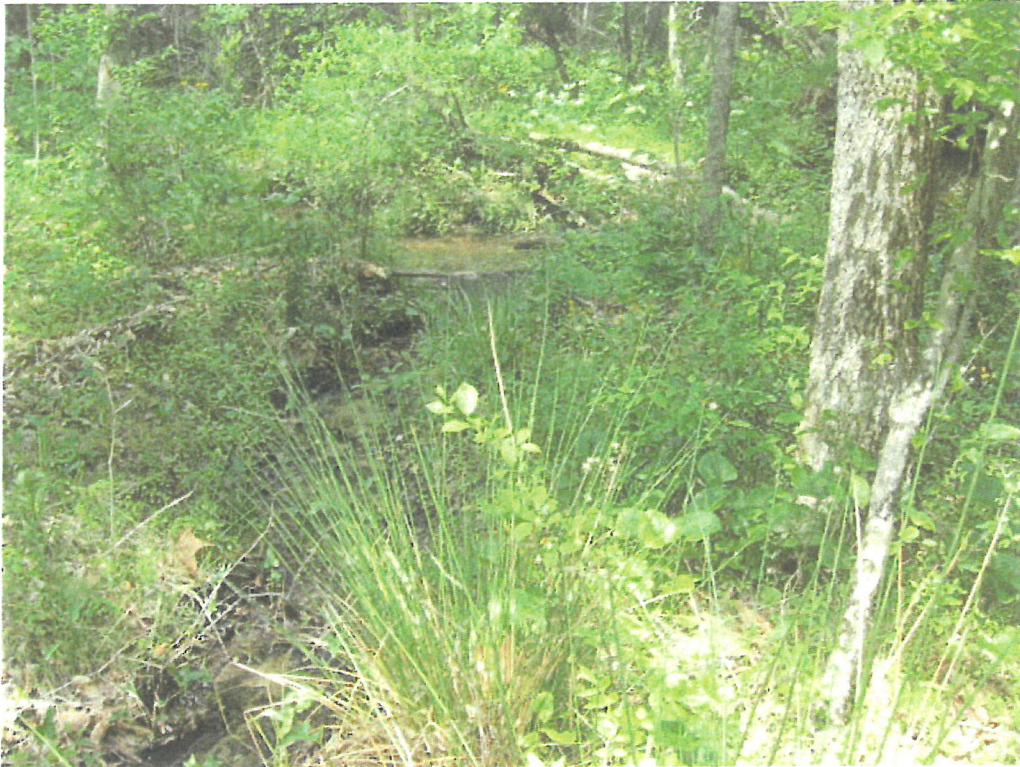
Photograph 9: Reach 8 – Looking downstream.

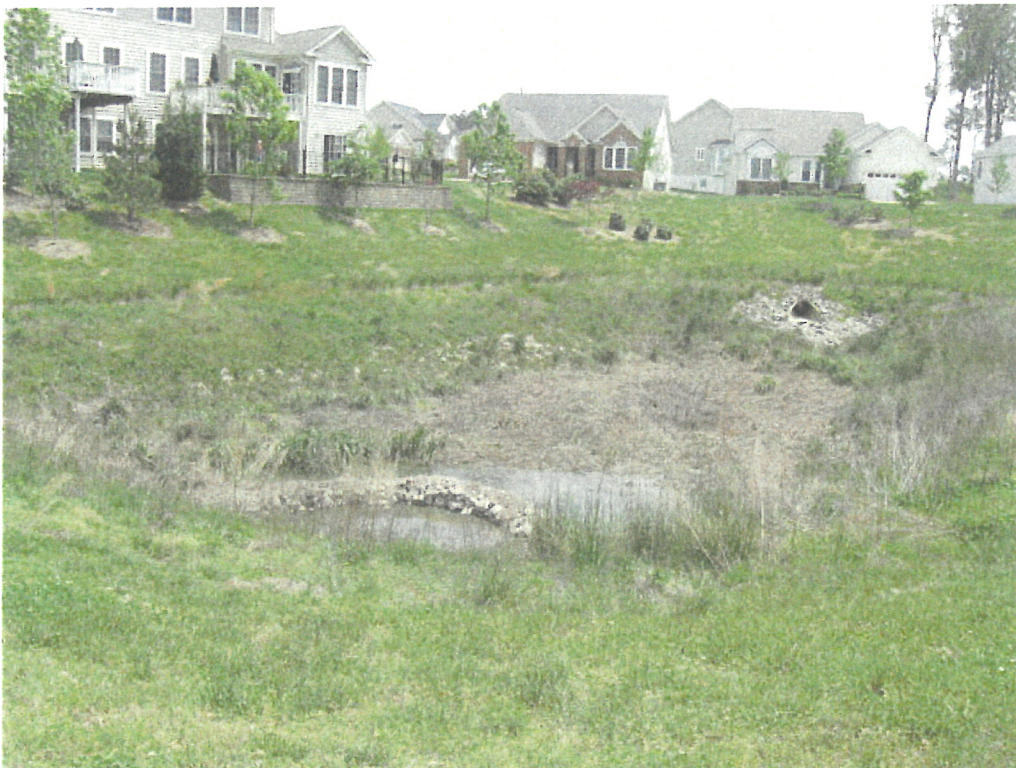
Photograph 10: Reach 8 – Representative existing BMP.

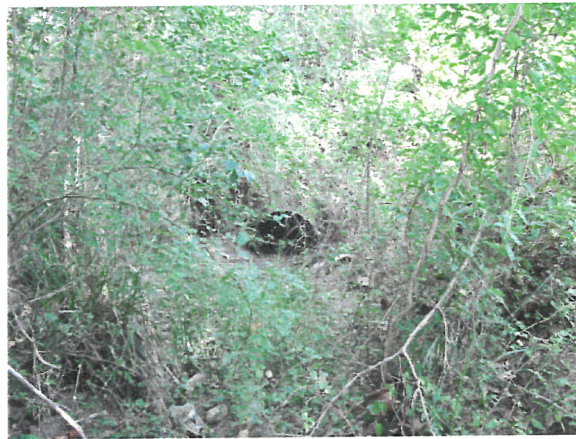
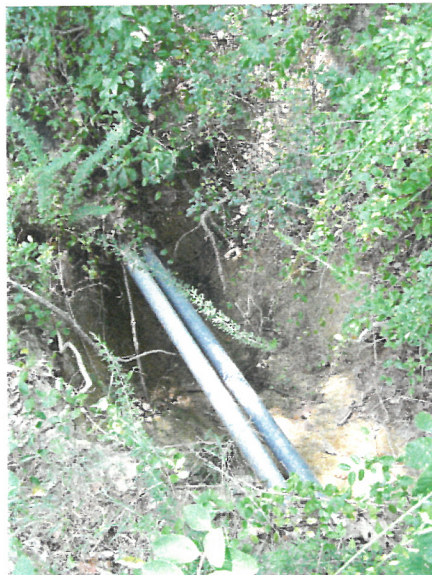
Identifier:	Kristiansand - 10
Location:	Between Econo Lodge and BayLands Federal Credit Union
<p><u>Existing Conditions:</u></p> <p>Uncontrolled runoff from Rt. 60 causing major erosion downstream of outfall, exposed utilities, and incised channel.</p>	
<p><u>Potential Improvements:</u></p> <p>Pending intended use of barren lot adjacent to Econo Lodge, a stormwater management basin could be constructed upstream of existing stream channel. Proposed BMP may be a retention pond or enhanced extended-detention facility, pending detailed design considerations. New BMP construction would require significant grading and adjustment of storm sewer outfall. Stabilize downstream headcut and restore incised portions of stream channel. At a minimum, proper energy dissipation and headcut stabilization required at outfall.</p>

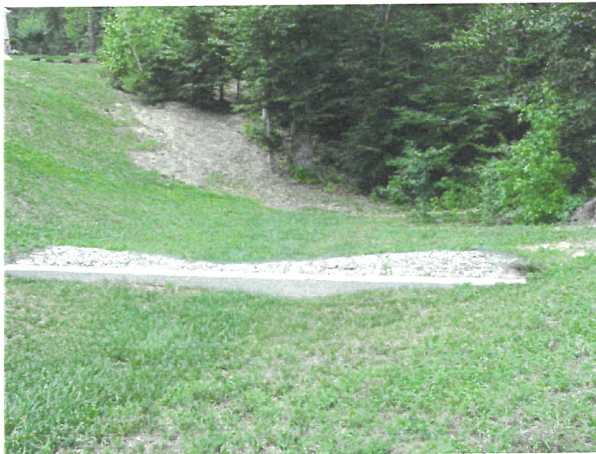
Identifier:	Kristiansand - 18
Location:	North of Pinebrook Rd, between Newport Forest and Livingston Lon
<p><u>Existing Conditions:</u></p> <p>Concrete level spreader and filter strip which appear to be functioning moderately well, but downslope area is relatively steep with some rills forming. May be too steep/channelized for proper function of filter strip.</p>	
<p><u>Potential Improvements:</u></p> <p>Construct bioretention filter upslope of level spreader. Recommend removing level spreader and provide stable conveyance down slope, especially if erosion problems begin to occur. At a minimum, ensure ends of level spreader are fully tied into slopes, repair rills, and consider the use of natural buffer enhancement downslope.</p>

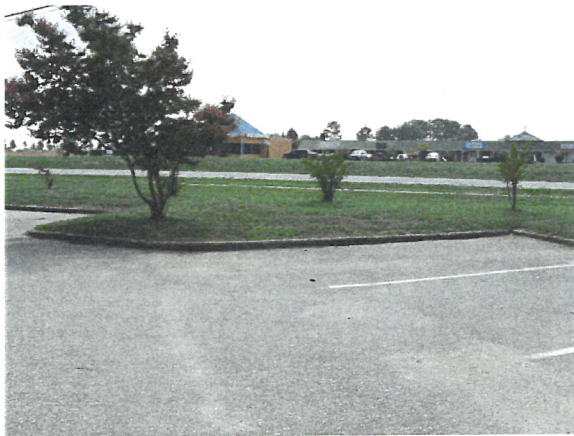
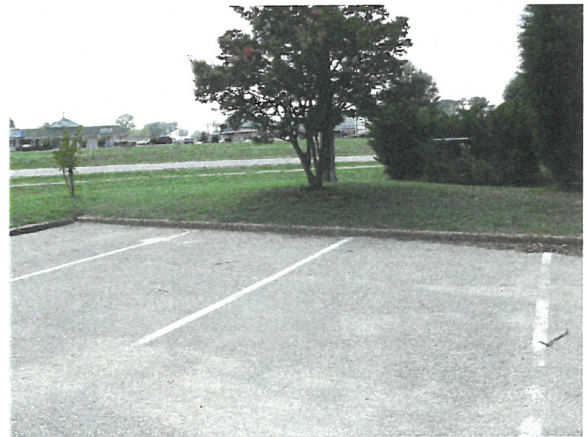
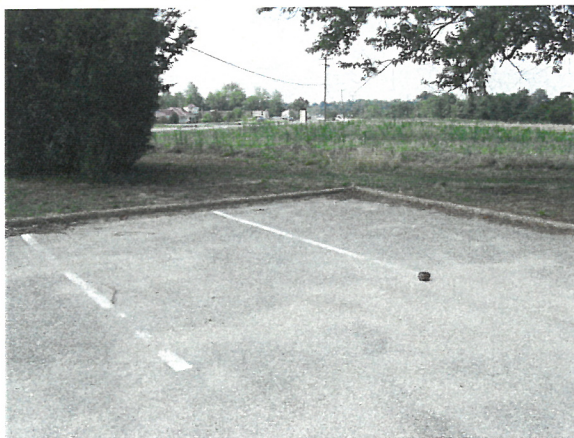
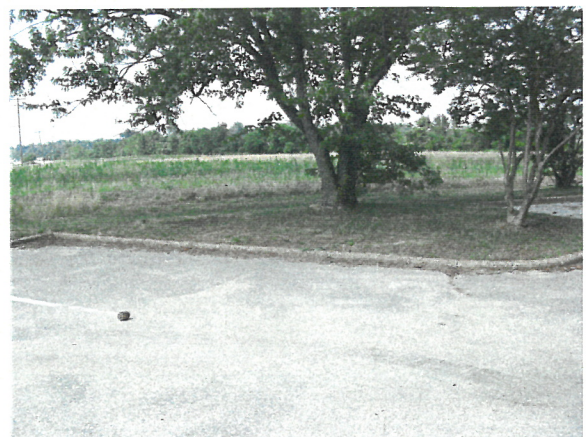
Identifier:	Kristiansand - 4
Location:	Go-Karts Plus (northern edge of parking lot)
<u>Existing Conditions:</u>	
Open areas adjacent to curb and gutter along parking lot.	
<u>Potential Improvements:</u>	
Install curb cuts and offline bioretention filters treating parking lot. May be difficult to daylight underdrains.

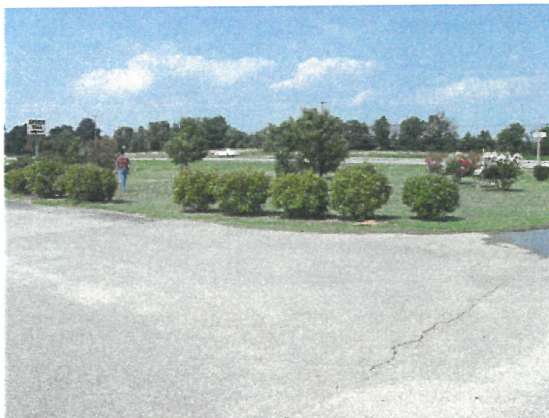
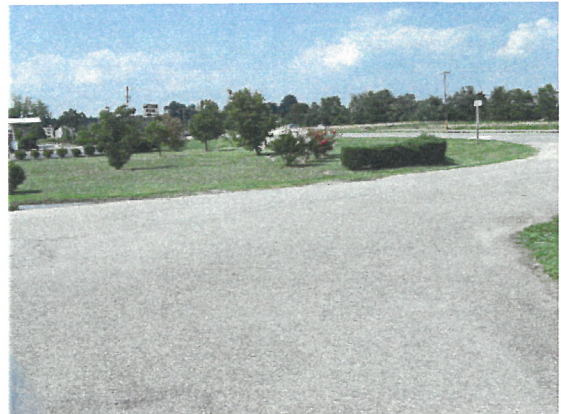
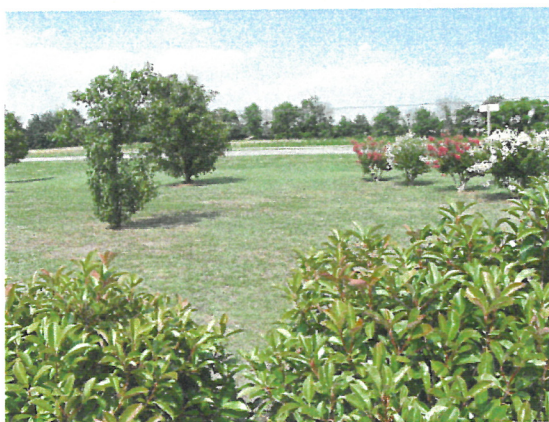
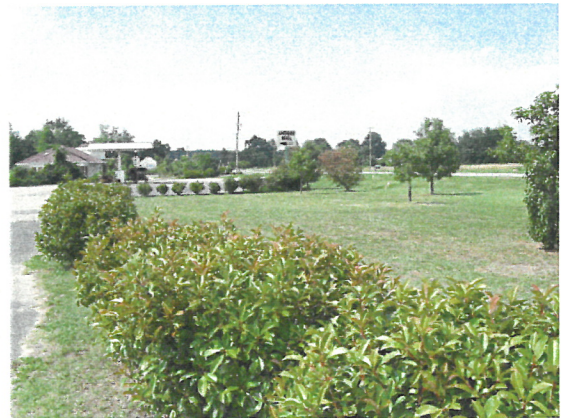
Identifier:	Kristiansand - 8
Location:	Colonial Towne Plaza (northeast of Shopping Center near Antique Mall)
<p><u>Existing Conditions:</u></p> <p>Uncontrolled runoff from much of the parking lot draining into an open area near Rt. 60. There are multiple drop inlets located near Rt. 60 receiving the runoff, one covered with debris and damaged.</p>	
<p><u>Potential Improvements:</u></p> <p>Construct a stormwater management basin within the open area between the Shopping Center and the Antique Mall. Repair the existing storm sewer system and modify to accommodate the basin outlet structure. The use of an enhanced extended-detention basin (shallow marsh) or an infiltration/bioretention facility should be explored pending further soil evaluation.</p>

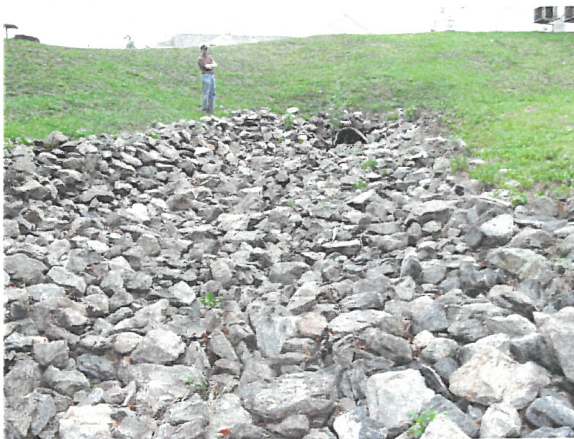
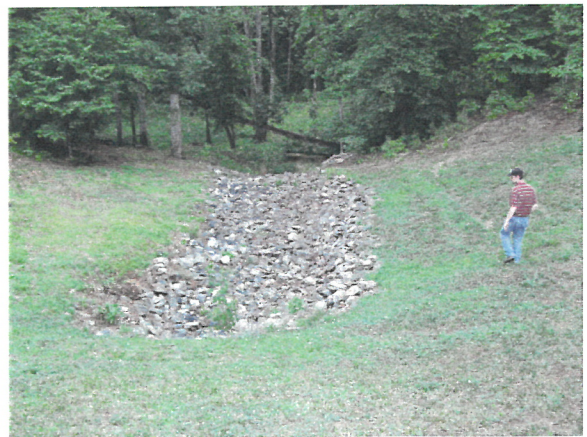
Identifier:	Kristiansand - 23
Location:	North of Valley Green
<u>Existing Conditions:</u>	
Riprap apron at storm sewer outfall. Appears to be stable.	
<u>Potential Improvements:</u>	
Construct small stormwater basin (such as a shallow marsh) within apron area for improved water quality treatment.

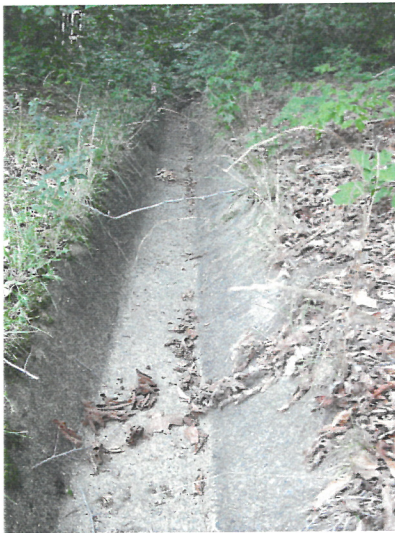
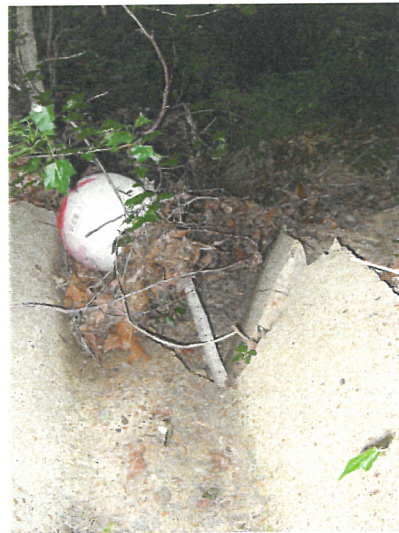
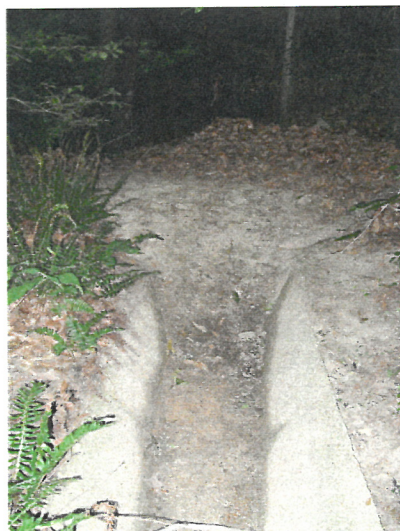
Identifier:	Kristiansand - 25
Location:	South of Nina Lane, between Drammon Ct and Sandstad Ct
<p><u>Existing Conditions:</u></p> <p>Existing concrete channel conveying stormwater from roadway to stream. Segments of the channel are damaged and clogged with debris. The ultimate outfall has a significant amount of sediment accumulation upstream of an apparent riprap check dam. Some erosion occurring between riprap and stream channel.</p>	
<p><u>Potential Improvements:</u></p> <p>Repair damaged segments of channel and remove debris. Remove and dispose of sediment at channel outfall. Modify outfall and/or extend riprap protection as needed to ensure stable transition to stream channel.</p>

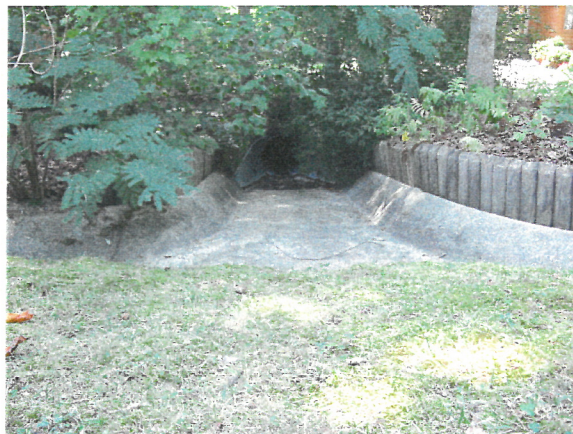
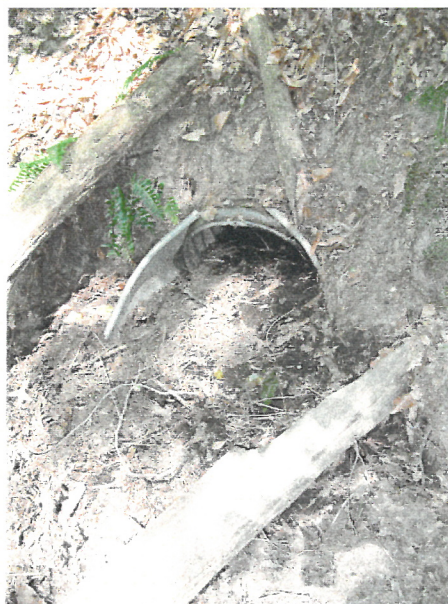
Identifier:	Kristiansand - 27
Location:	Herstad Ct Cul-de-sac
<p><u>Existing Conditions:</u></p> <p>Stormwater runoff from existing roadways is collected in concrete ditches and transported to this outfall culvert which connects to a manhole in the adjacent property owner's backyard and ultimately to the stream channel.</p>	
<p><u>Potential Improvements:</u></p> <p>Remove and dispose of sediment and debris from downstream invert. Modify outfall and/or provide outlet protection as needed to ensure stable transition to stream channel.</p>

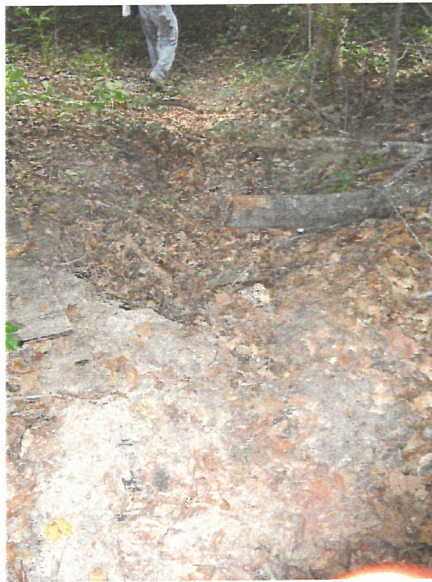
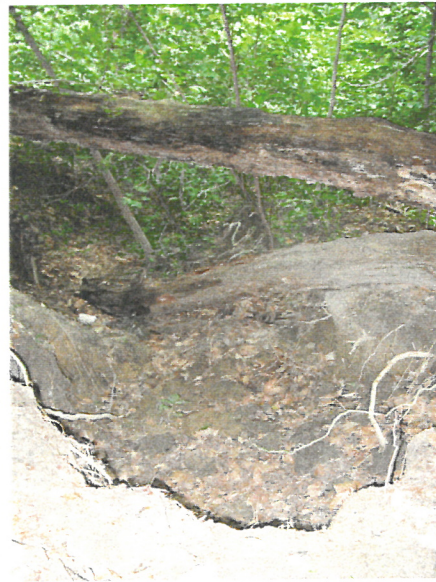
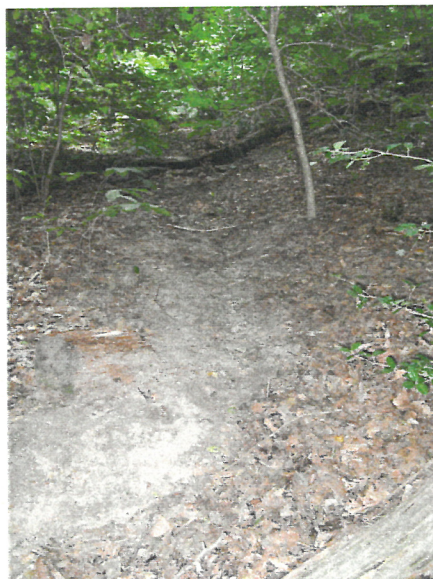
Identifier:	Kristiansand - 28
Location:	West of Torea Court, downstream of Retrofit # 29
<p><u>Existing Conditions:</u></p> <p>Shallow swale conveying stormwater runoff through existing woods. Not well defined flowpath and some erosion present within the swale. Headcut formed at confluence with stream channel.</p>	
<p><u>Potential Improvements:</u></p> <p>Improve existing swale to better promote infiltration. Improvements may include minor grading, soil amendments, and/or installation of check dams. Repair and stabilize all eroded areas. Provide headcut stabilization.</p>

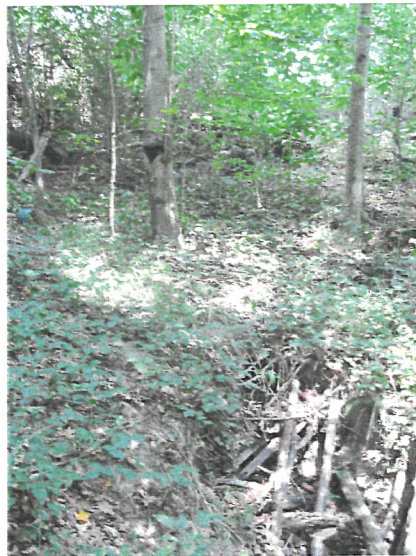
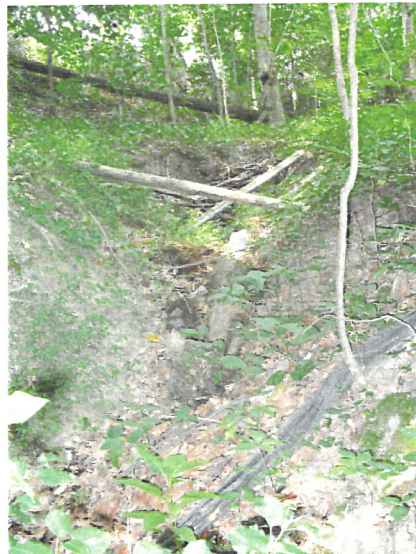
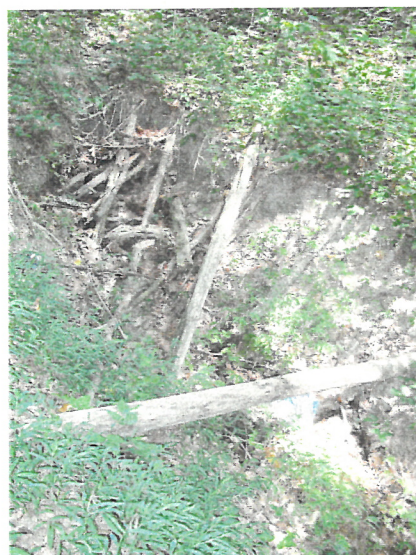
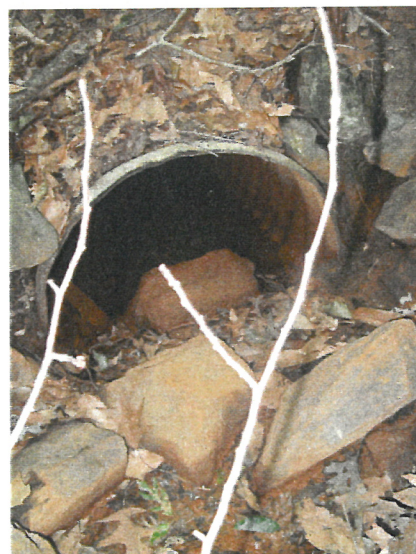
Identifier:	Kristiansand - 32
Location:	Corner of Telemark Drive and Rodane Place
<p><u>Existing Conditions:</u></p> <p>Open space parcel leading to stream channel. A substantial amount of yard waste is piled along the treeline near the roadway. Roadway storm sewer discharges to stream at toe of slope. Extensive gully erosion present upslope of outfall and channel erosion downstream. Some debris and sediment clogging part of pipe.</p>	
<p><u>Potential Improvements:</u></p> <p>Excavate back from storm sewer outfall and shorten pipe. Install energy dissipation at outfall and repair/stabilize all eroded areas. May be potential to construct small shallow marsh facility between outfall and stream channel, pending earthworks.</p>

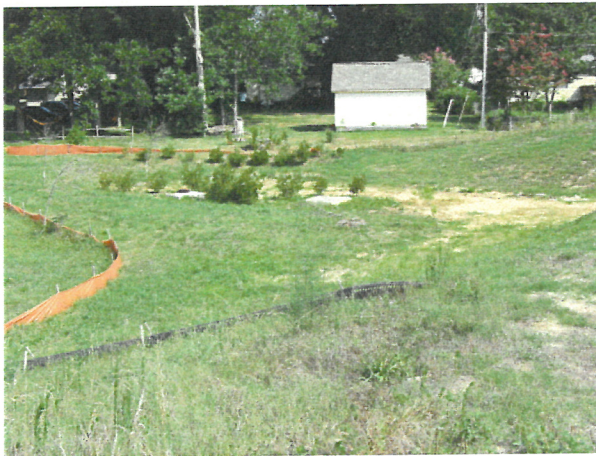
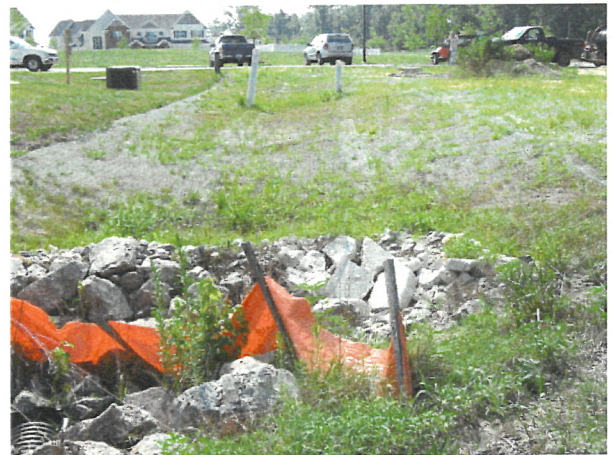
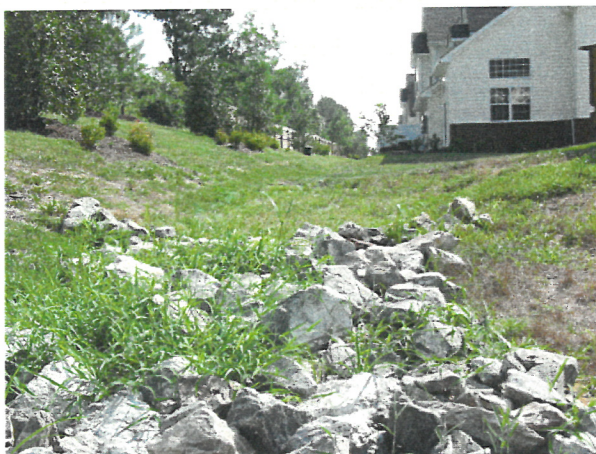
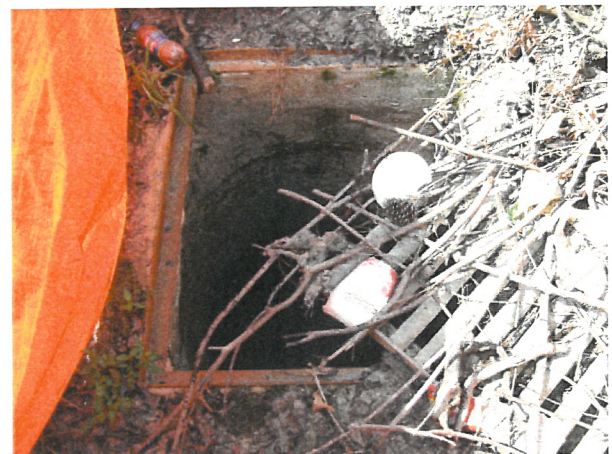
Identifier:	Kristiansand - 33
Location:	Western edge of Williamsburg Village
<u>Existing Conditions:</u>	<p>Appears to be a large, shallow dry detention/infiltration facility, but currently under construction. Some sediment accumulation and rill erosion present. Pretreatment swales direct runoff from condos to basin. Drop inlet structure uncovered and clogged with debris. Standing water within riser, and outfall pipe could not be located.</p>
<u>Potential Improvements:</u>	<p>Remove and dispose of accumulated sediment. Install nested bioretention filter within basin area. Potential for compost amended soils and enhanced vegetative cover for improved water quality treatment. Remove debris from drop inlet, locate and remove blockage, replace top of inlet structure, and ensure outfall pipe is properly daylighted. Additional review may yield potential to optimize outlet structure for improved water quality treatment and channel protection.</p>

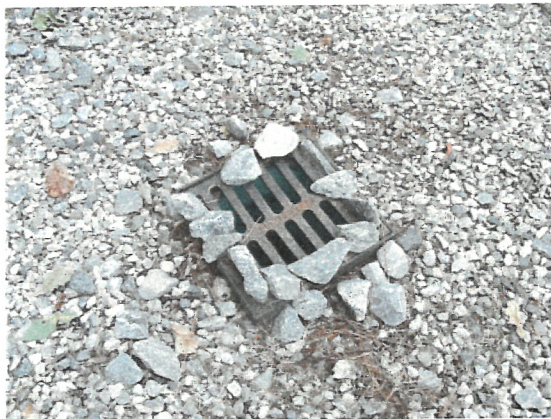
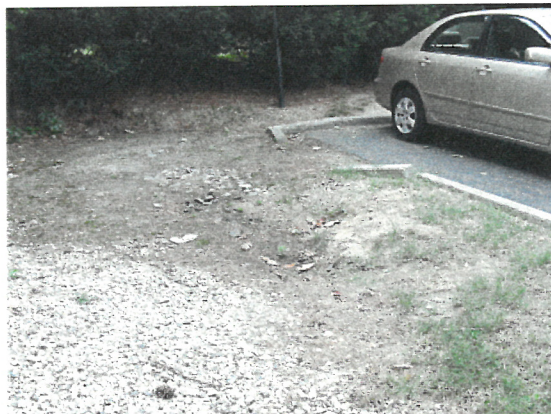
Identifier:	Kristiansand - 38
Location:	Corner of Norge Office Park
<p><u>Existing Conditions:</u></p> <p>Existing gravel infiltration trench adjacent to parking lot. Some sediment accumulation/bare soil present at inlet to basin. The overflow structure is near level with the basin surface. Another riser is present which appears to contain electrical features, but is not covered.</p>	
<p><u>Potential Improvements:</u></p> <p>Remove and dispose of accumulated sediment and ensure inflow to basin is stabilized. Recommend extending overflow structure so that a larger amount of surface ponding is possible before bypassing. Evaluate the additional riser and electrical features to ensure the basin function does not create a concern. A locked cover should be provided over electrical area to prevent tampering (especially considering that children may have played within the basin in the past, as visible in the stone alignment on the overflow structure). Additionally, to improve the aesthetic value of the facility, perimeter landscaping and/or a surface layer of topsoil and vegetative ground cover could be employed. If the basin is to be topdressed, further evaluation of its function should be performed to ensure water quality benefits are not compromised and to determine the new design configuration.</p>

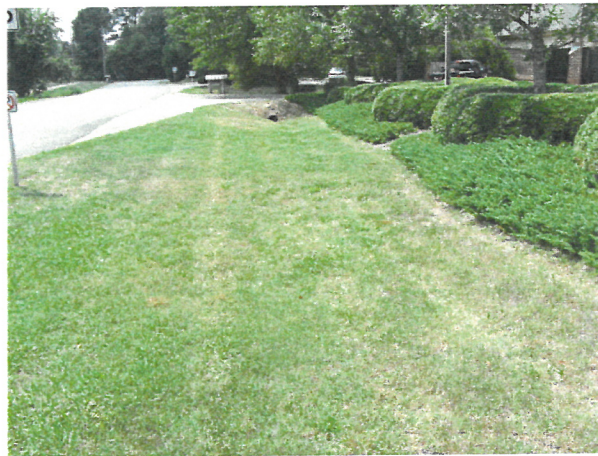
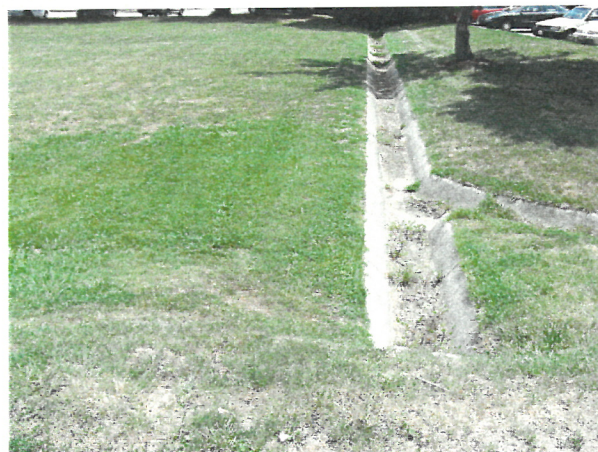
Identifier:	Kristiansand - 41
Location:	Shops at Kristiansand, North of Nina Lane
<p><u>Existing Conditions:</u></p> <p>Existing concrete-lined channels and grassed swales receiving runoff from Nina Lane and the Shops at Kristiansand. Some sediment accumulation within concrete channels.</p>	
<p><u>Potential Improvements:</u></p> <p>Improve existing channels to better promote infiltration. Improvements may include minor grading, soil amendments, and/or check dams. Remove and dispose of accumulated sediment. Further evaluate the concrete channels to determine if they can be replaced by grassed swales with check dams. Alternately, bioretention filters could be installed within select areas of the swale.</p>

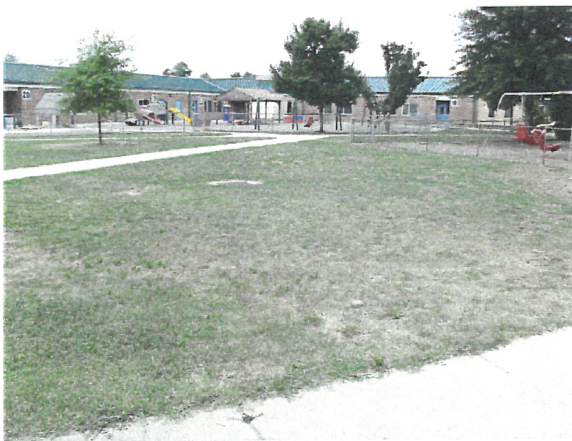
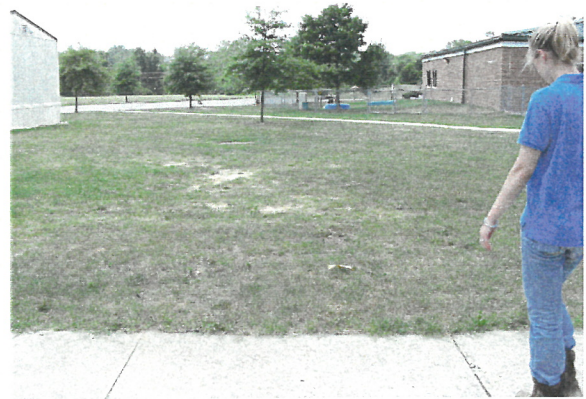
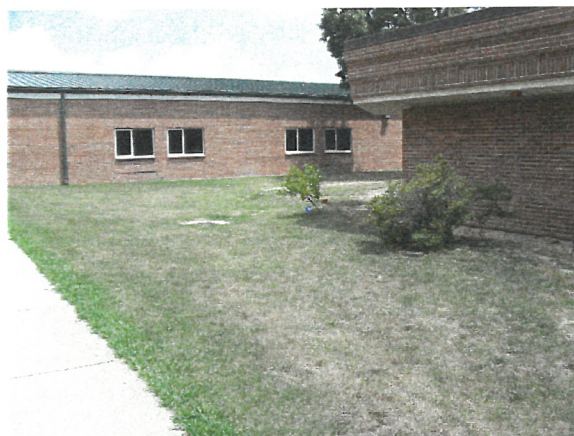
Identifier:	Kristiansand - 46
Location:	Norge Elementary School (within the school grounds)
<p><u>Existing Conditions:</u></p> <p>Multiple drop inlets (some not shown) receiving surface runoff. Building downspouts do not discharge to surface but are piped underground.</p>	
<p><u>Potential Improvements:</u></p> <p>Construct bioretention filters around existing drop inlets. Modify building downspouts in these areas to discharge above ground, across a level spreading device and grassed filter strip, and ultimately into the biofilters (similar rooftop disconnection measures may be employed elsewhere onsite). Tie underdrains of biofilters into existing inlets. Cooperation with the school as an educational tool is also recommended. Other retrofits not identified herein may also be feasible at the school pending further evaluation.</p>
