**BMP NUMBER:** PC001

Mews at Williamsburg

Designed	JHB	Drawn	BB
Scale	1"=30'	Date	JULY, 1984
Project No.	5656		
Drawing No.	4

# MEWS DETENTION BASIN

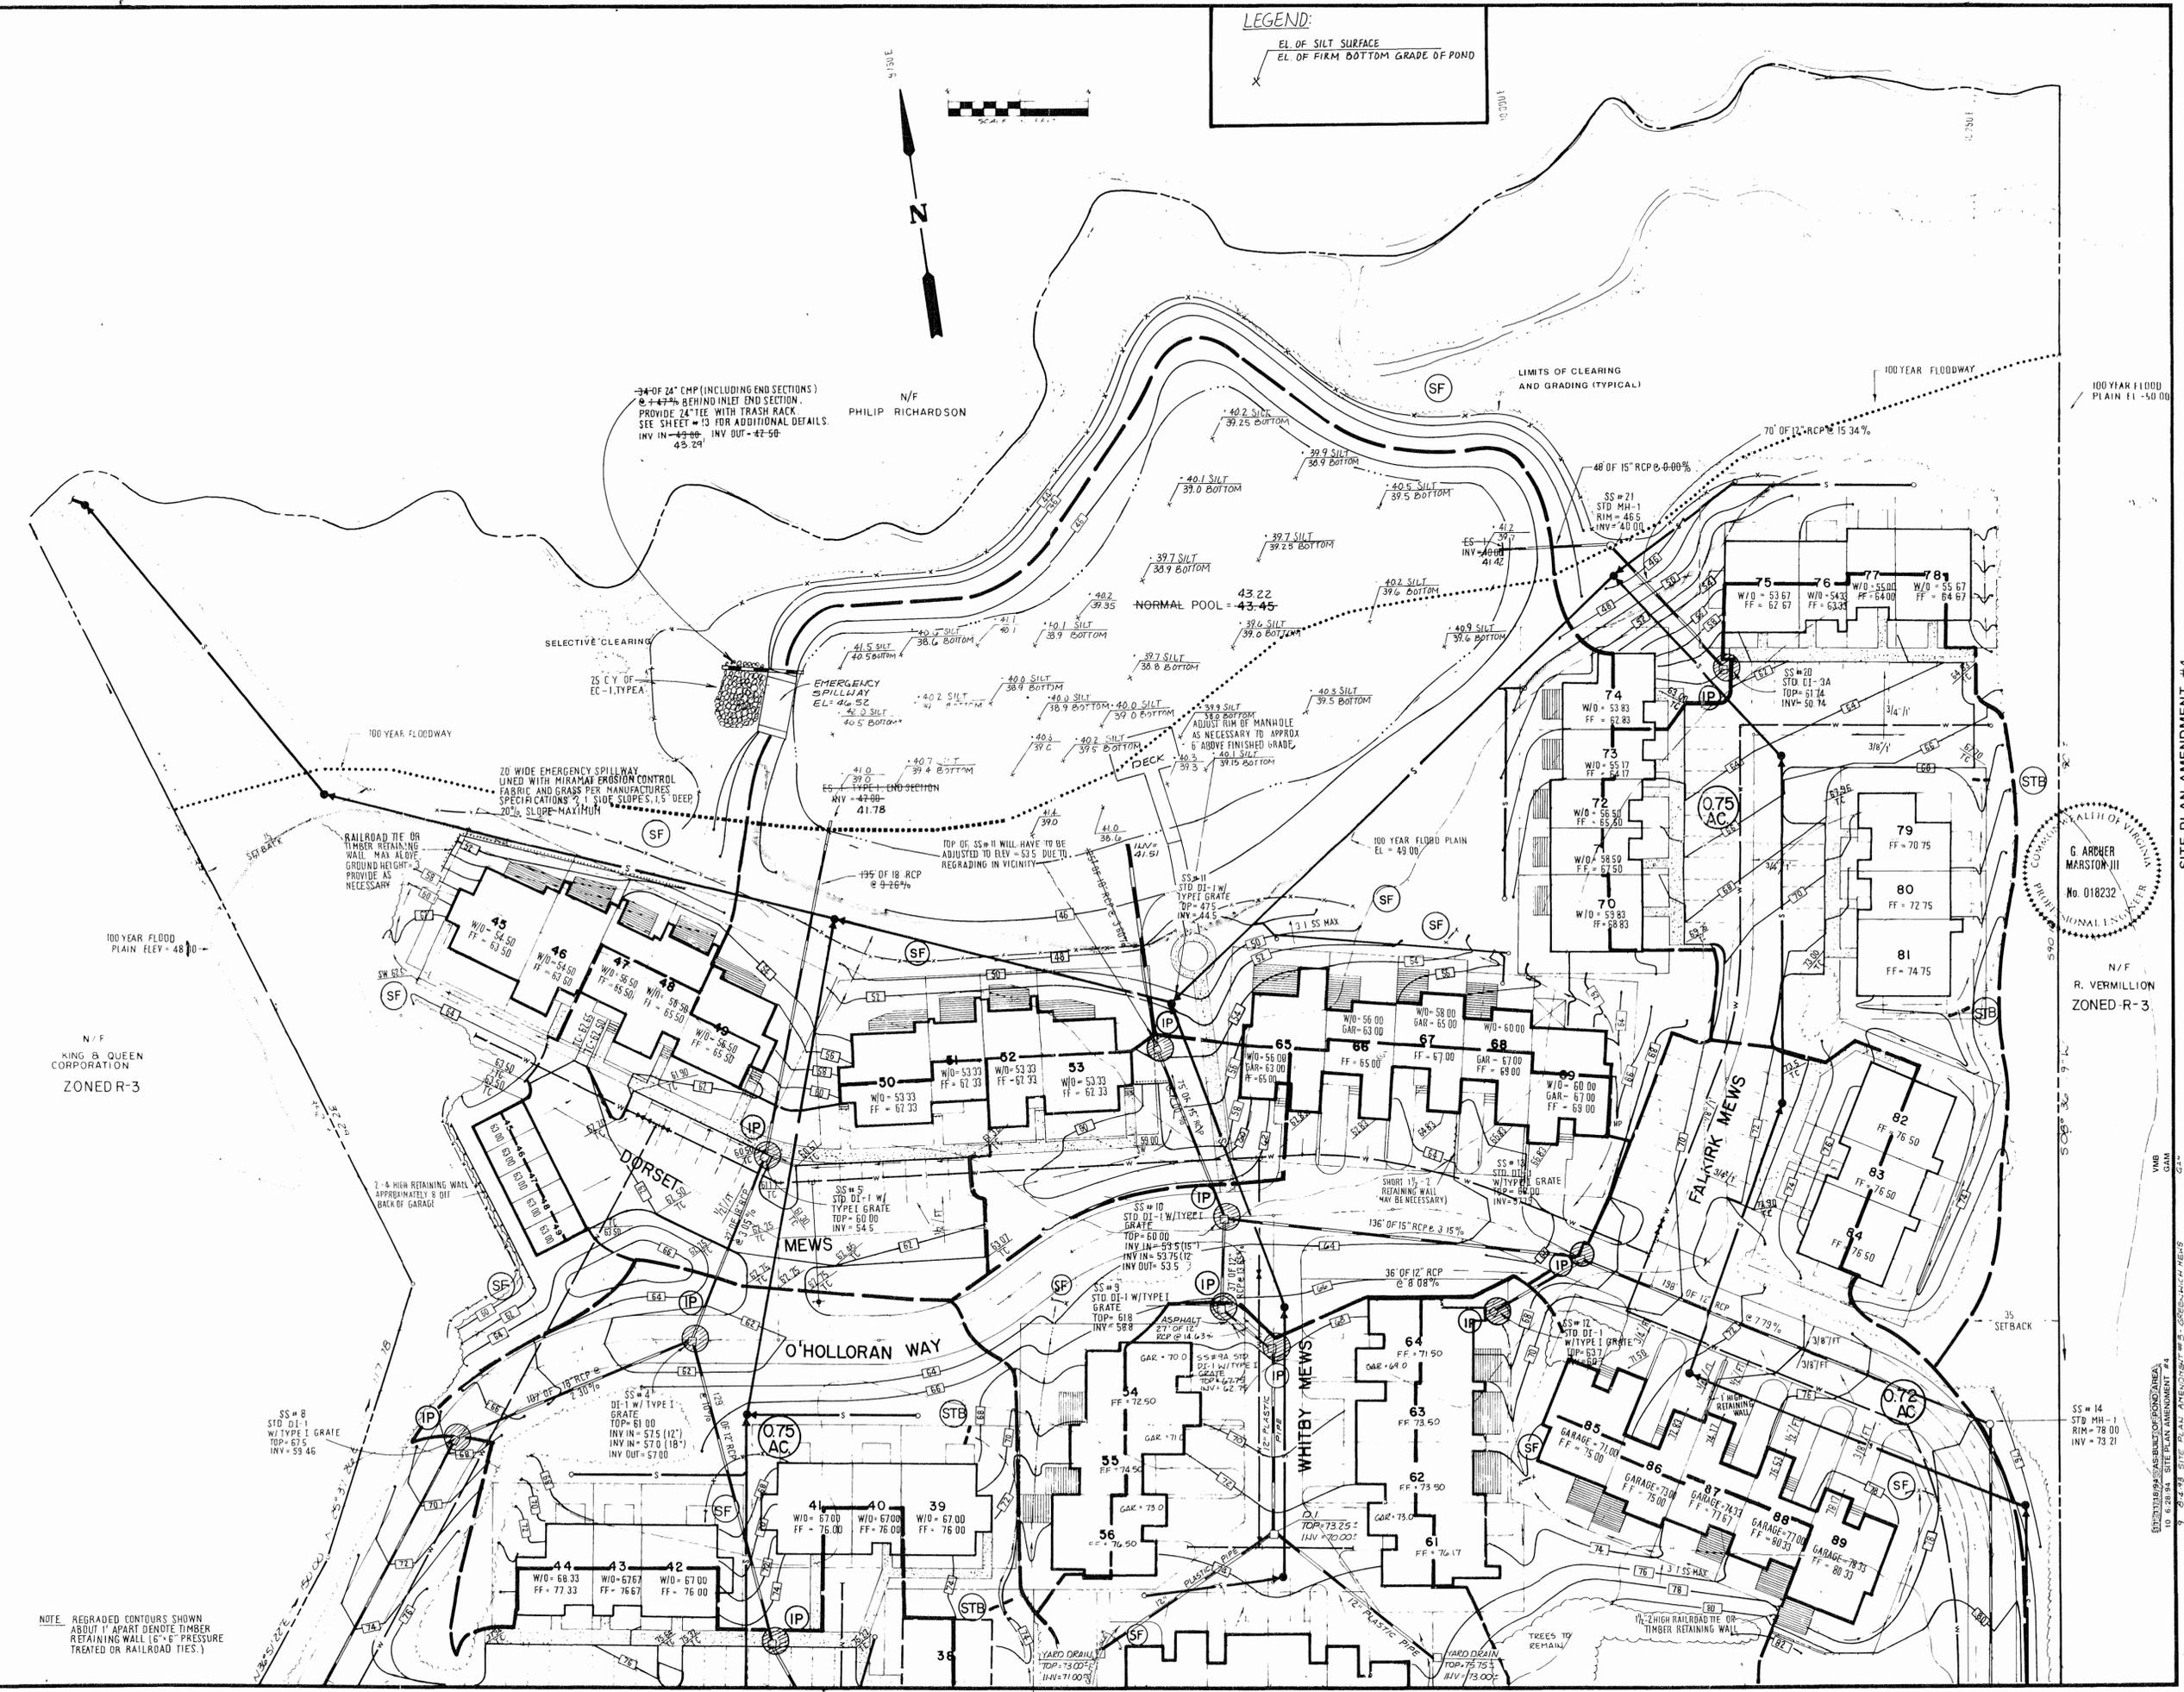
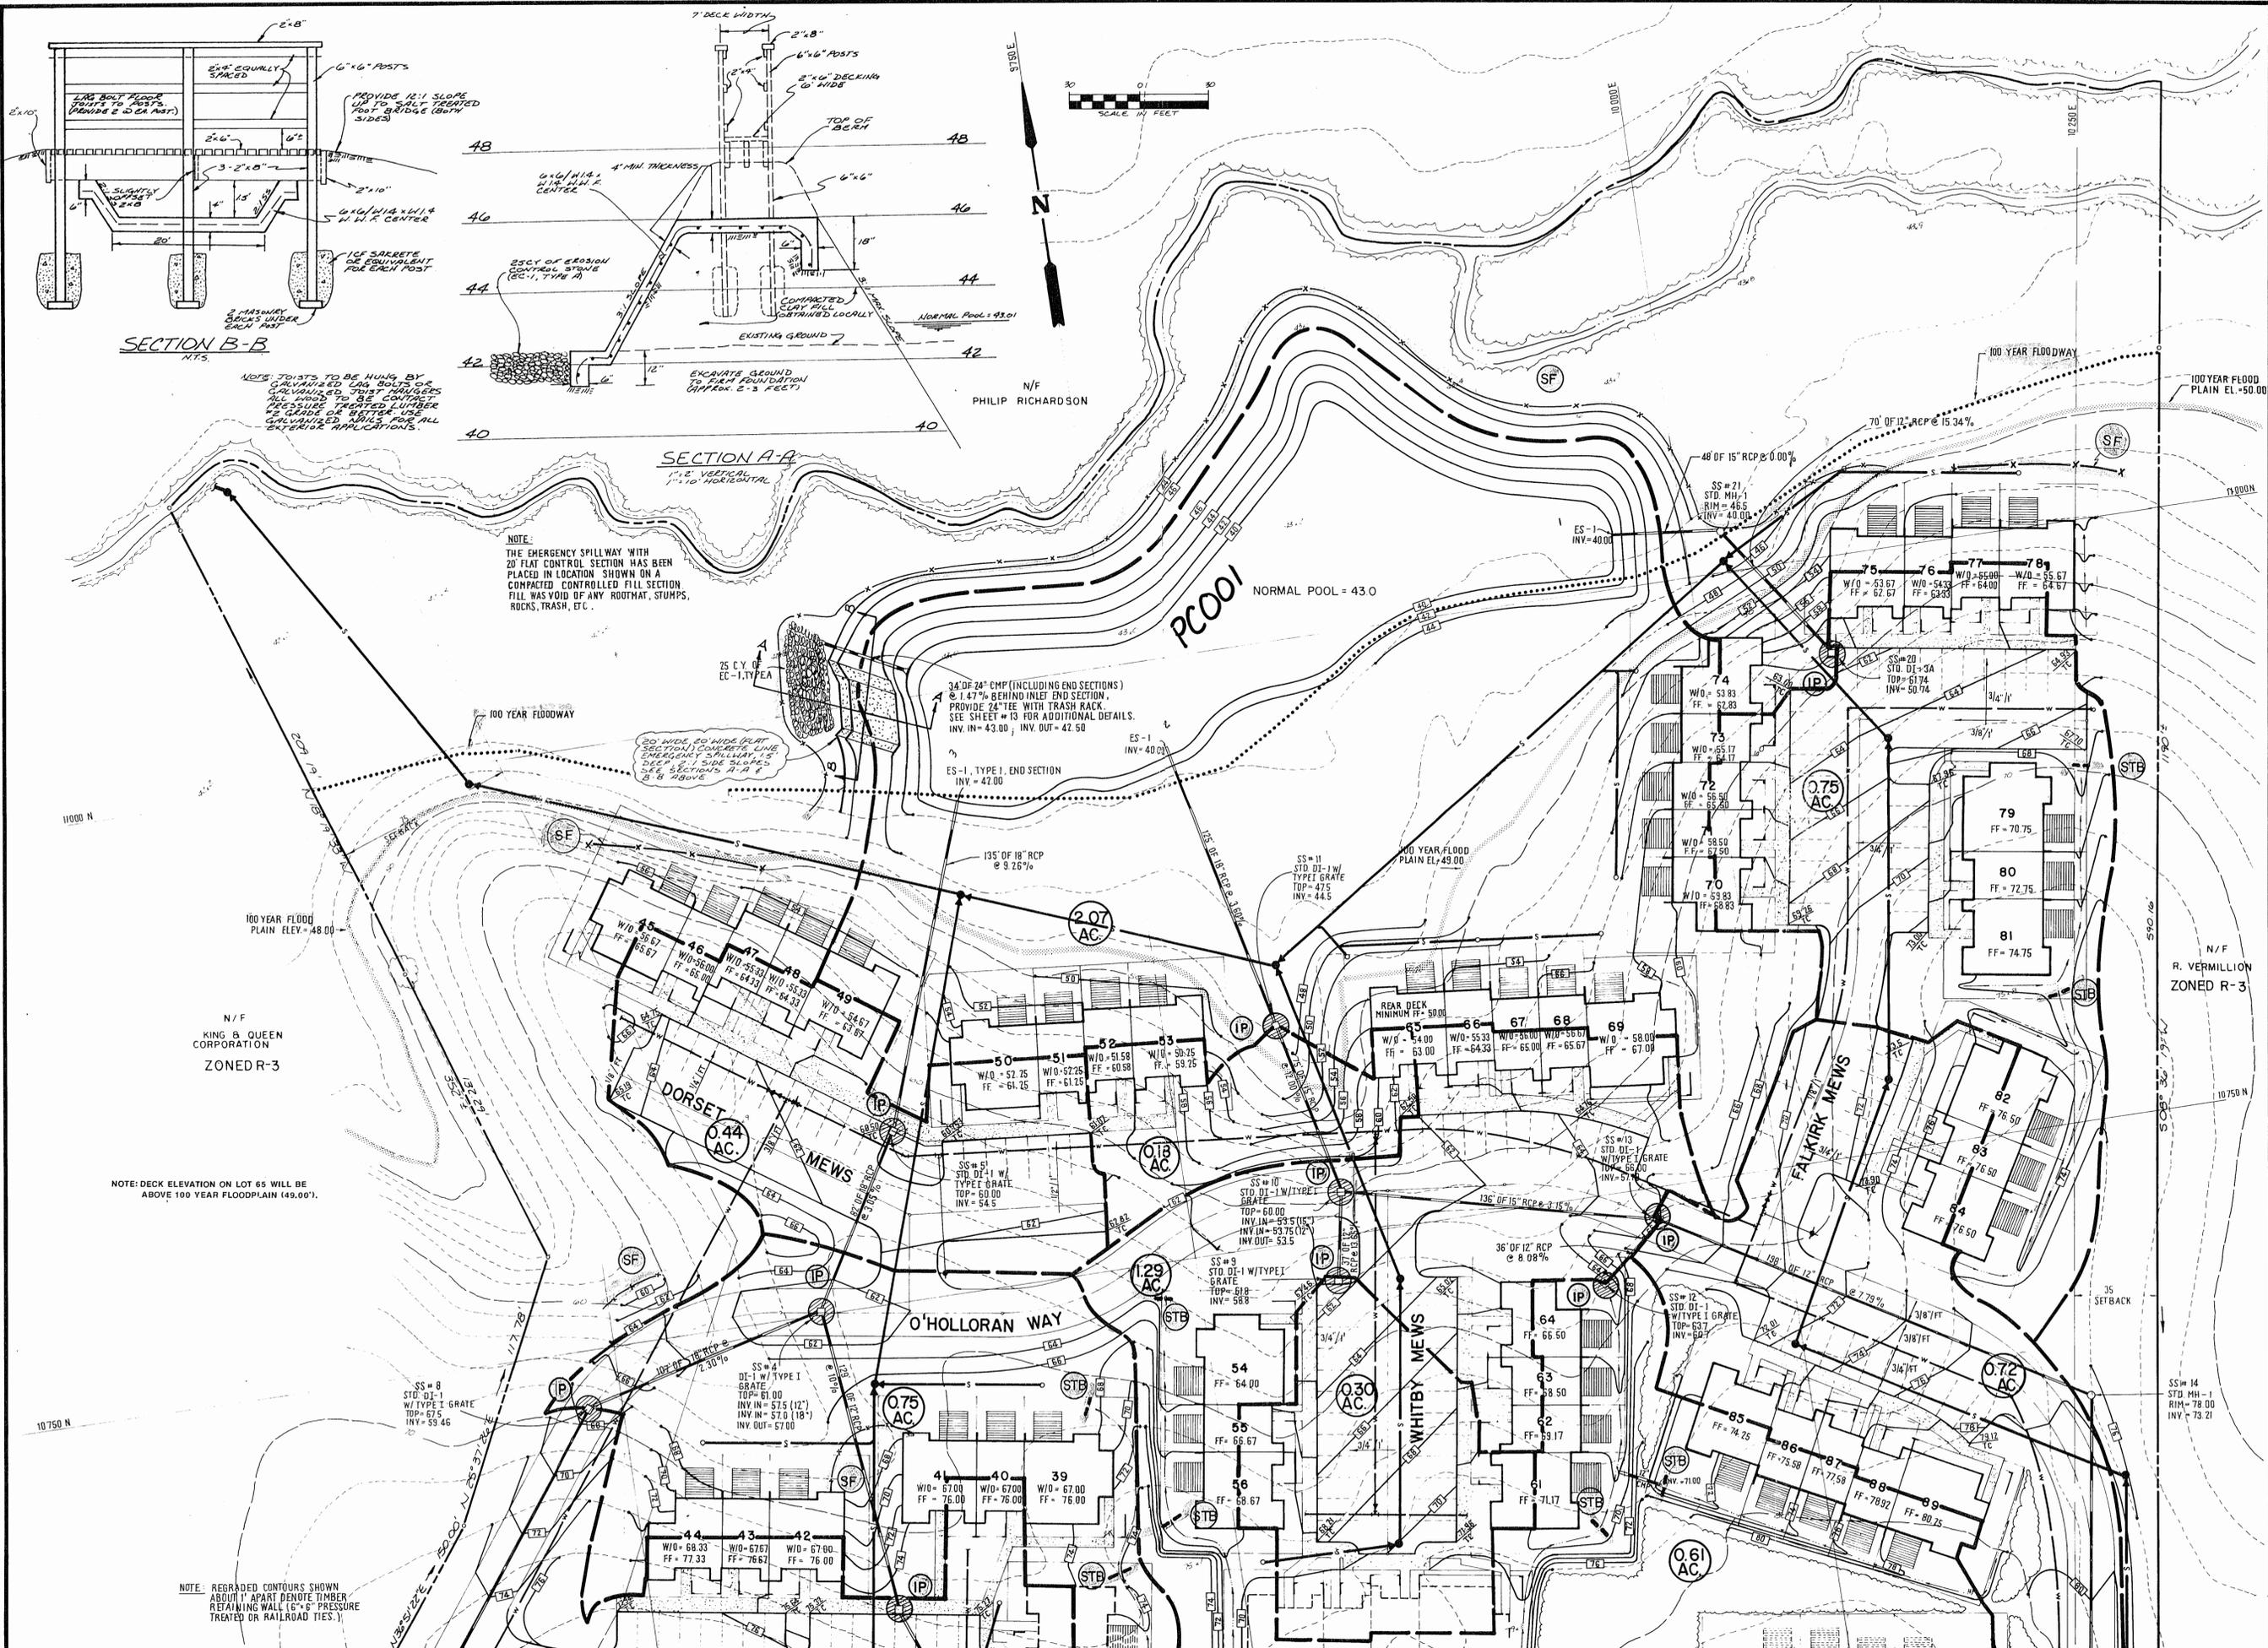
NOTE: REGRADED CONTOURS SHOWN ABOUT 1' APART DENOTE TIMBER RETAINING WALL (5'-6\"/>

NOTE: JOISTS TO BE HUNG BY GALVANIZED LAG BOLTS OR GALVANIZED JOIST BRACKETS. ALL WOOD TO BE CONTIGUOUS PRESSURE TREATED LUMBER #2 GRADE OR BETTER. USE GALVANIZED BRACES FOR ALL EXTERIOR APPLICATIONS.

NOTE: THE EMERGENCY SPILLWAY WITH 20' FLAT CONTROL SECTION HAS BEEN PLACED IN LOCATION SHOWN ON A COMPACTED CONTROLLED FILL SECTION. FILL WAS VOID OF ANY ROOTS, STUMPS, ROCKS, TRASH, ETC.
