BMP NUMBER: PC081

Marsh Hawk Course Holes 1-18

DRAINAGE, EROSION AND SEDIMENT CONTROL PLAN
 SECTION X
FORD'S COLONY
 @ **WILLIAMSBURG**
 OWNER/DEVELOPER: FORD'S COLONY @ WILLIAMSBURG VIRGINIA
 JAMES CITY COUNTY

STORM SEWER PLAN
 SECTION X
**FORDS COLONY
 @ WILLIAMSBURG**
 OWNER/DEVELOPER: FORDS COLONY @ WILLIAMSBURG
 WAREHIRE COUNTY, VIRGINIA

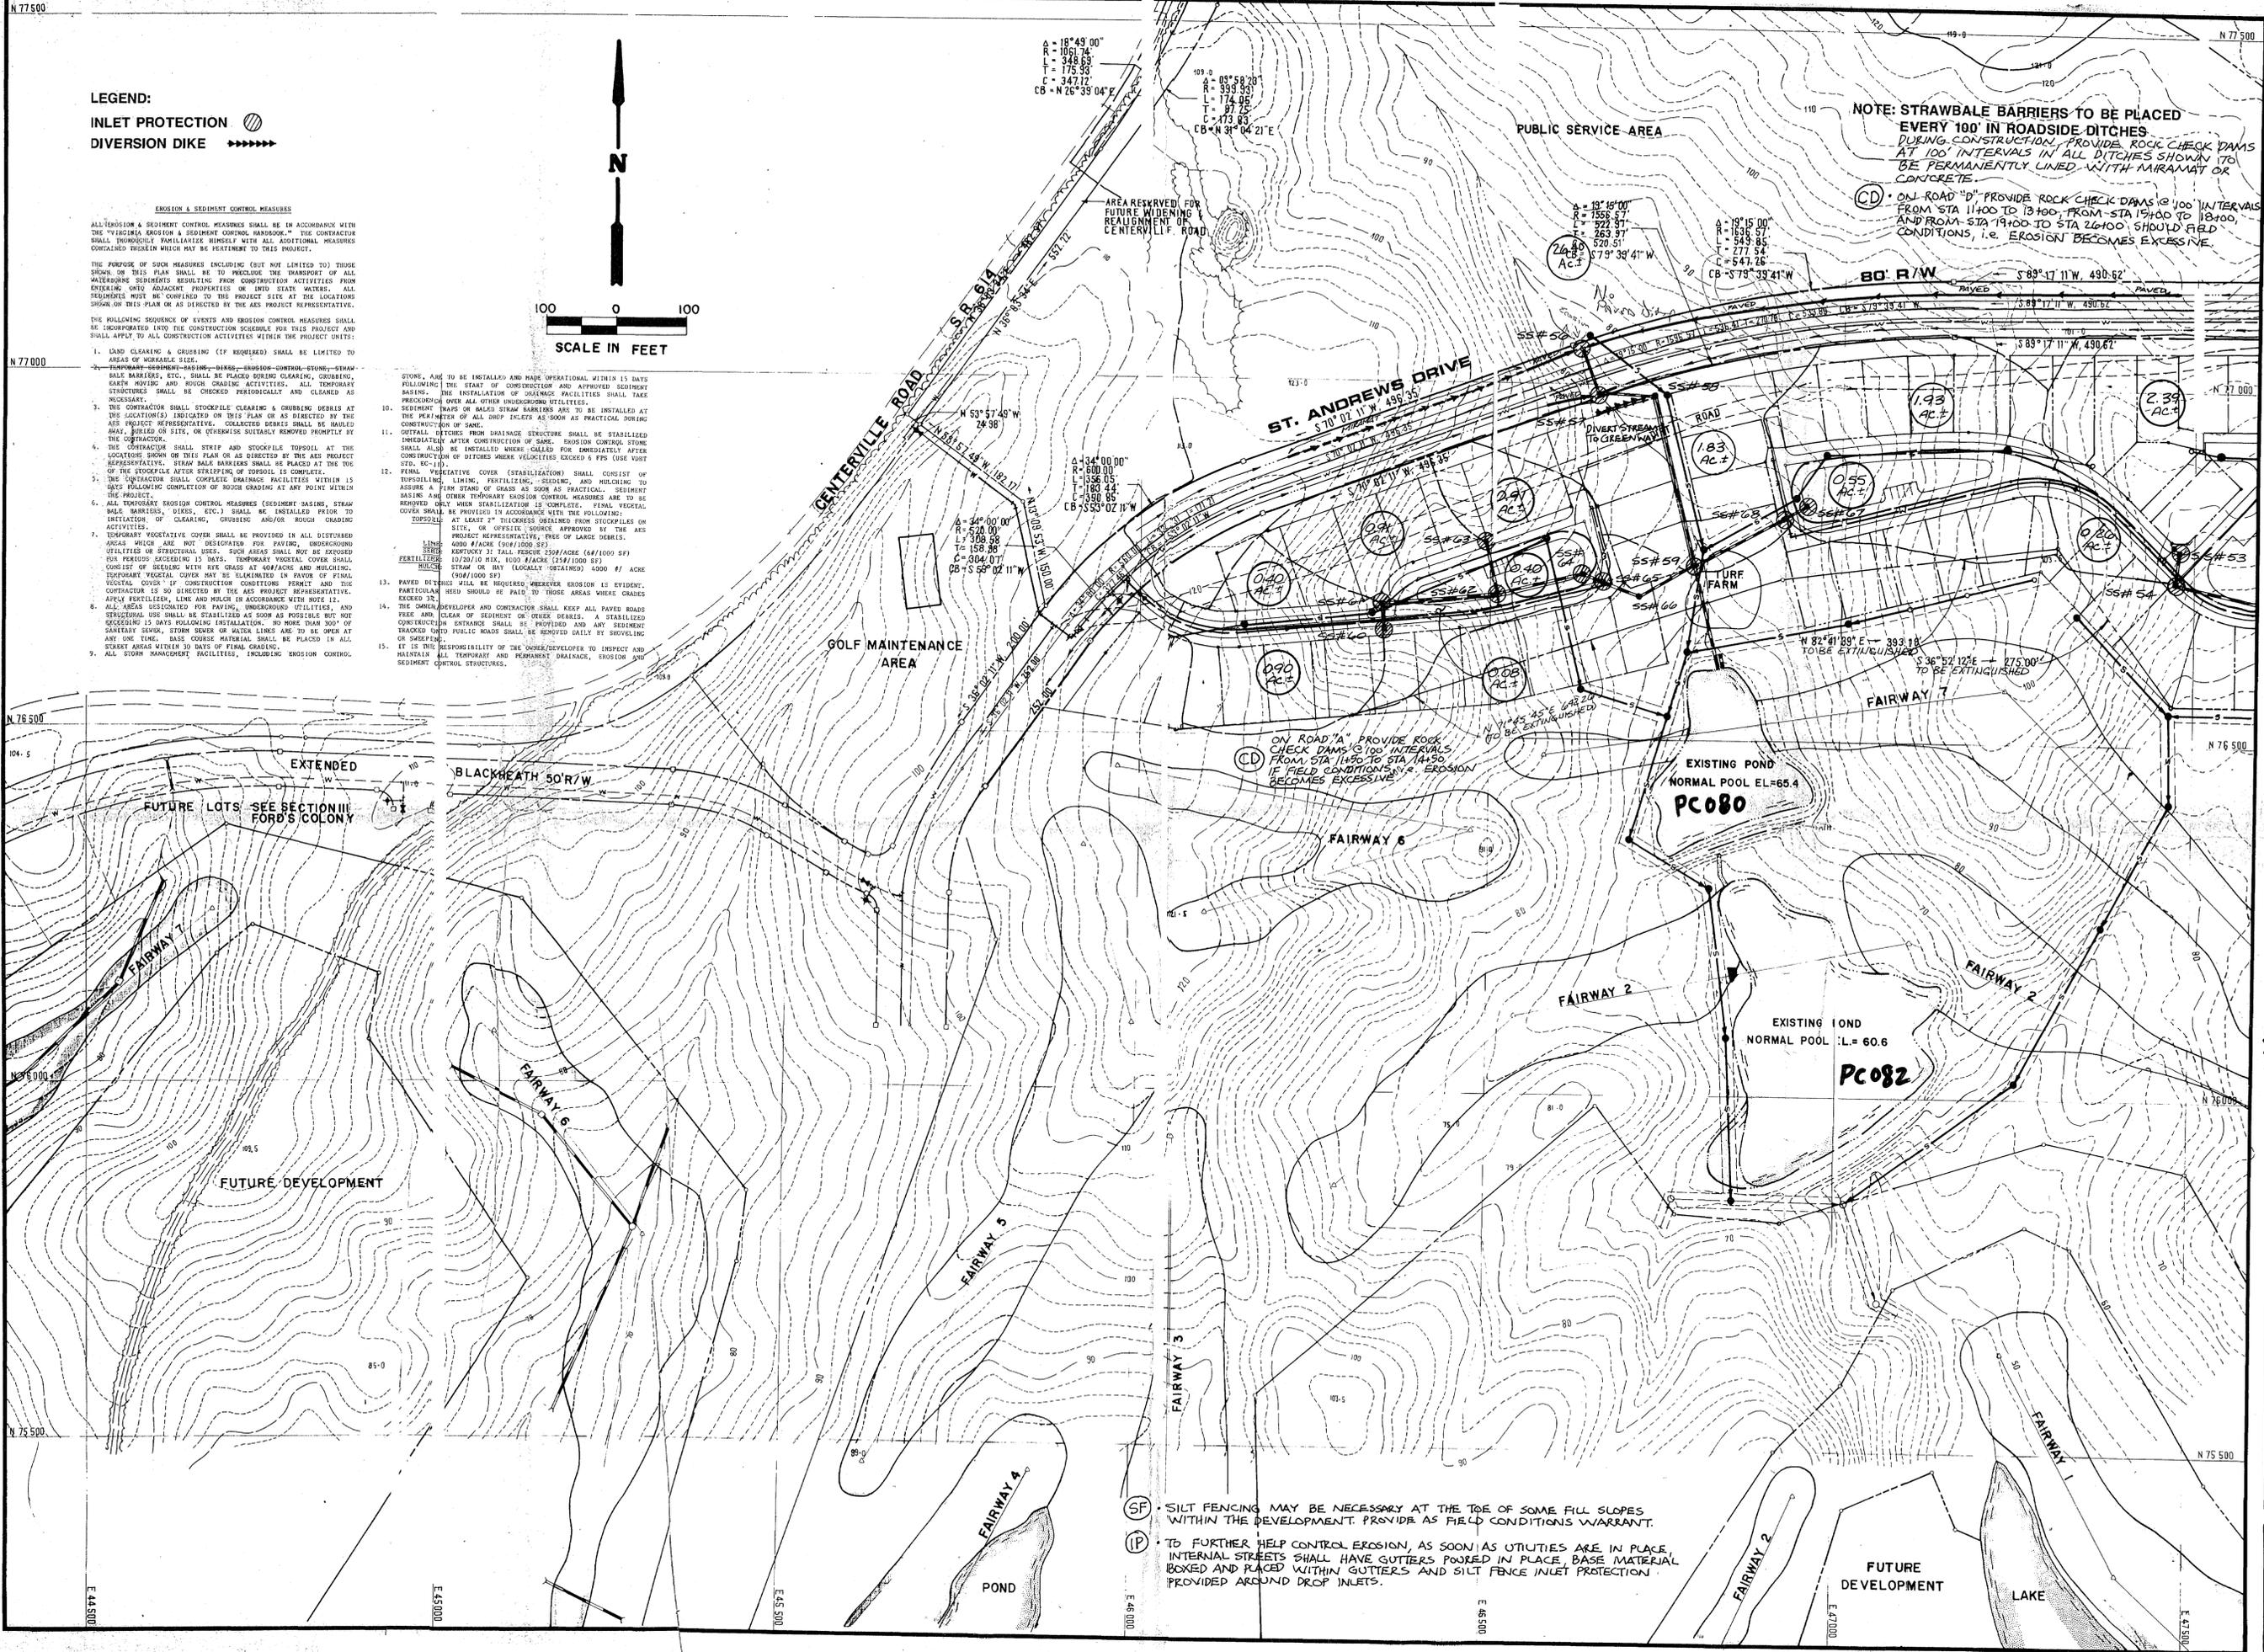
Designed by AES
 Drawn by AES
 Scale 1"=100'
 Date NOV. 1986
 Project No. 5652
 Drawing No. 13

NOTE: STRAWBALE BARRIERS TO BE PLACED EVERY 100' IN ROADSIDE DITCHES DURING CONSTRUCTION. PROVIDE ROCK CHECK DAMS AT 100' INTERVALS IN ALL DITCHES SHOWN TO BE PERMANENTLY LINED WITH MARRAMAT OR CONCRETE.
 (CD) ON ROAD "B" PROVIDE ROCK CHECK DAMS @ 100' INTERVALS FROM STA 11400 TO 13400, FROM STA 15400 TO 18400, AND FROM STA 19400 TO STA 20400. SHOULD FIELD CONDITIONS, I.E. EROSION BECOMES EXCESSIVE.

(CD) ON ROAD "A" PROVIDE ROCK CHECK DAMS @ 100' INTERVALS FROM STA 11490 TO STA 14490 IF FIELD CONDITIONS I.E. EROSION BECOMES EXCESSIVE.

(SF) SILT FENCING MAY BE NECESSARY AT THE TOE OF SOME FILL SLOPES WITHIN THE DEVELOPMENT. PROVIDE AS FIELD CONDITIONS WARRANT.
 (P) TO FURTHER HELP CONTROL EROSION, AS SOON AS UTILITIES ARE IN PLACE, INTERNAL STREETS SHALL HAVE GUTTERS POURED IN PLACE. BASE MATERIAL BOXED AND PLACED WITHIN GUTTERS AND SILT FENCE INLET PROTECTION PROVIDED AROUND DROP INLETS.

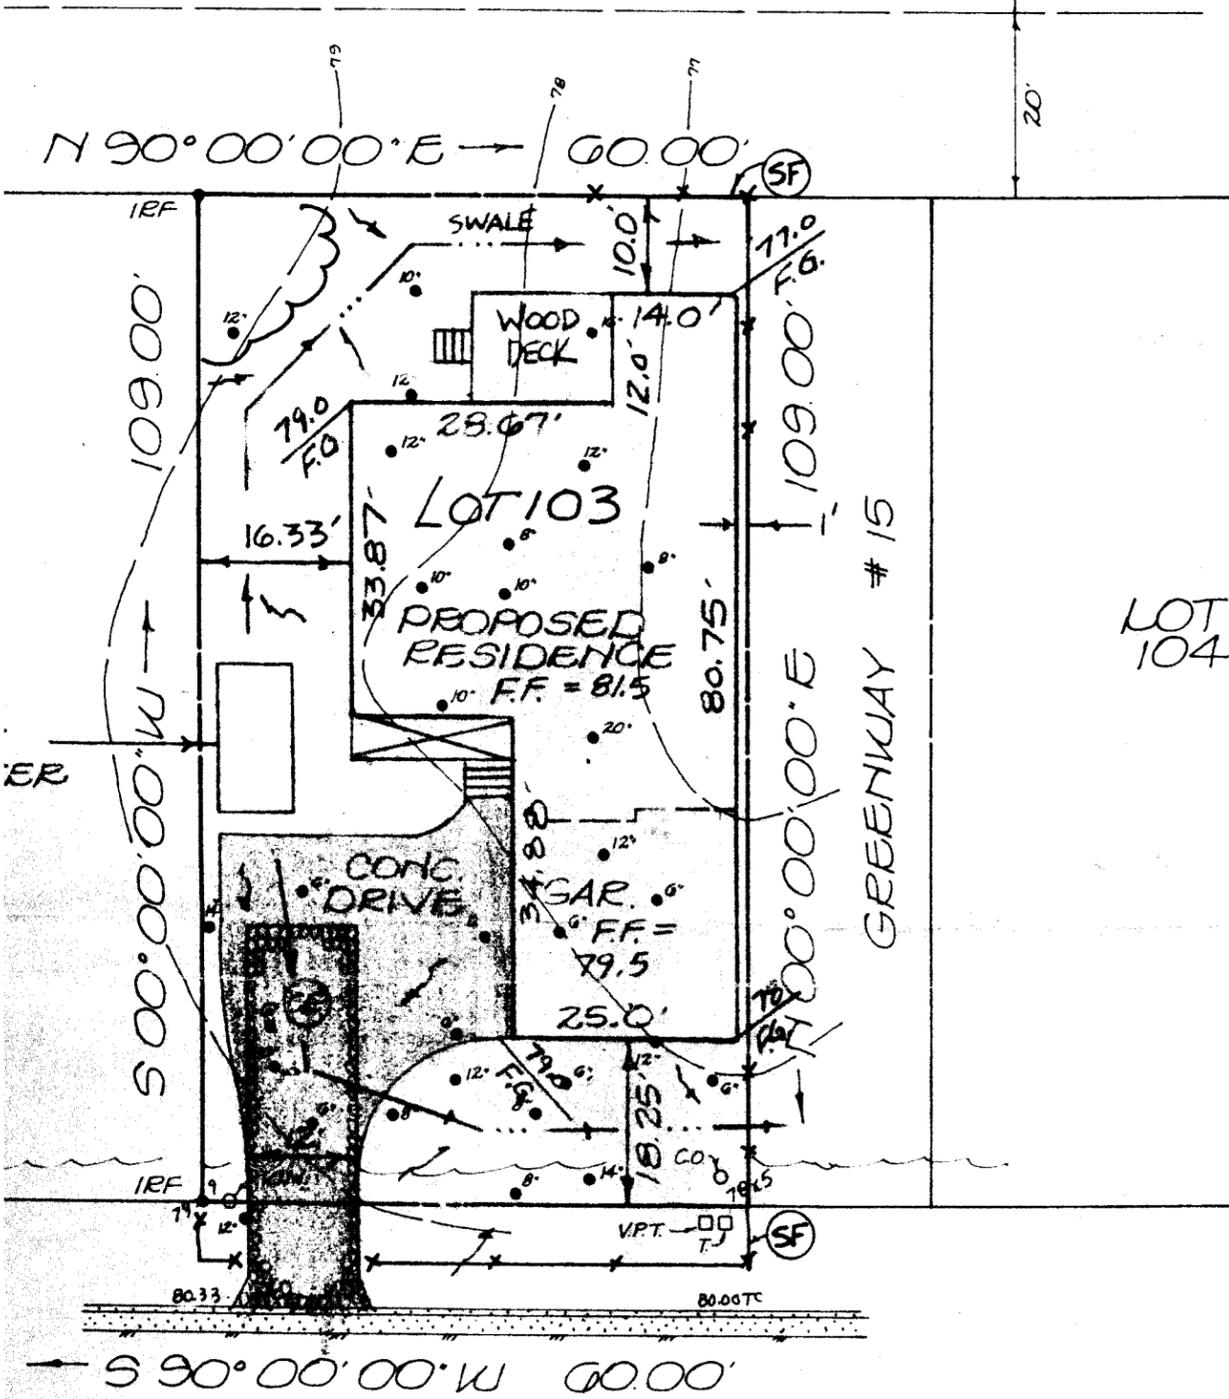
EXIST. D.I.
TOP=79.06
INV.=76.29(E)
INV.=76.24(S)

EXIST. D.I.
TOP=79.29
INV.=76.97(W)

DRAINAGE
UTILITY
EASEMENT

CE-CONSTRUCTION
10ft x 70ft x 6in of #1
FILTER FABRIC

SF-SILT FENCE
4in, STAKED EV

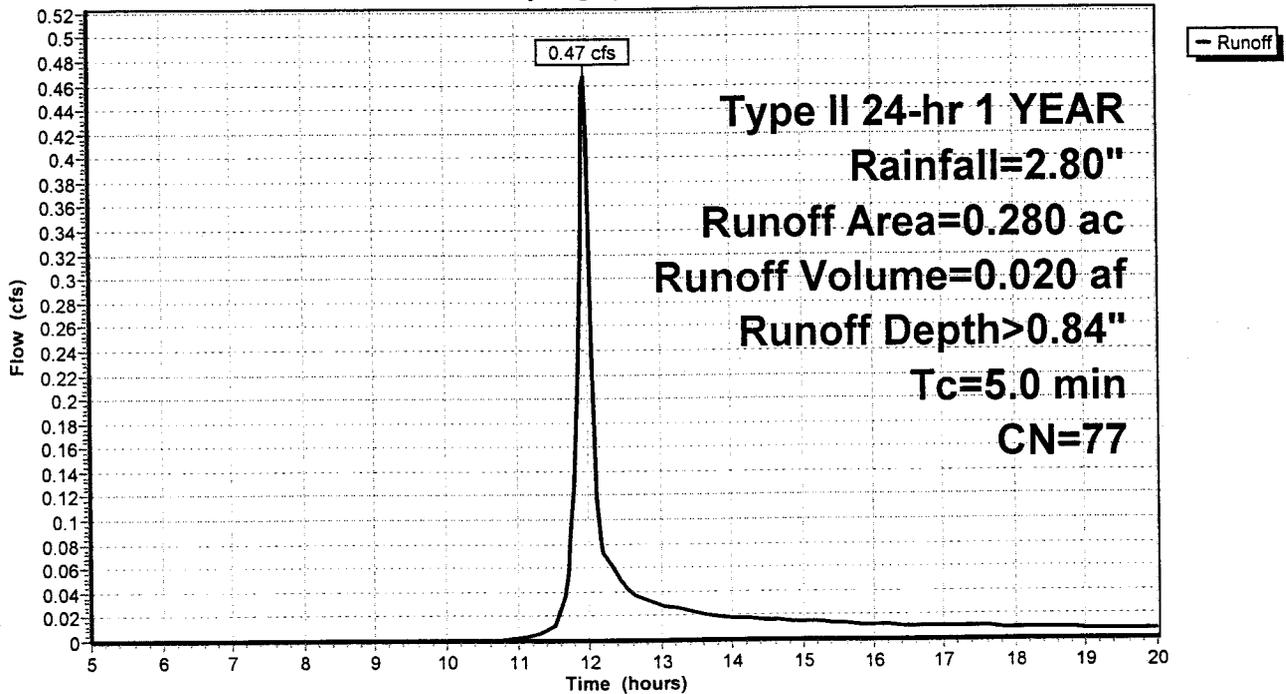
Subcatchment 1S: da-1

Hydrograph

Summary for Subcatchment 1S: da-1

Runoff = 0.72 cfs @ 11.96 hrs, Volume= 0.030 af, Depth> 1.31"

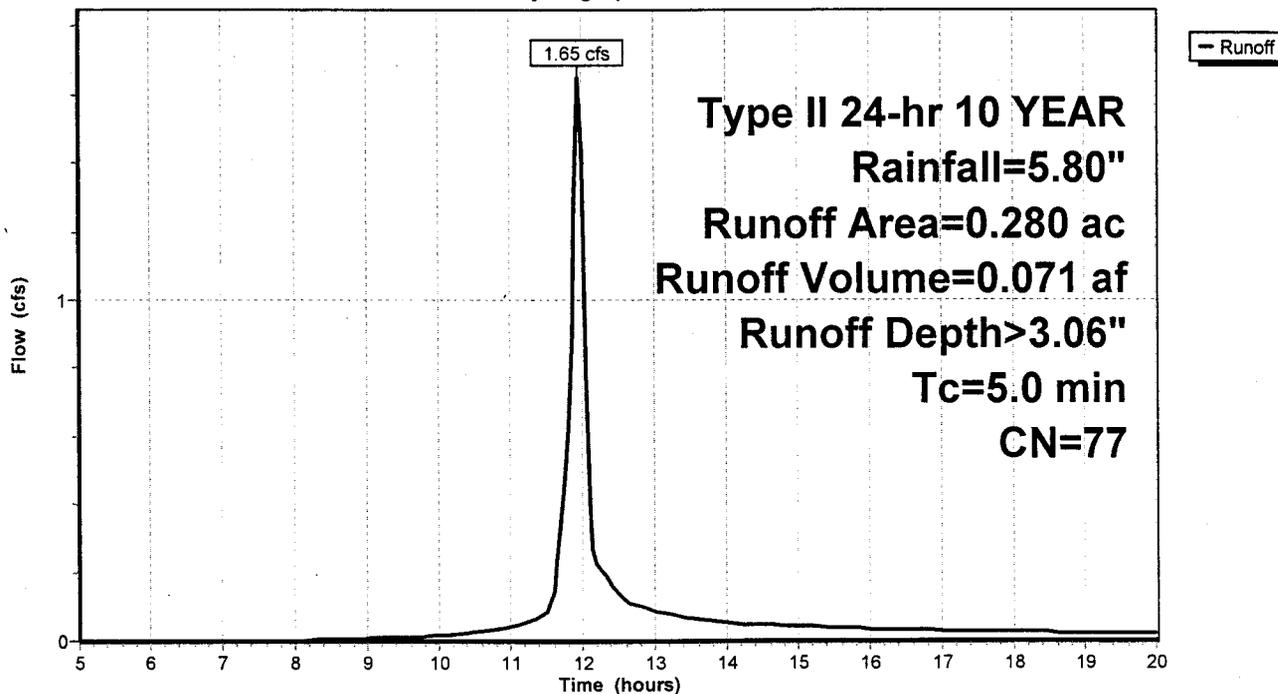
Subcatchment 1S: da-1

Hydrograph

Summary for Subcatchment 1S: da-1

Runoff = 1.90 cfs @ 11.96 hrs, Volume= 0.083 af, Depth> 3.56"

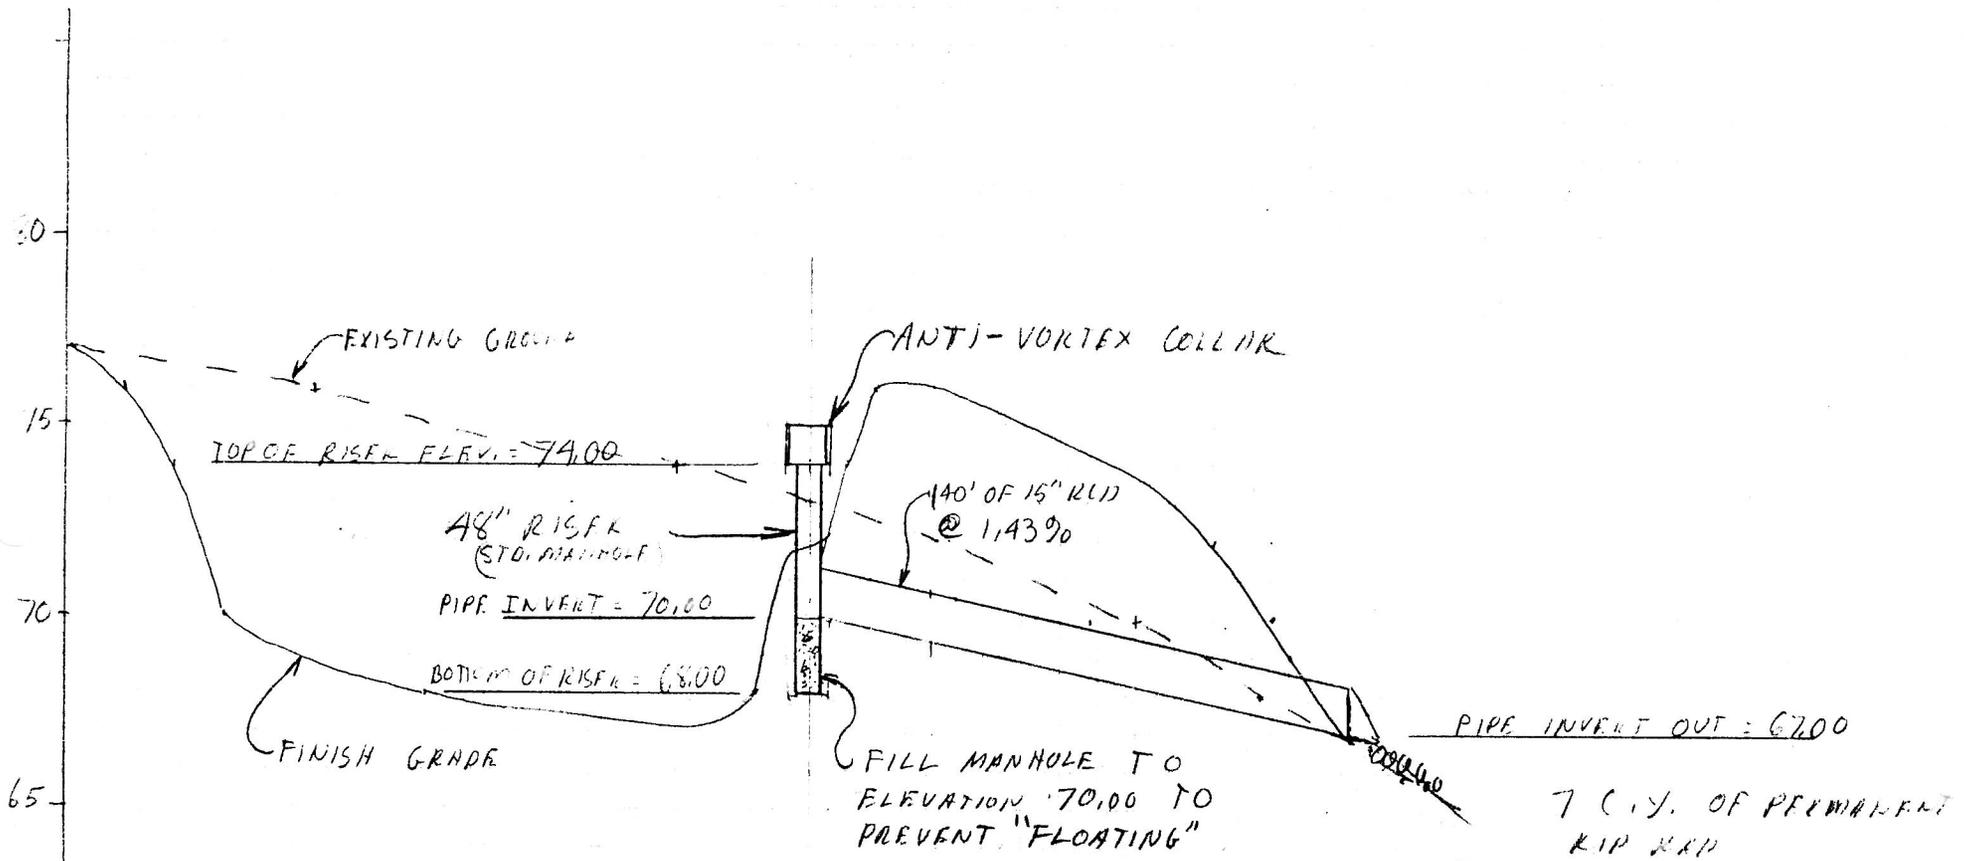
SECTION A-A
POND CROSS SECTION

POND BETWEEN 7TH AND 8TH HOLE

DRAINAGE AREA = 26.60 Ac $T_c = 25.0$ min $I_{10} = 4.0$ in/hr.
 $C = 0.40$ FULLY DEVELOPED
 $Q_{10} = 0.40 (4.0) 26.60 = 42.56$ cfs

SCALE: 1" = 5' VERT.
1" = 50' HORIZ.

RUNOFF VOLUME - STORAGE VOLUME = VOLUME TO PASS THROUGH SPILLWAY STRUCTURE DURING DESIGN STORM ($3T_c$)
 $95,760 \text{ ft}^3 - 73,000 \text{ ft}^3 = 22,760 \text{ ft}^3$

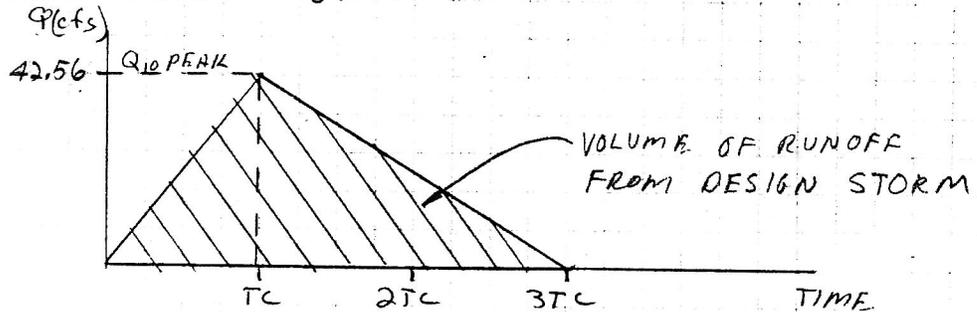
RUNOFF VOLUME

LENGTH OF DESIGN STORM = $3T_c$

$$\begin{aligned} \text{Volume}_{10} &= \frac{1}{2} (Q_{10})(T_c) + \frac{1}{2} (Q_{10})(2T_c) \\ &= \frac{1}{2} (42.56)(25)(60) + \frac{1}{2} (42.56)(25)(60) 2 \\ &= 95,760 \text{ ft}^3 \end{aligned}$$

RUNOFF VOLUME - STORAGE VOLUME = VOLUME TO PASS THROUGH SPILLWAY STRUCTURE DURING DESIGN STORM ($3T_c$)
 $95,760 \text{ ft}^3 - 73,000 \text{ ft}^3 = 22,760 \text{ ft}^3$
