CERTIFICATE OF AUTHENTICITY

BMP NUMBER: PC117

Seasons Trace

Wet pond

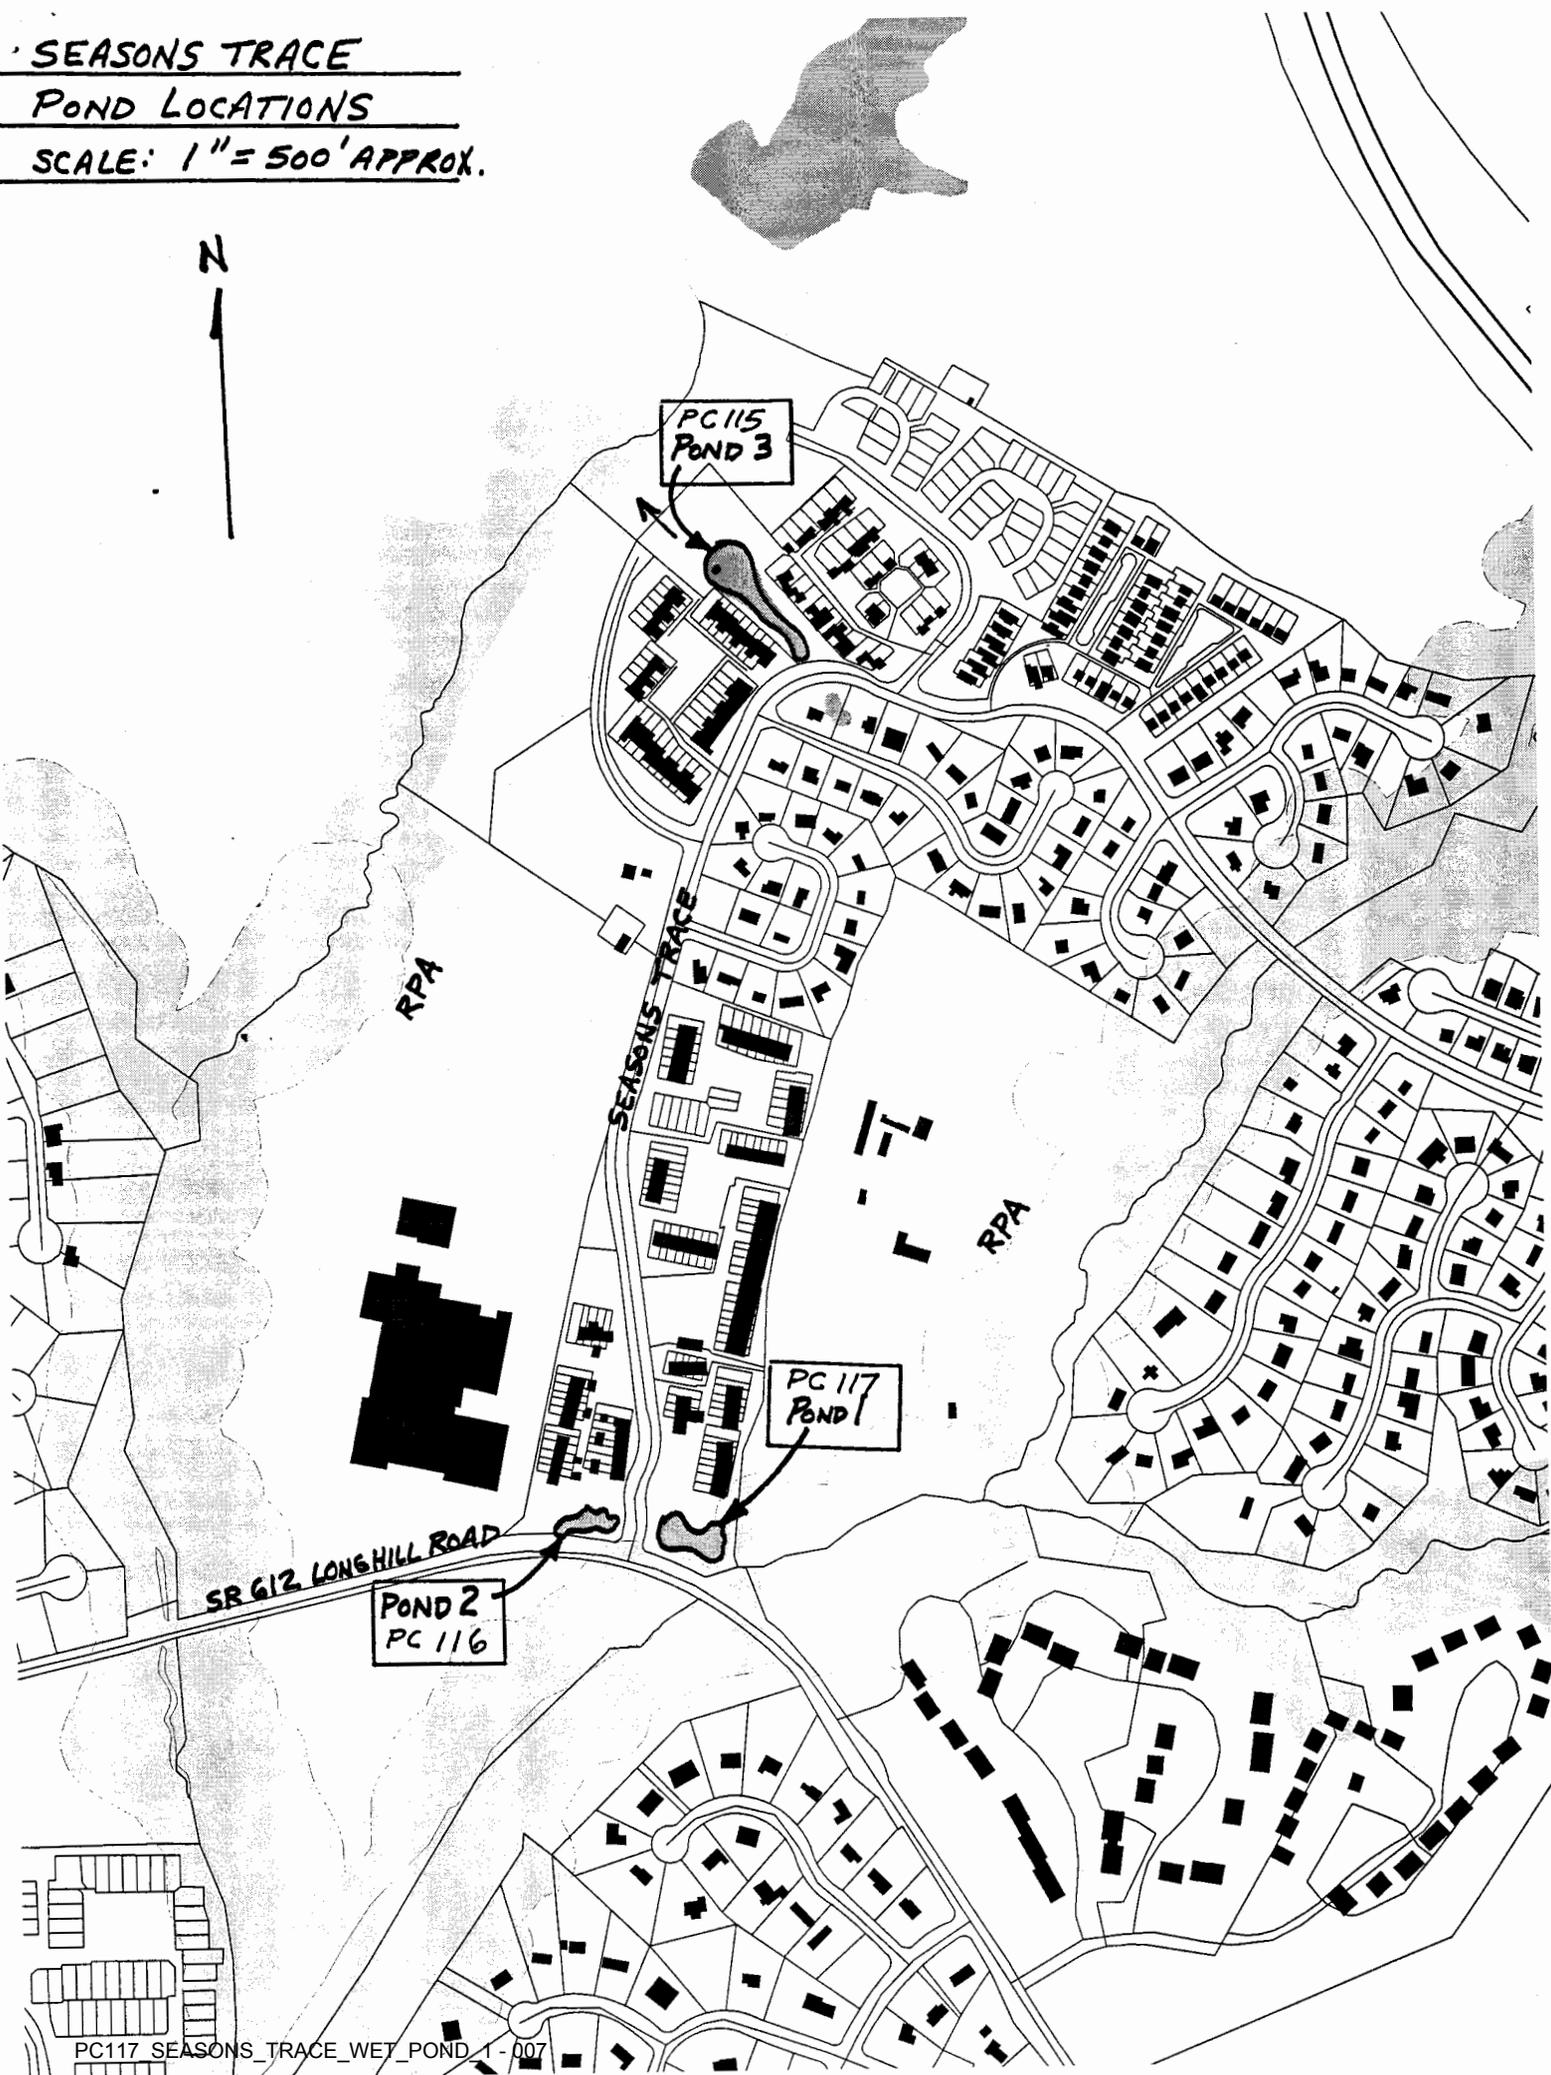
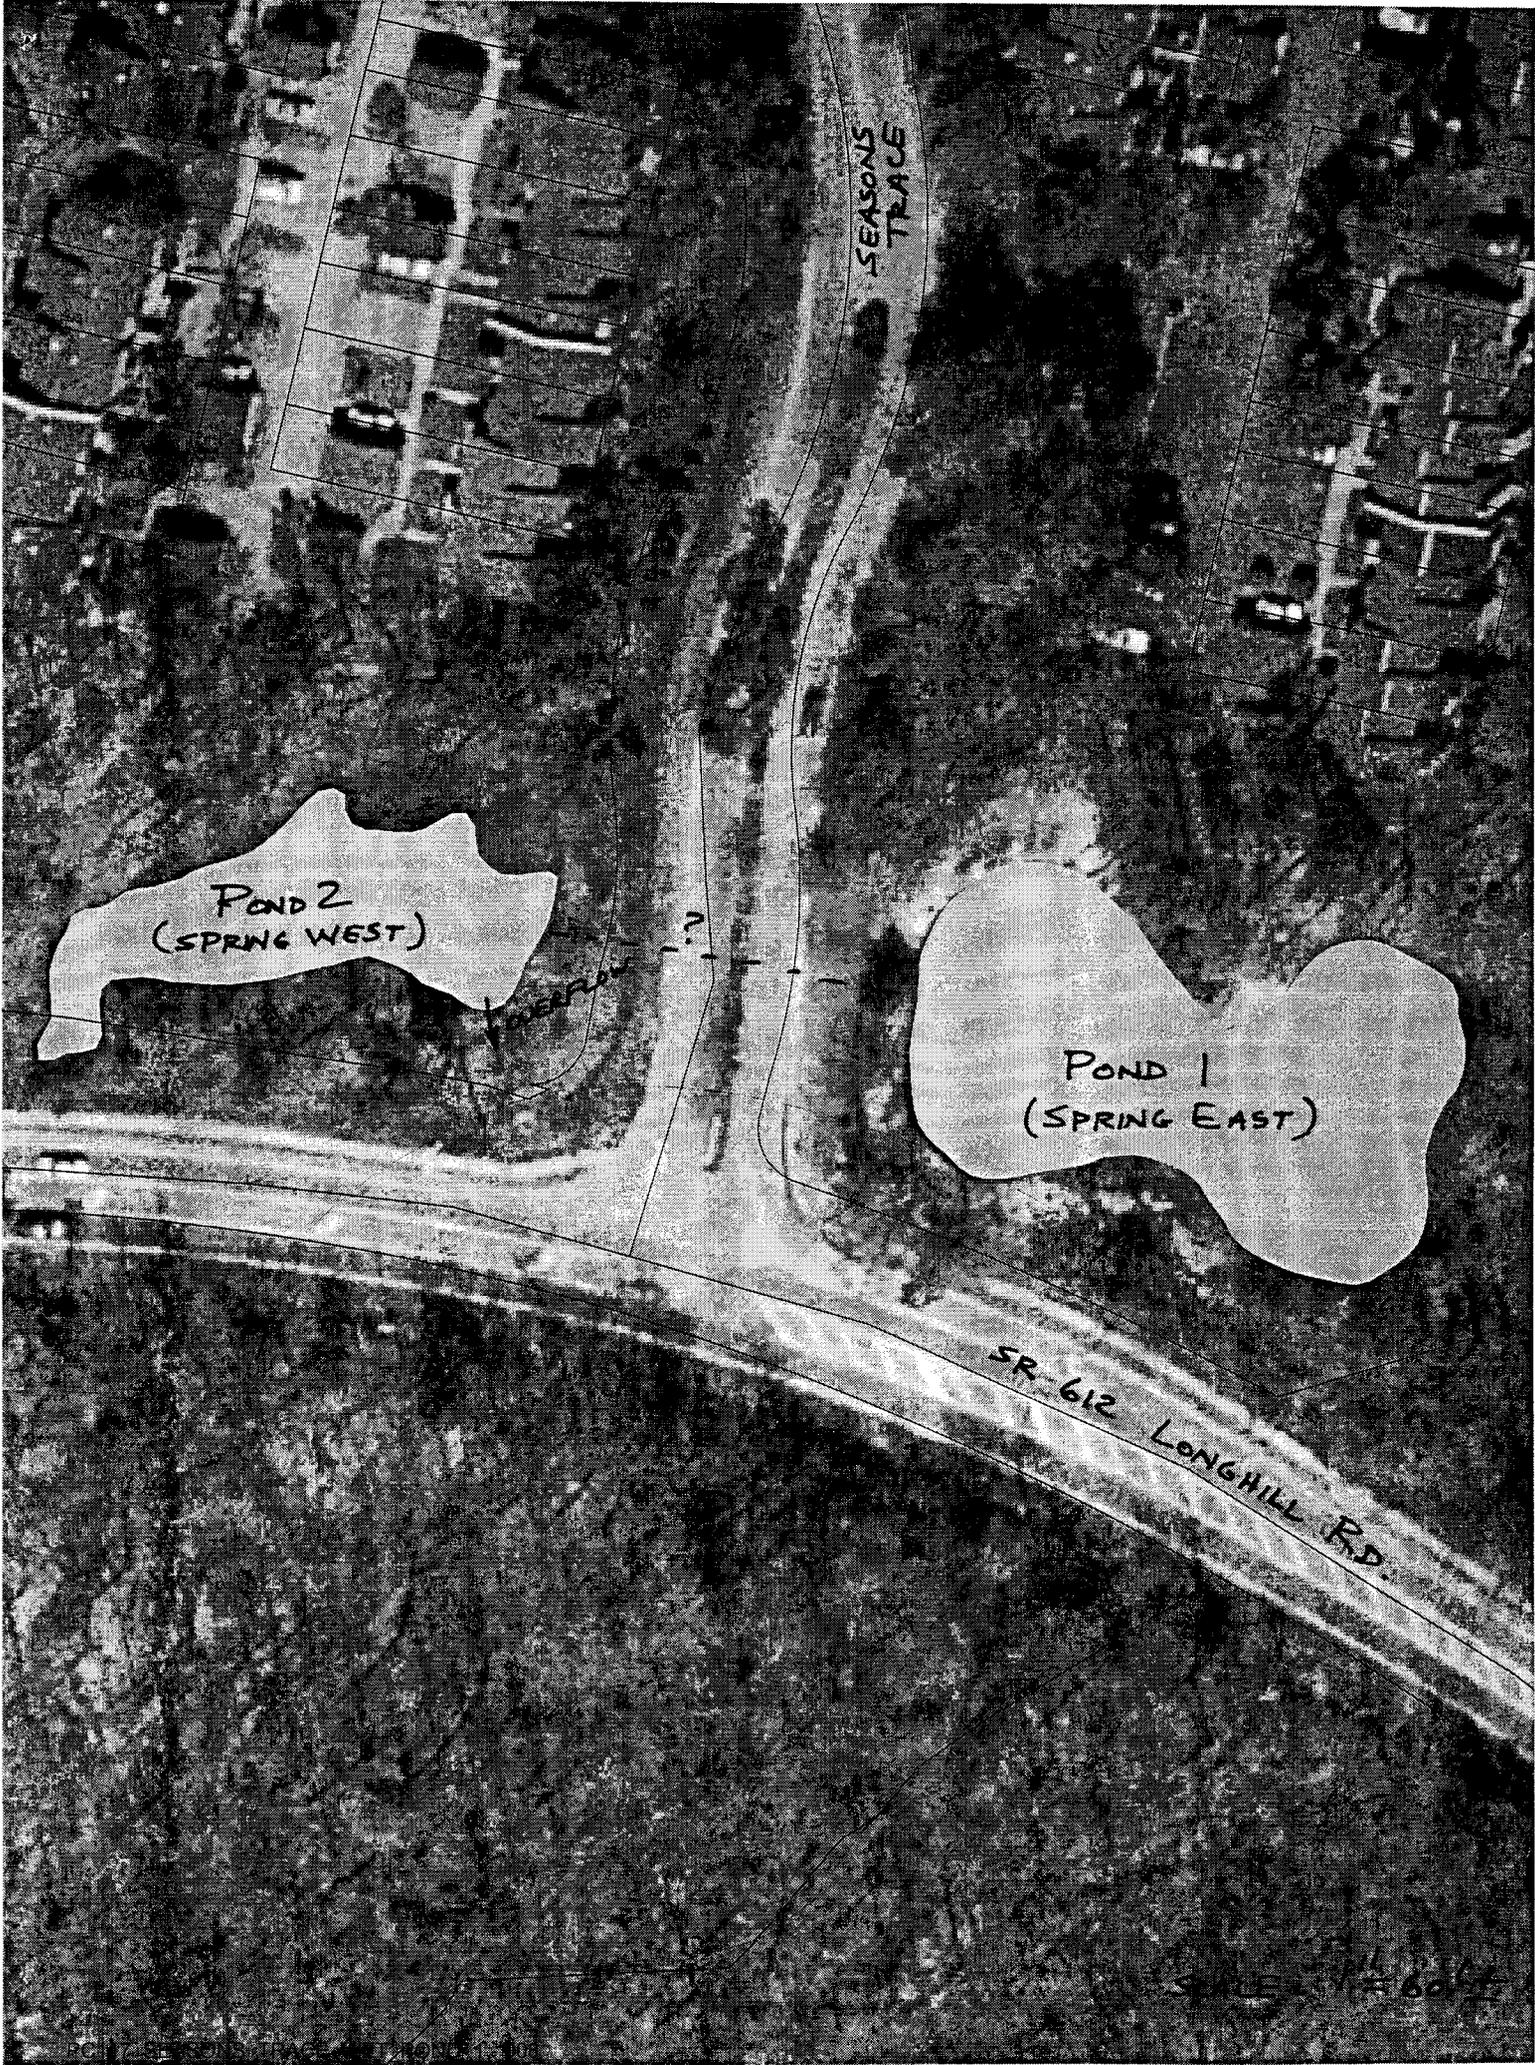
SEASONS TRACE
POND LOCATIONS
SCALE: 1" = 500' APPROX.

POND 2
(SPRING WEST)

POND 1
(SPRING EAST)
