**BMP NUMBER:** SC002

**Name (if known):** Brookside Haven

**DRAINAGE, GRADING, EROSION CONTROL**  
**BROOKSIDE**  
 OWNER/DEVELOPER:  
 FERRELL GENERAL CONSTRUCTION CORPORATION  
 JESSE FERRELL, PRESIDENT  
 ROBERTS DISTRICT JAMES CITY COUNTY VIRGINIA

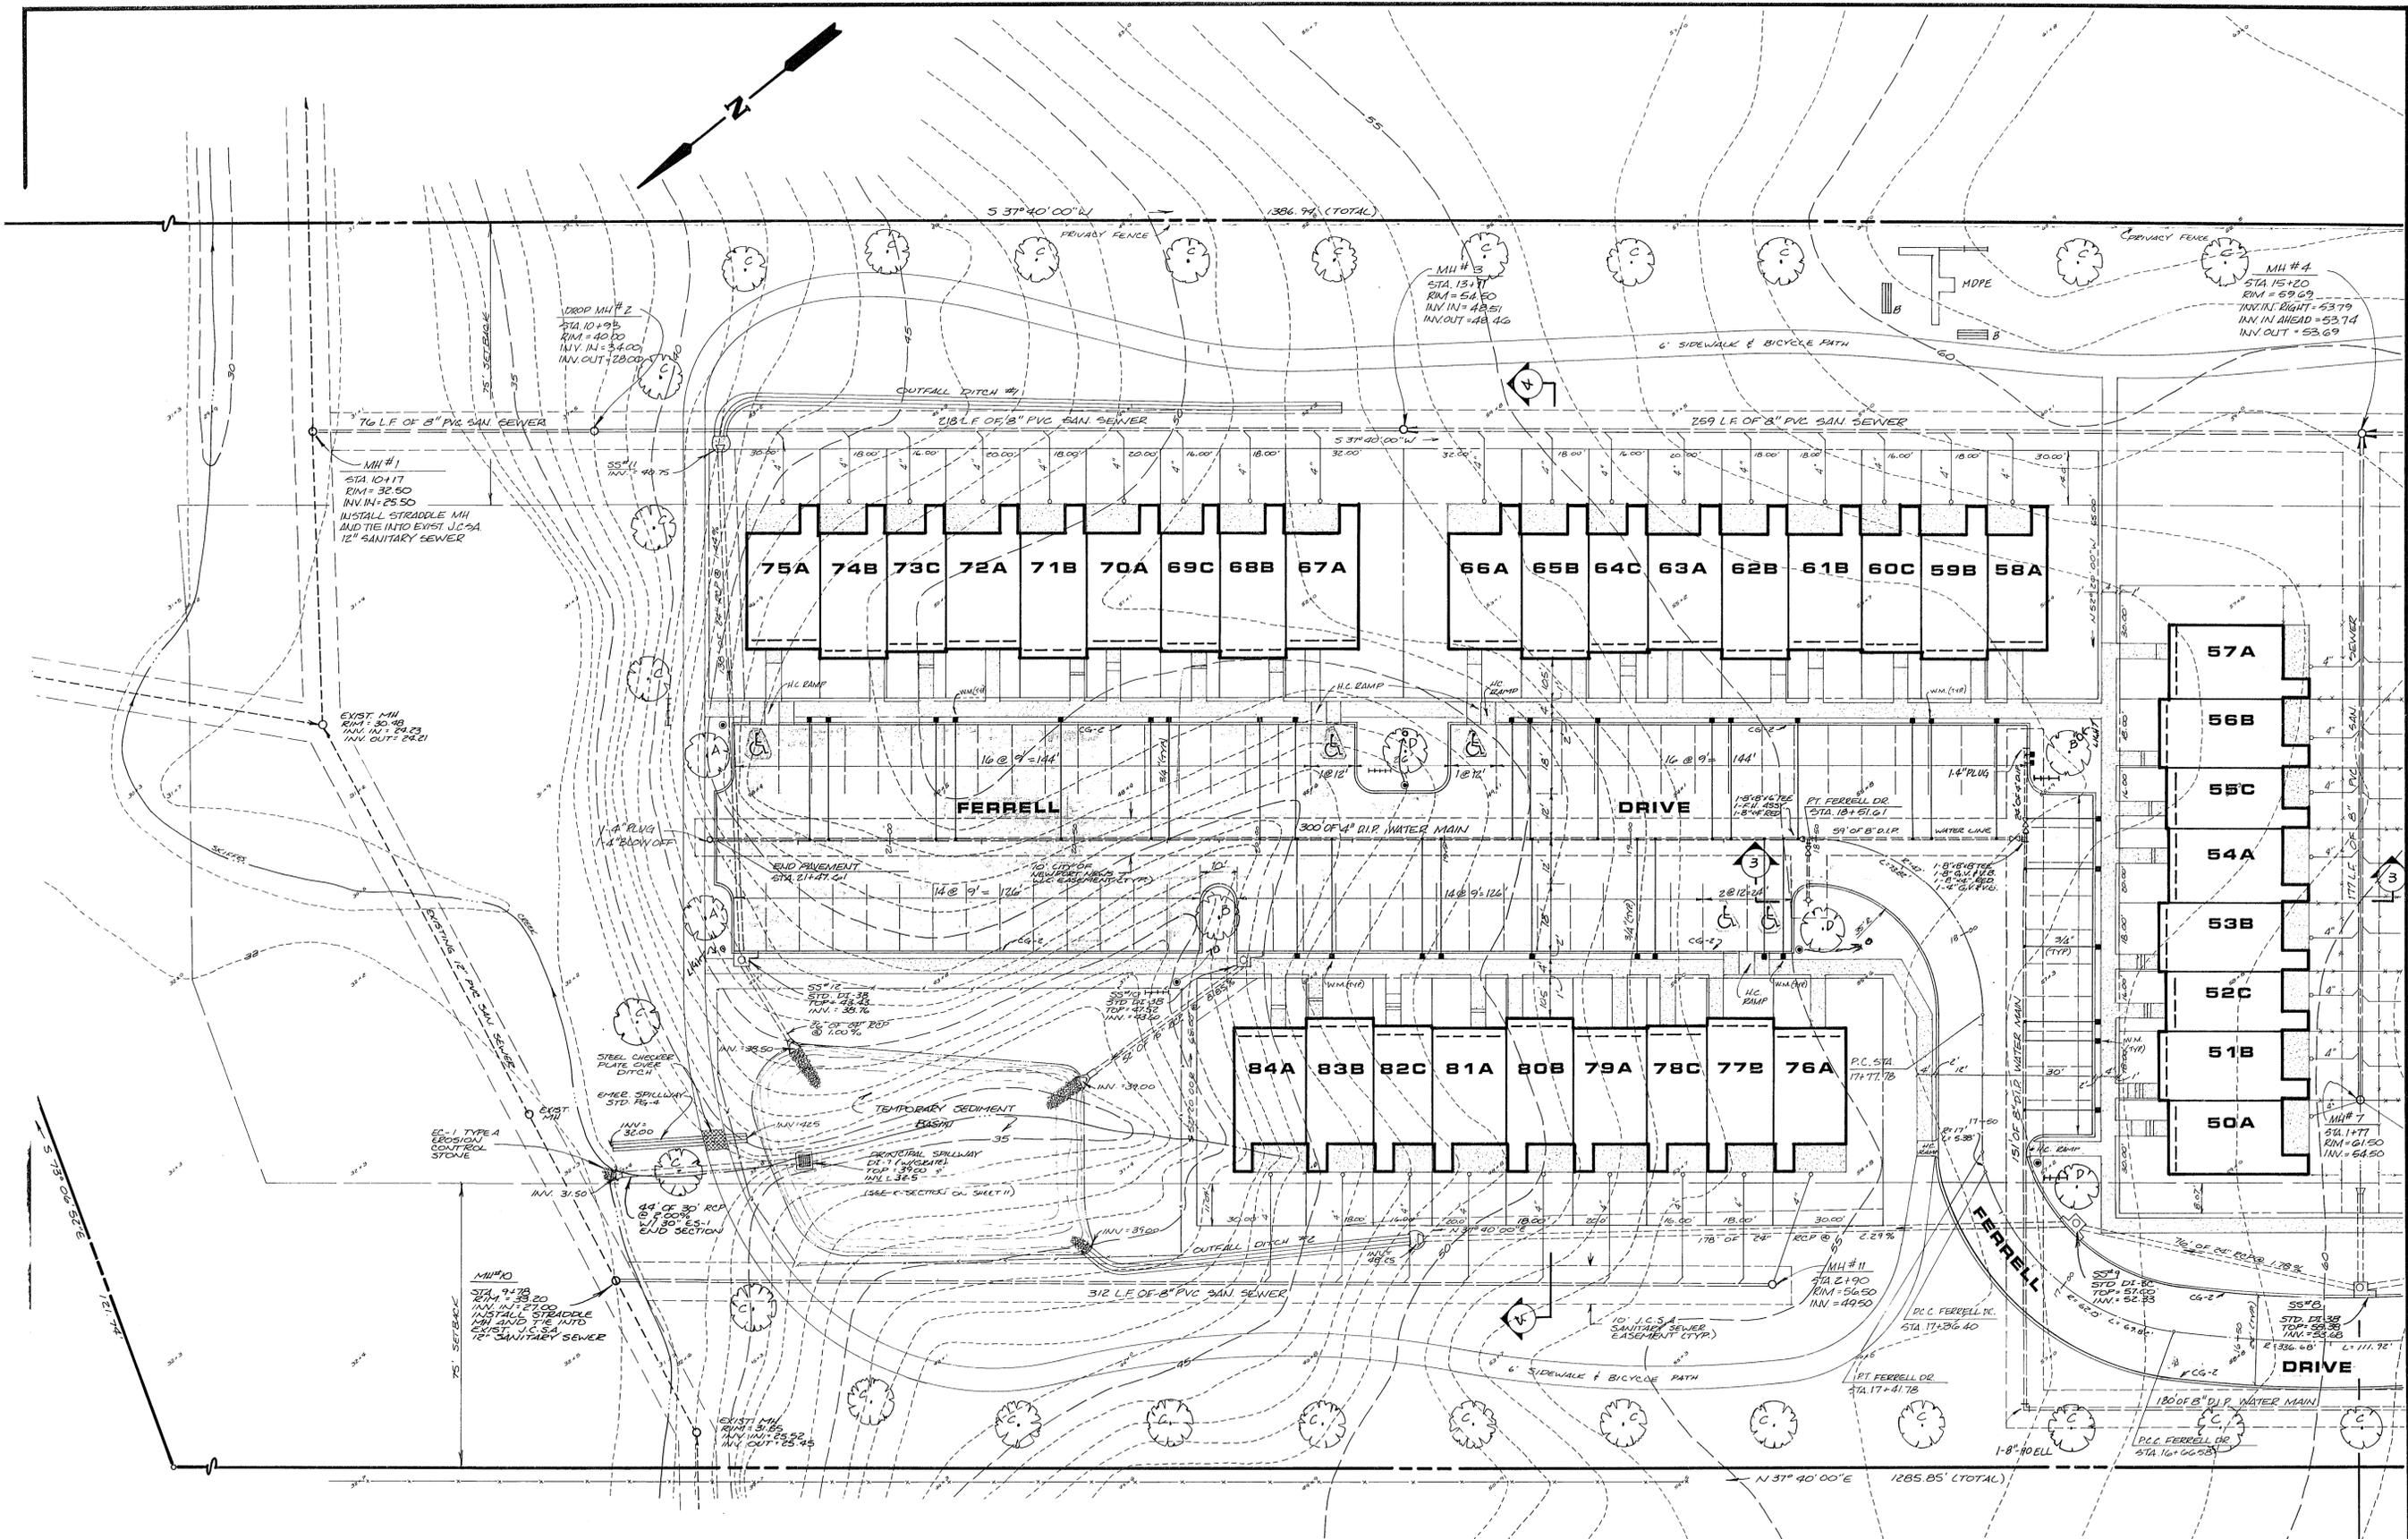
Designed JHB	Drawn BKL/OSB
Scale 1"=20'	Date FEB.1984
Project No. 5446	
Drawing No. 4

- NOTES:**
- SEE SHEET 6 FOR MORE DETAILED STORM SEWER INFORMATION.
  - MDPE: MULTI-DISCIPLINED PLAY EQUIPMENT (SWINGS, SLIDE, CLIMB, ETC.)
  - DASHED LINE SHOWN ON UNIT FRONT IS FRONT WALL AT FIRST FLOOR LEVEL.
  - FOR SITE CROSS SECTIONS, SEE SHEET 10.
  - SEE SHEET 3 FOR PLANTING SCHEDULE.

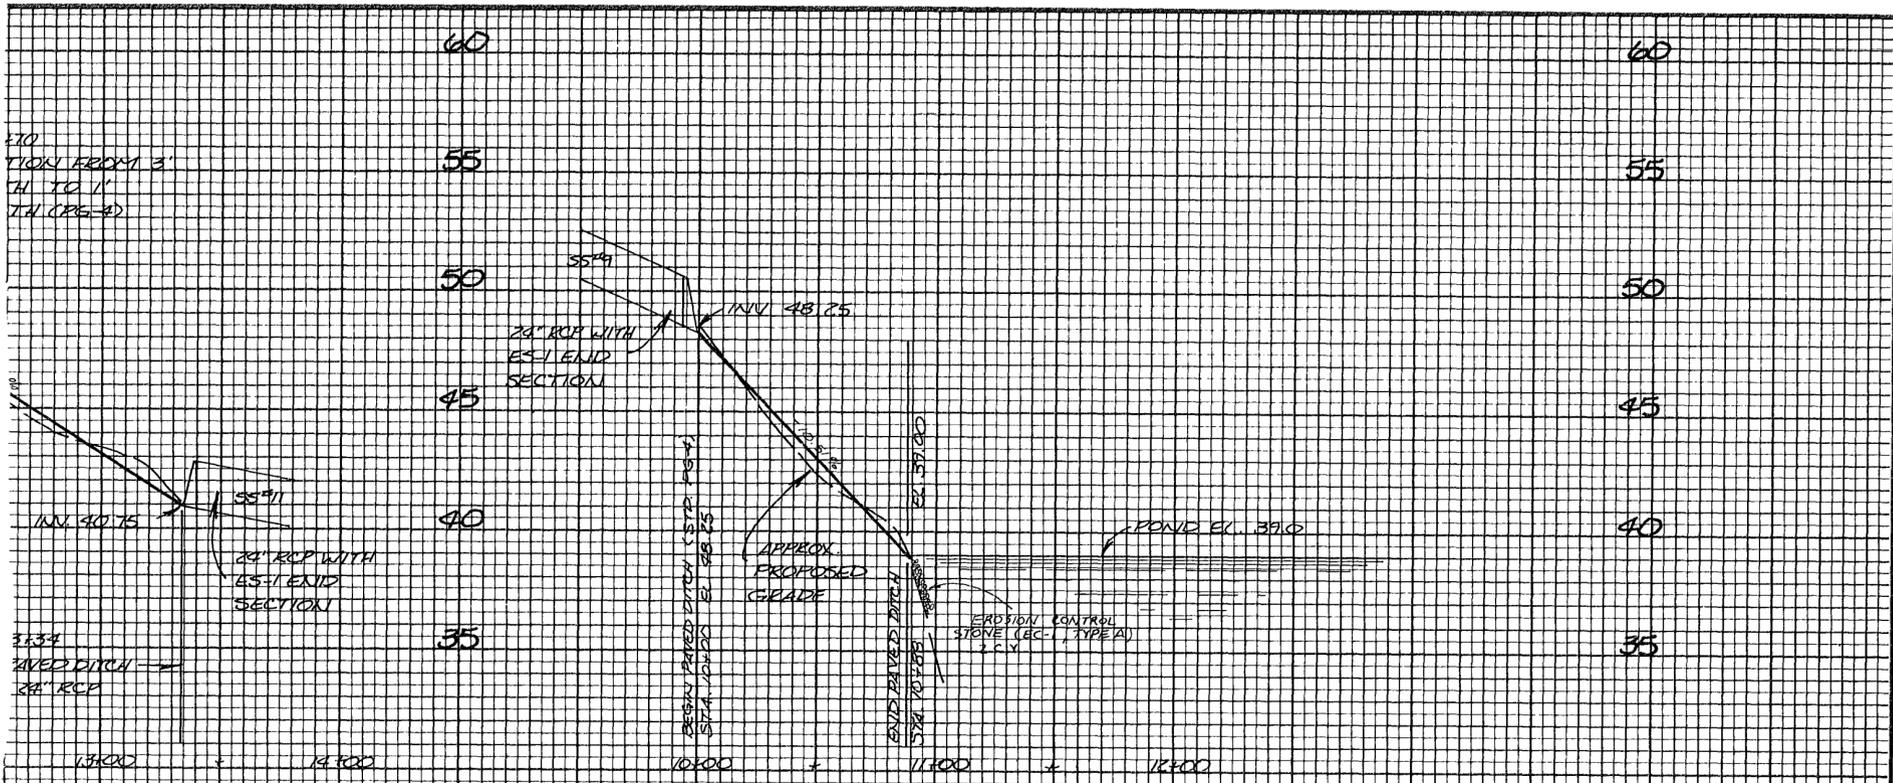
**OUTFALL DITCH #2**

BEHIND UNITS 76 = 5' 6"  
 SCALE: 1" = 5' VERTICAL, 1" = 50' HORIZONTAL  
 STD. PG. 4, 1/1 SIDE SLOPES, 1' BOTTOM, 1' DEPTH

16" WIDE ASPHALT OR CONCRETE WALKWAY (MAINTENANCE OVER SECTION)

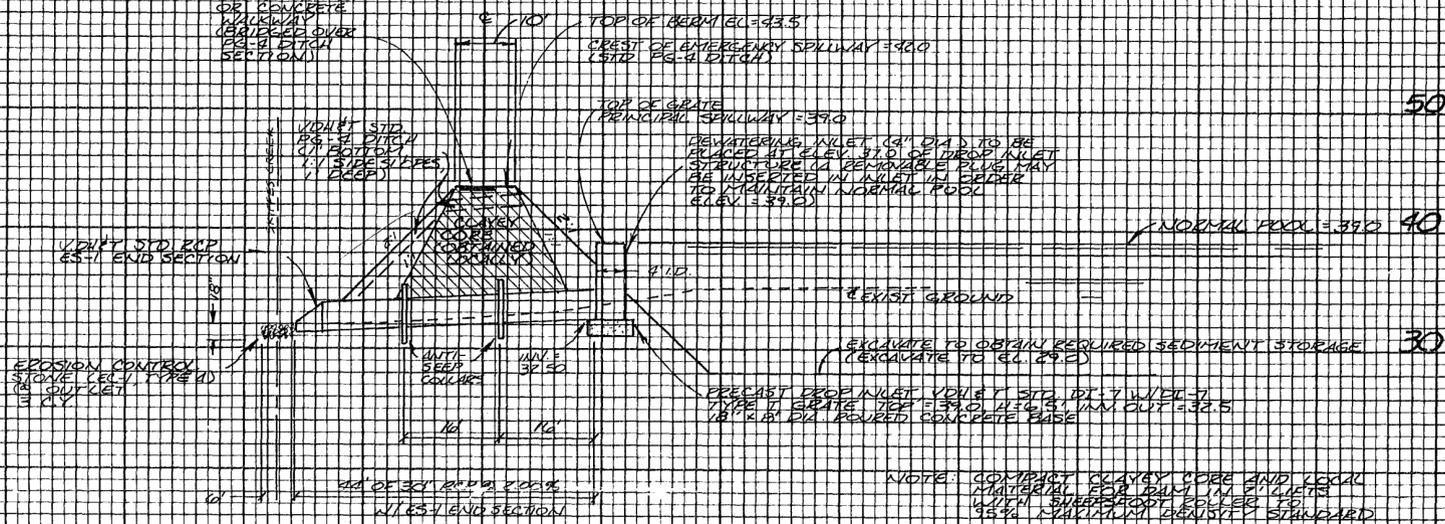
**CROSS SECTION OF TEMPORARY SEDIMENT BASIN AT PRINCIPAL SPILLWAY**  
 SCALE: 1" = 10' VERTICAL, 1" = 20' HORIZONTAL

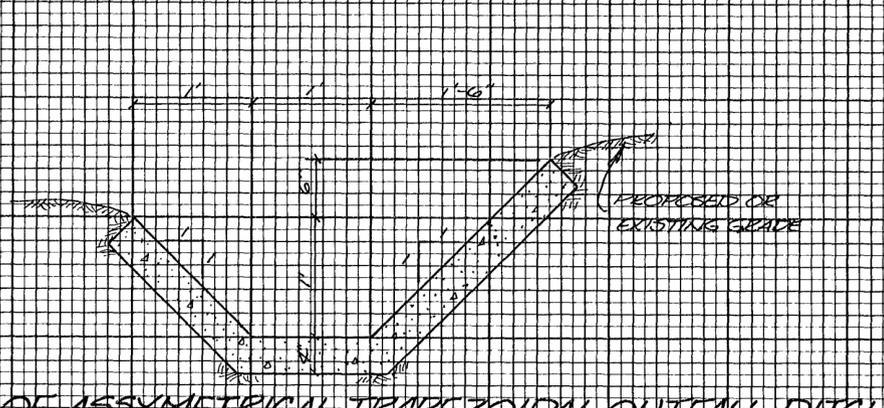
**DETAIL OF ASSYMETRICAL TRAPEZOIDAL OUTFALL DITCH**

1:1 SIDE SLOPES  
 BEHIND UNITS 58-75 FROM STA 1344 TO STA 1343  
 NOTE: HIGHER WALL SHALL BE CONSTRUCTED ON OUTSIDE OF BEHIND IN OUTFALL DITCH  
 SCALE: 1" = 1' VERTICAL, 1" = 1' HORIZONTAL

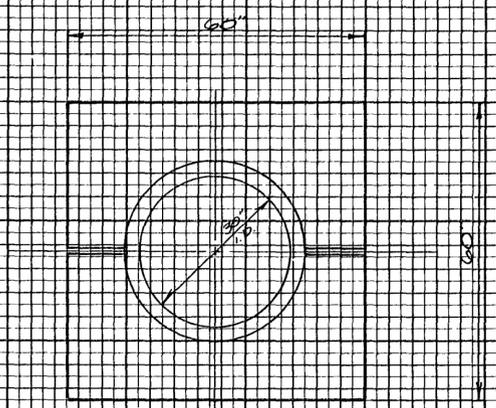
**ANTI-SEEP COLLAR**

2 REQUIRED  
 SCALE: 1" = 3'-0"  
 NOTE: SEE NOTE 'U' IN DESIGN OF PERMANENT SEDIMENT BASIN NOTES.
