BMP NUMBER: WC044

Hankins Industrial Park

Wise Recycling

STORMWATER MANAGEMENT/ BMP CALCULATIONS
FOR
WET POND BMP

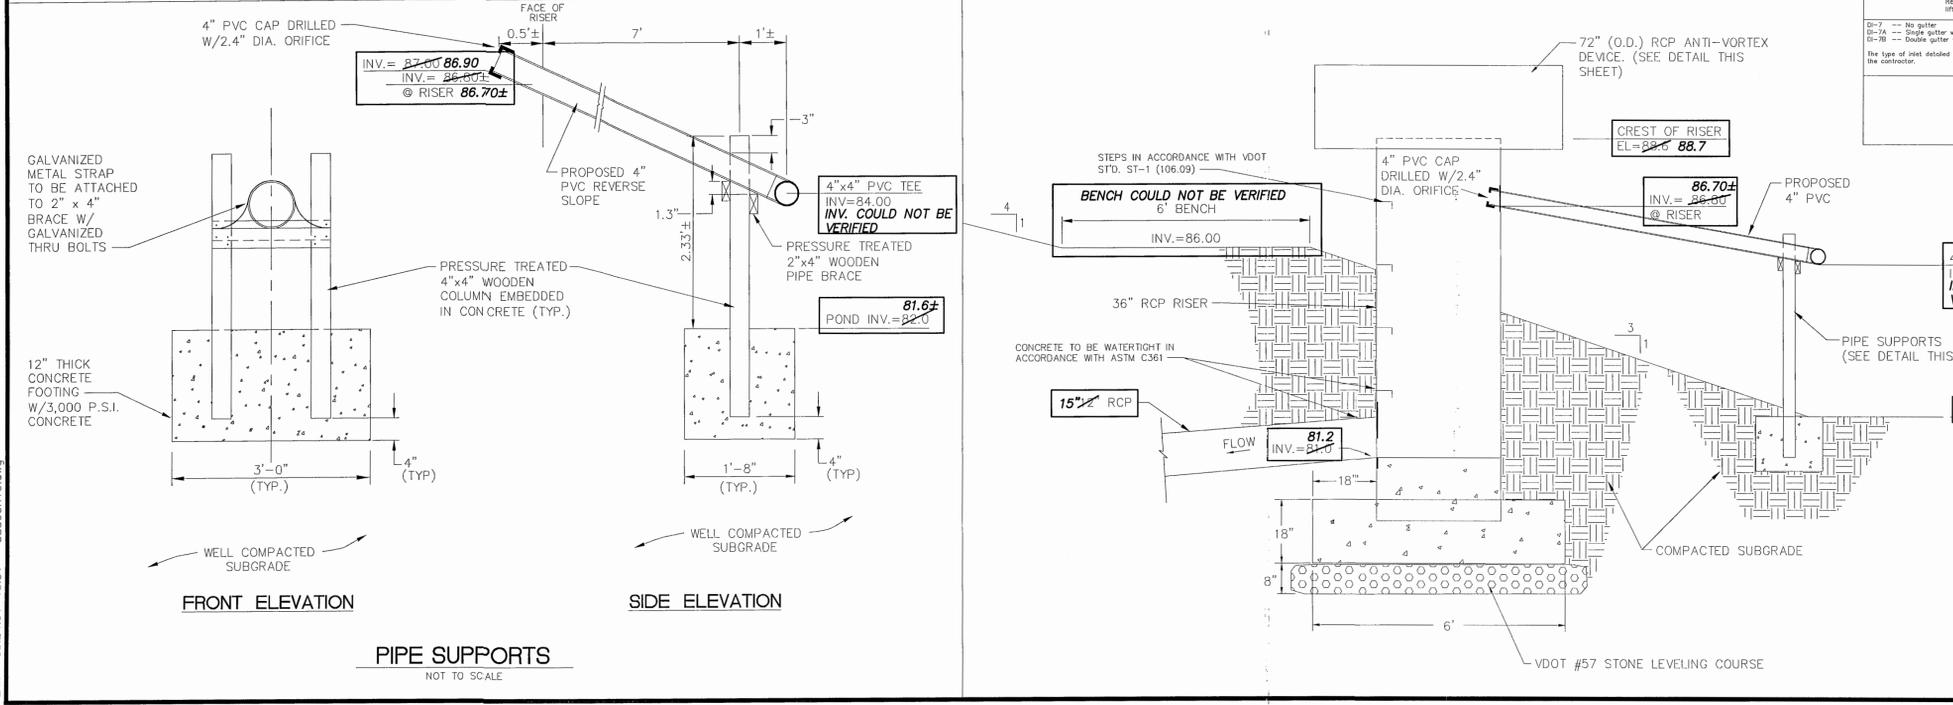
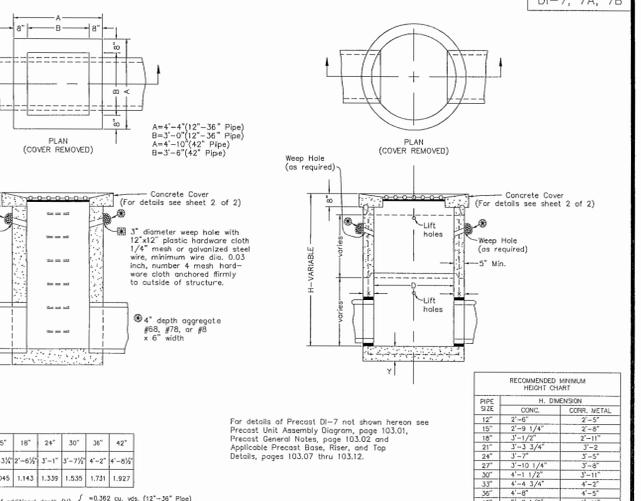
RECORD DRAWING BASED ON FIELD SURVEY PERFORMED BY AES CONSULTING ENGINEERS

CROSS SECTION PROP. 36" RISER STRUCTURE WITH ANTI-VORTEXING TOP

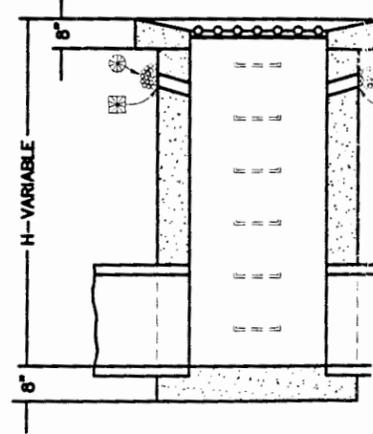
Steps are to be provided when 'H' is 4'-0" or greater. For step details see STD ST-1.

Pipe Size	12"	15"	18"	24"	30"	36"
Minimum Depth H	2'-0"	2'-3 1/2"	2'-6 1/2"	3'-1"	3'-7 1/2"	4'-2"
Cu. Yds. Conc.	.947	1.045	1.143	1.330	1.535	1.731

DI-7 --- No gutter
DI-7A --- Single gutter when drop inlet is on a grade.
DI-7B --- Double gutter when drop inlet is in a sag between two grades.
The type of inlet detailed hereon to be constructed will be at the option of the contractor.

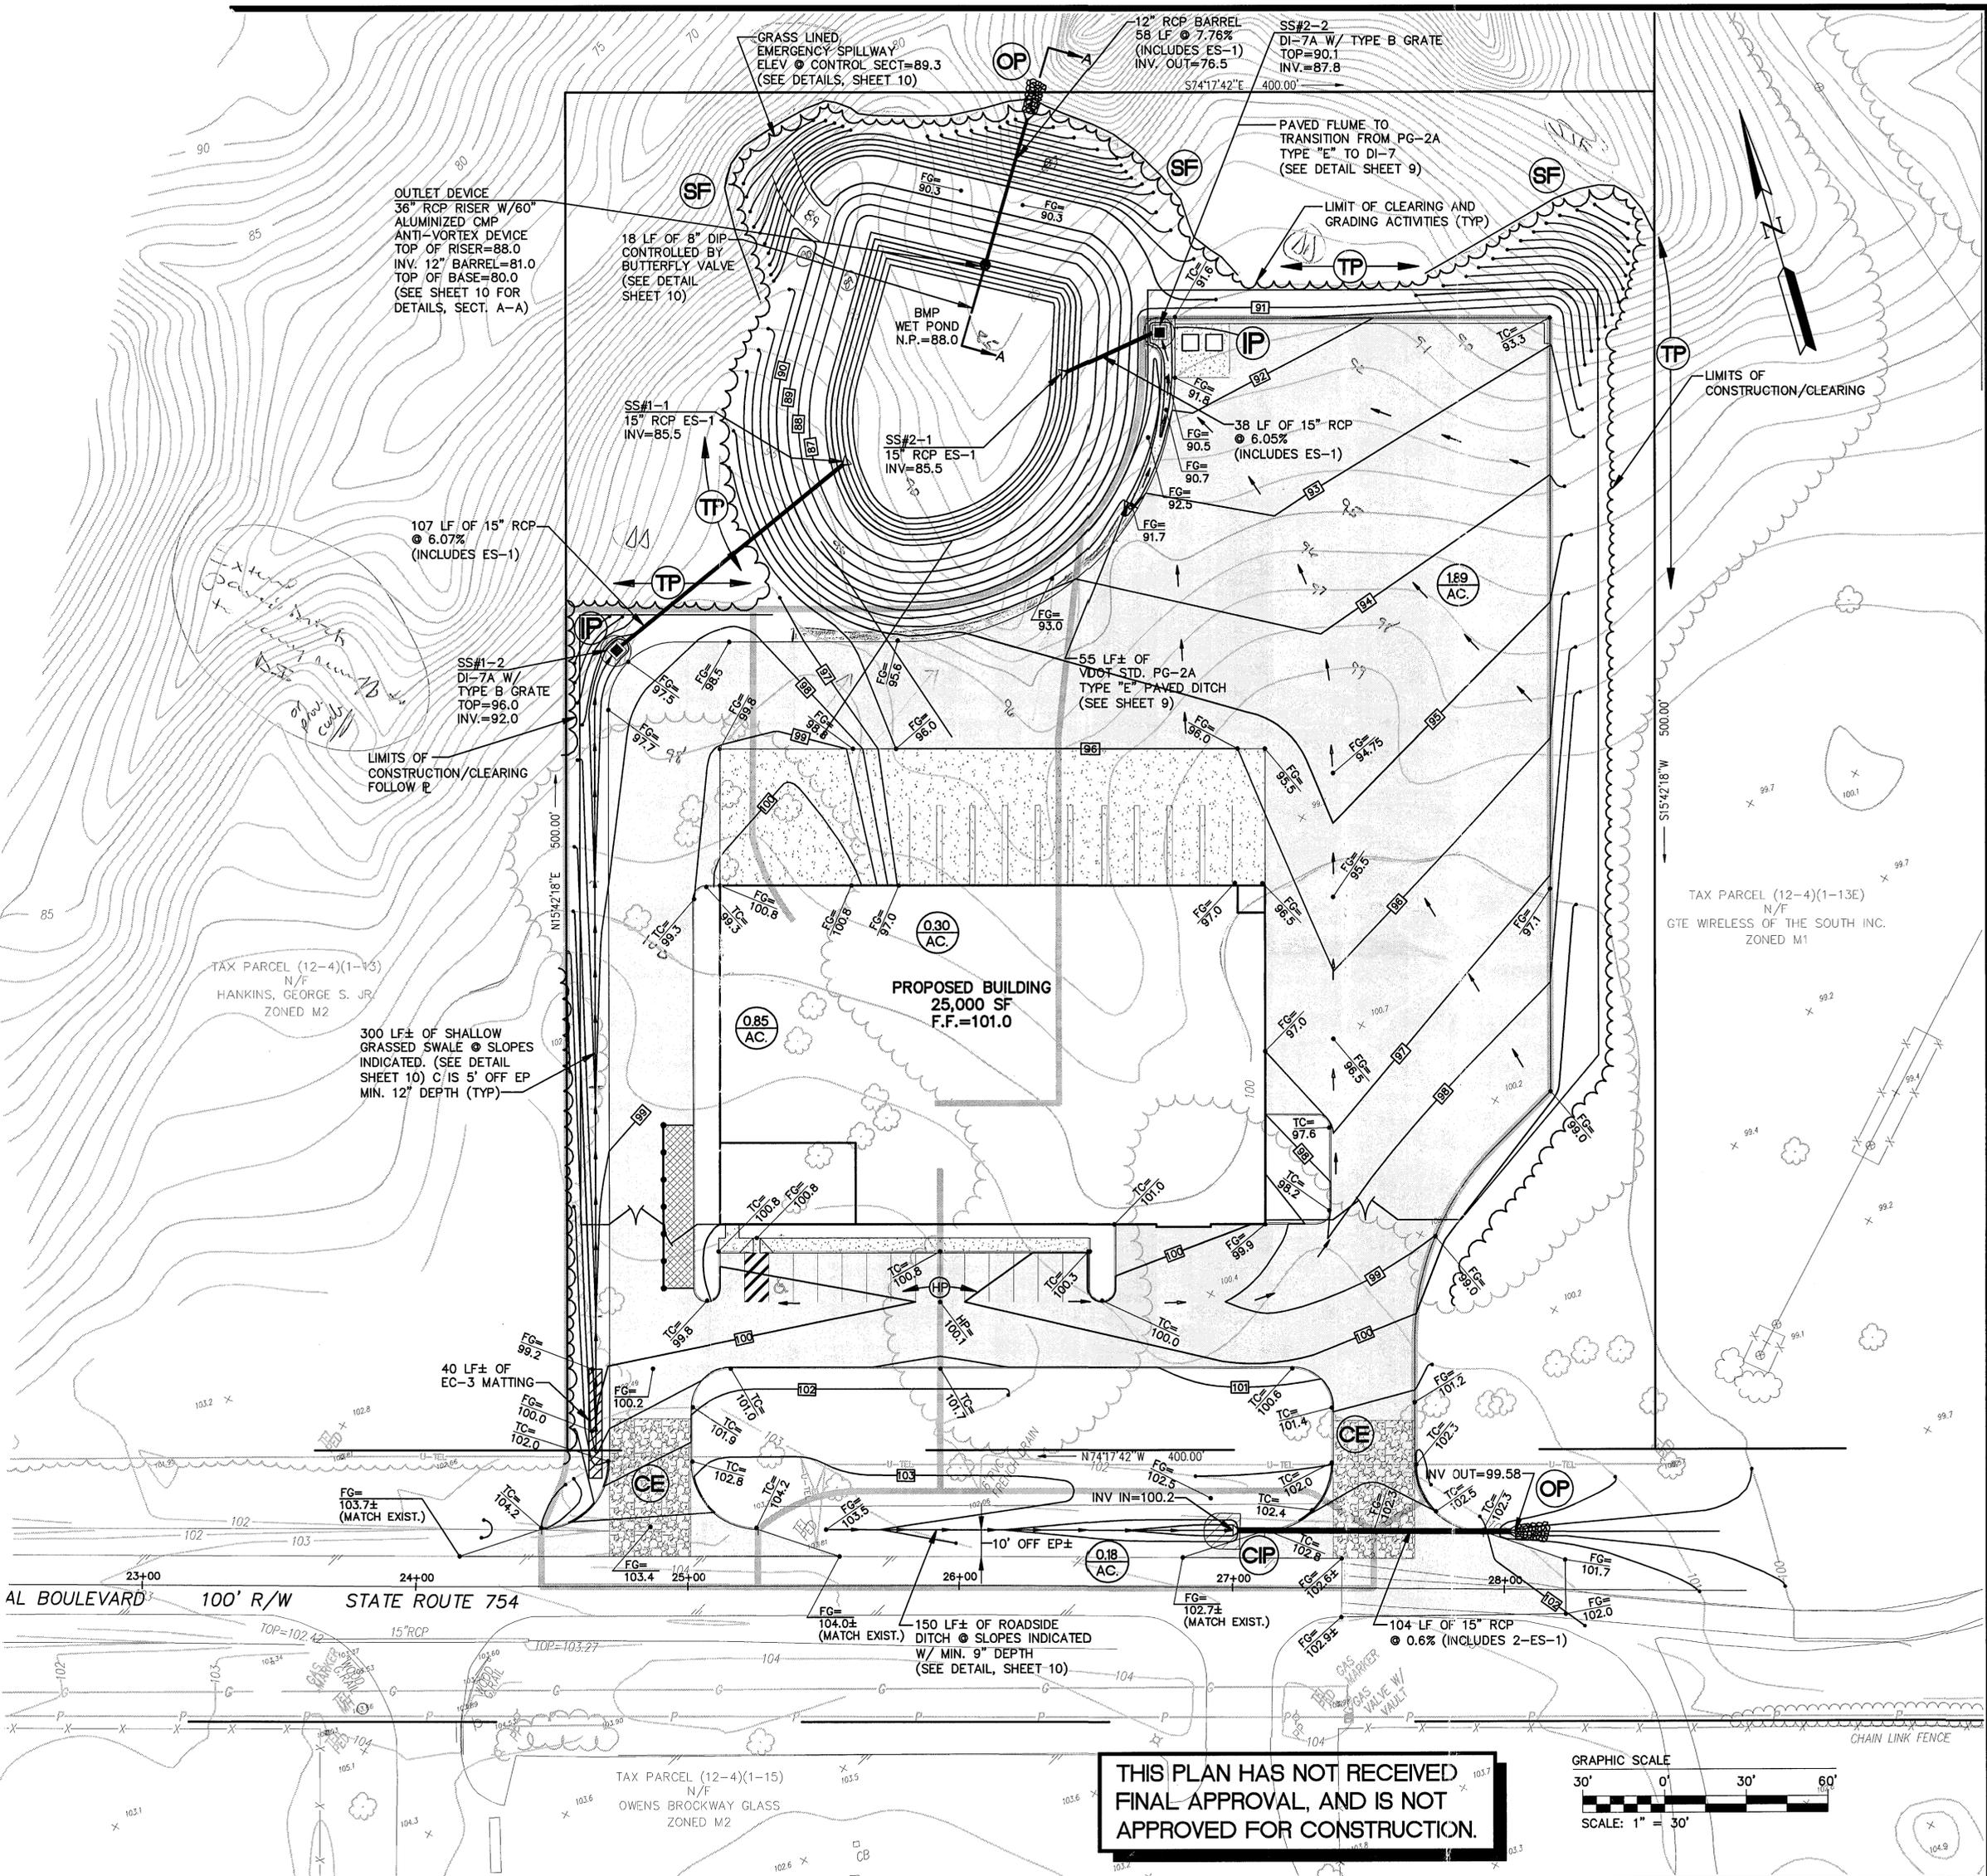
OUTLET DEVICE
36" RCP RISER W/60"
ALUMINIZED CMP
ANTI-VORTEX DEVICE
TOP OF RISER=88.0
INV. 12" BARREL=81.0
TOP OF BASE=80.0
(SEE SHEET 10 FOR
DETAILS, SECT. A-A)

SS#1-1
15" RCP ES-1
INV=85.5

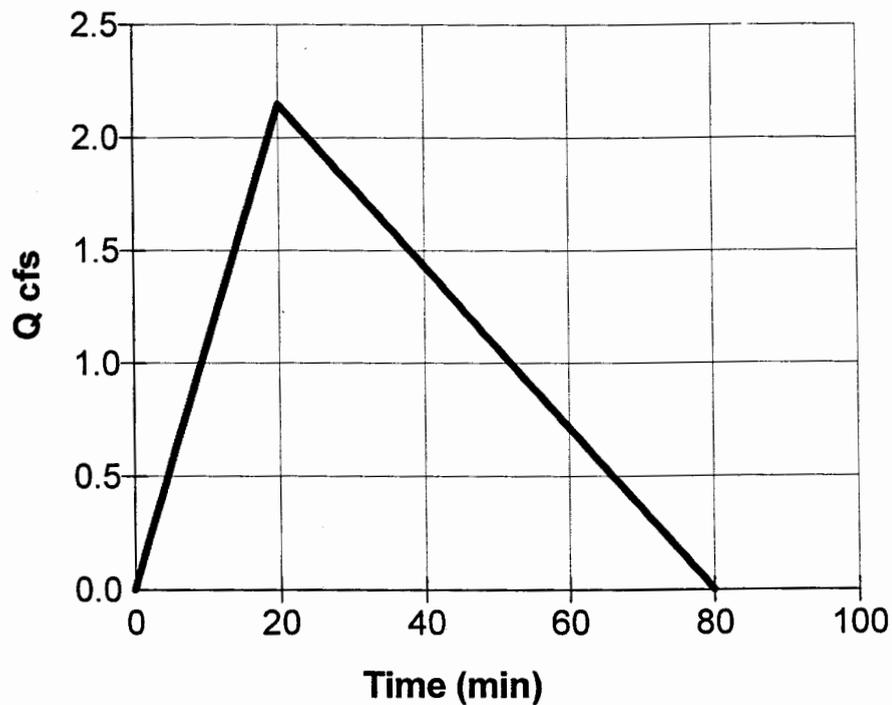
1 - Rational - 2 Yr - Qp = 2.15 cfs

Total Volume = 5,154 cuft

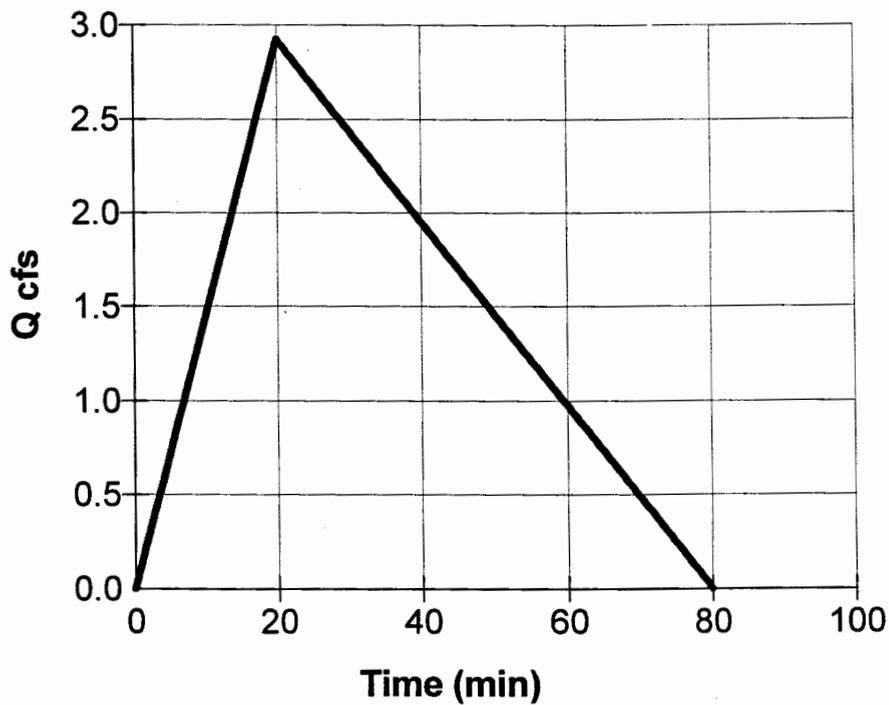
3 - Rational - 10 Yr - Qp = 2.92 cfs

Total Volume = 7,020 cuft

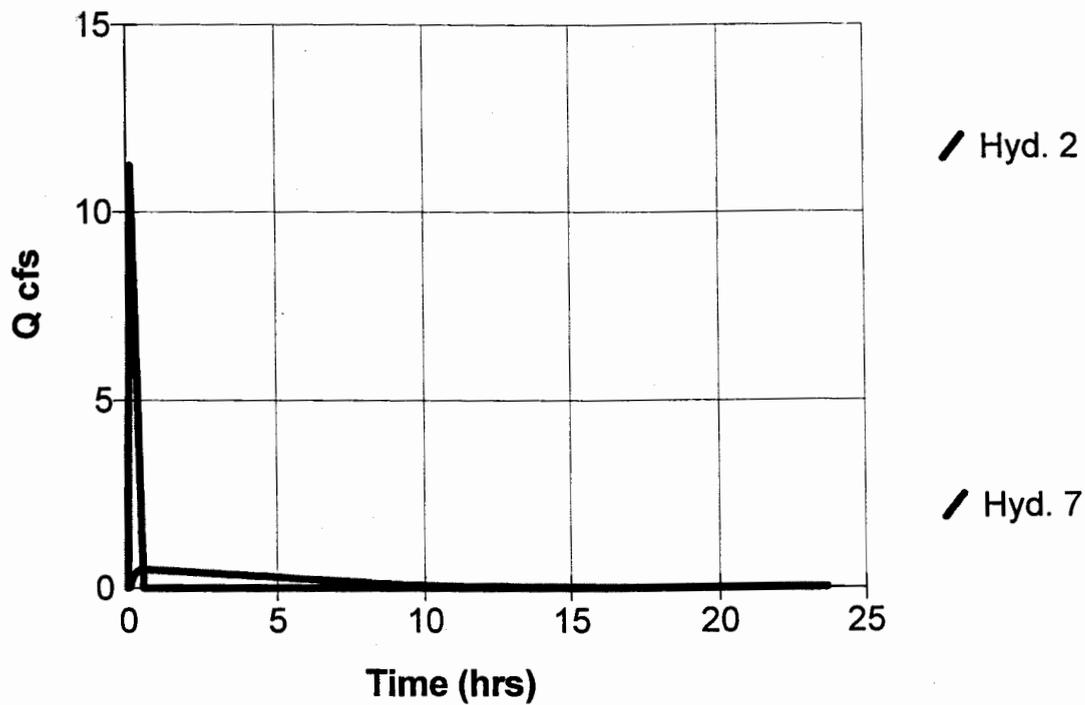
7 - Reservoir - 2 Yr - Qp = 0.49 cfs

Total Volume = 10,315 cuft

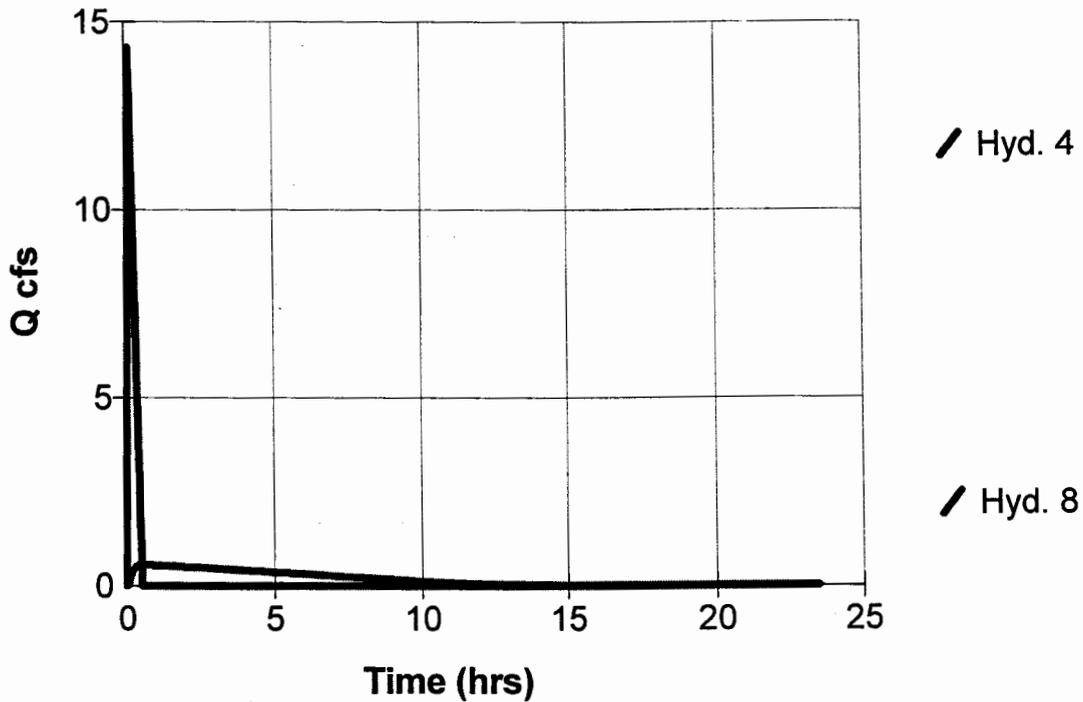
8 - Reservoir - 10 Yr - $Q_p = 0.55$ cfs

Total Volume = 13,255 cuft

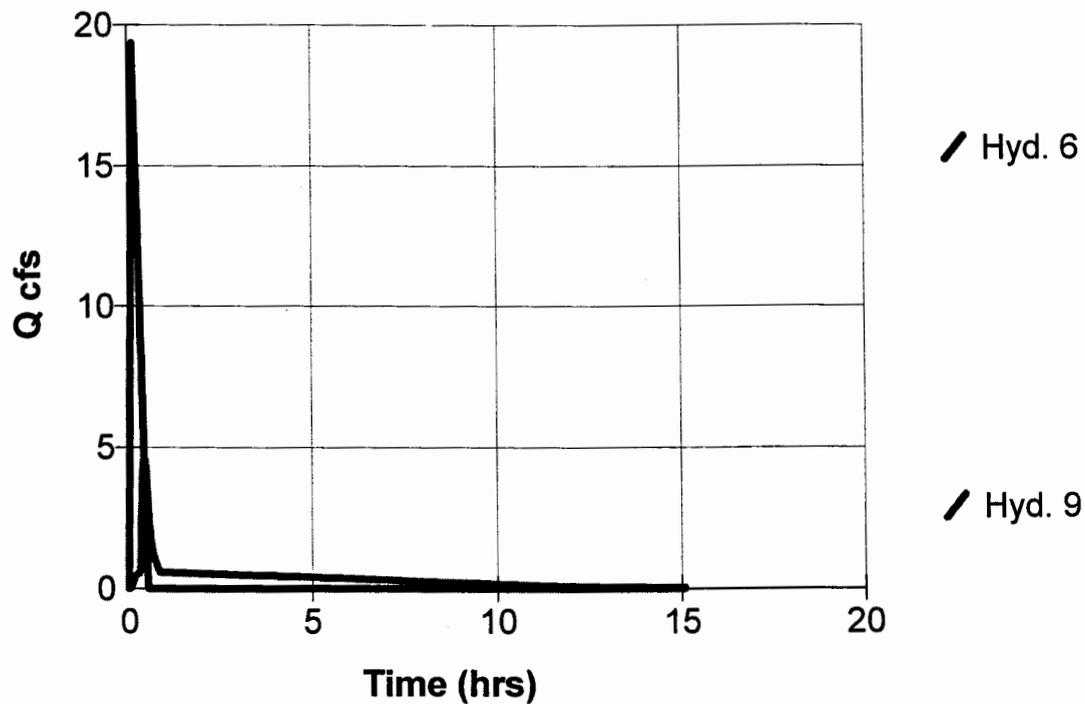
9 - Reservoir - 100 Yr - $Q_p = 4.60$ cfs

Total Volume = 18,098 cuft

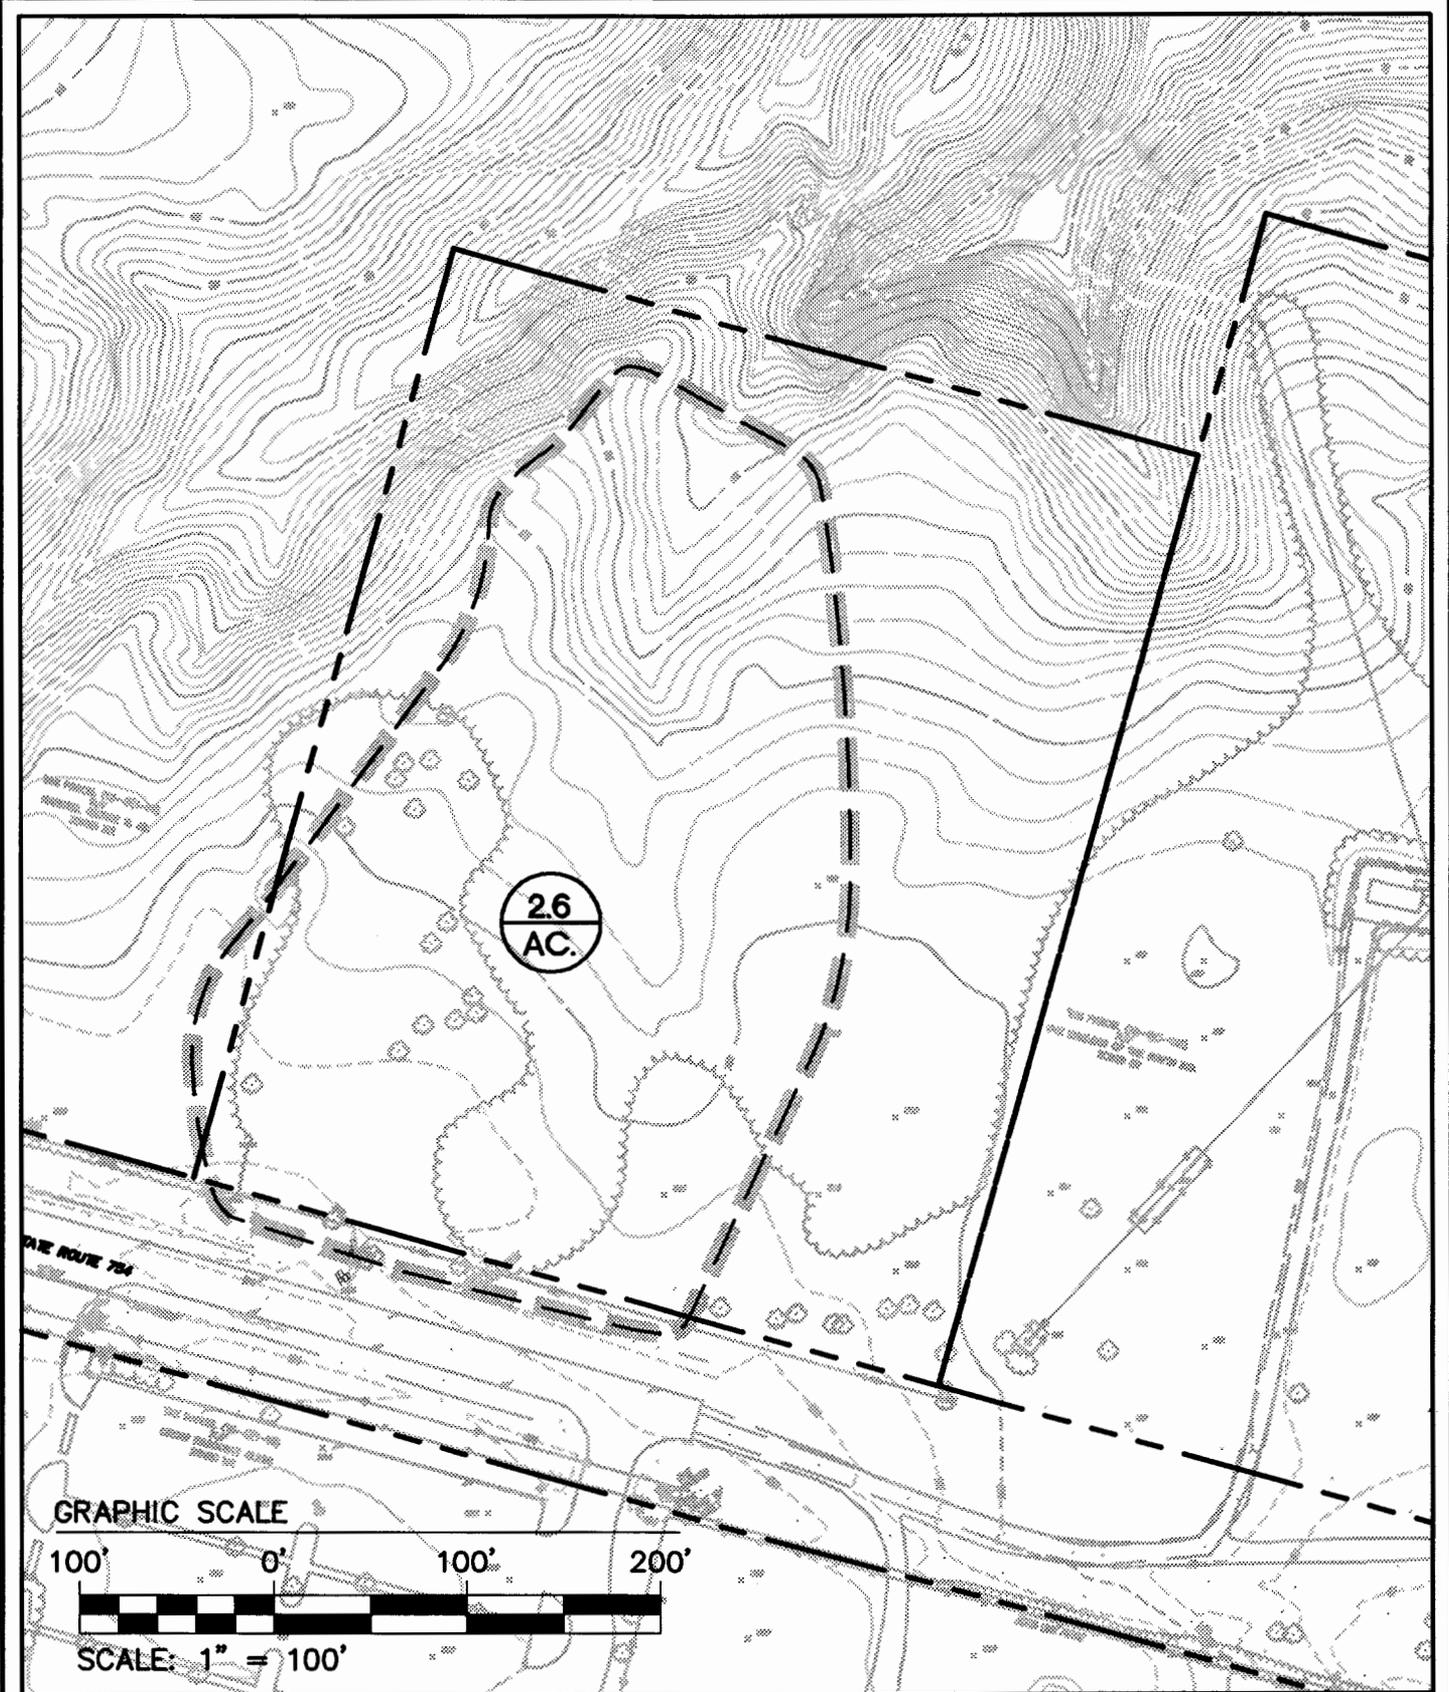
**WISE RECYCLING
PRE-DEVELOPMENT DRAINAGE AREA MAP**

Job No.
8850-0
Drawing No.
1 of 2
