Vineyards at Jockeys Neck  
Common Area Landscape and Hardscape Easements  
and Open Space  
2630 Lake Powell Road

**DAM AND LAKE NO.1**  
**PLAN**  
**JOCKEY'S NECK**  
OWNER : DAVID M. MURRAY  
CITY COUNTY

**DAM AND LAKE NO.2  
JOCKEY'S NECK**  
OWNER/DAVID M. MURRAY

**AMENDMENT TO  
THE VINEYARDS AT JOCKEY'S NECK  
PHASE III**

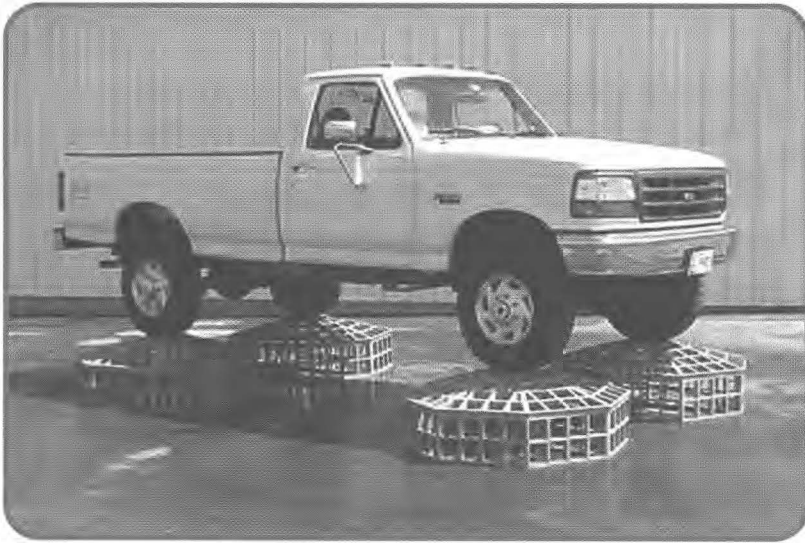
**5000 lb. truck** is supported by four 48" Pyramid structures.

*Structural plastic* has a cellular core surrounded by integral skins forming a totally integrated structure. Structural molded parts made from H.D.P.E. and fiberglass have a high strength-to-weight ratio and have 3 to 4 times greater rigidity than solid parts of the same material of equal weight.
