BMP NUMBER: CC-014

Re: Kingspoint Subdivision Large Lake (County ID No. CC 014) East Side/Overlook Drive Vicinity

Kingspoint Dam Repair

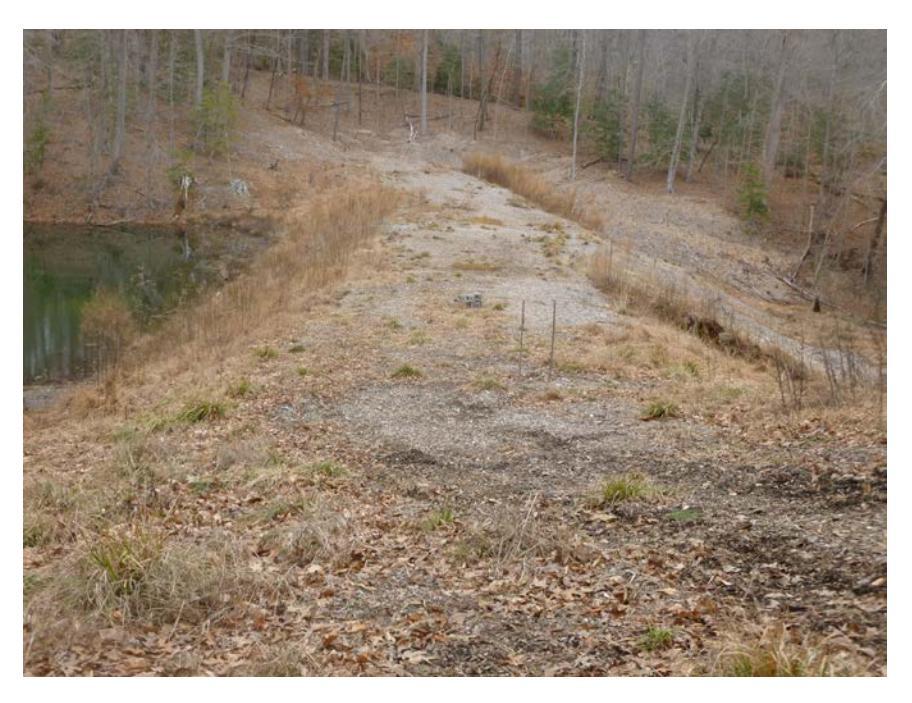
View along top of dam, from right abutment.

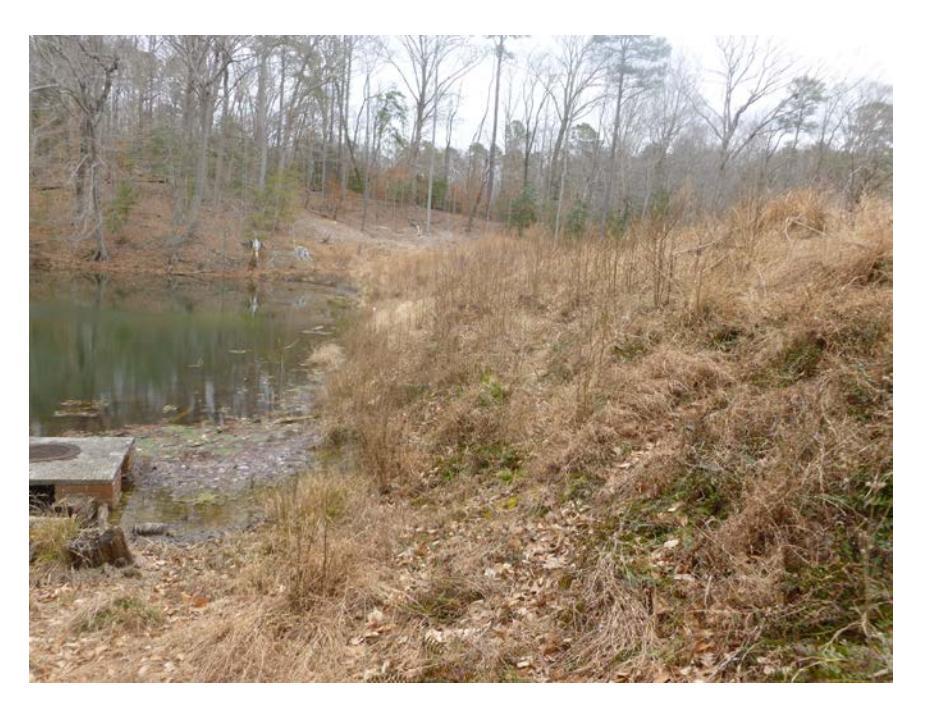
View along upstream face of dam, from right abutment.

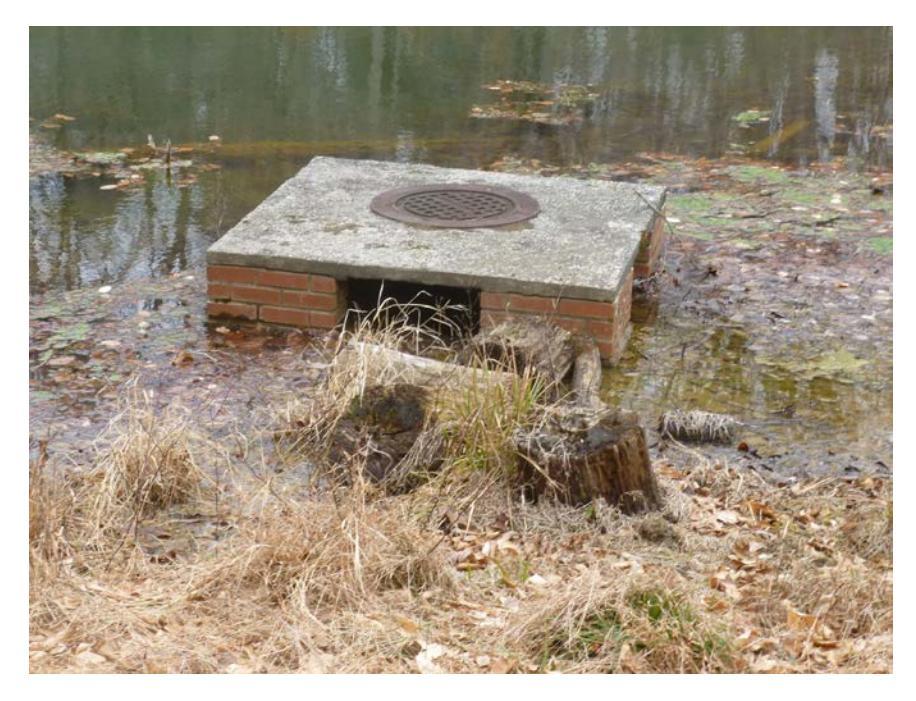
Brick principal spillway with four (4) control orifices.

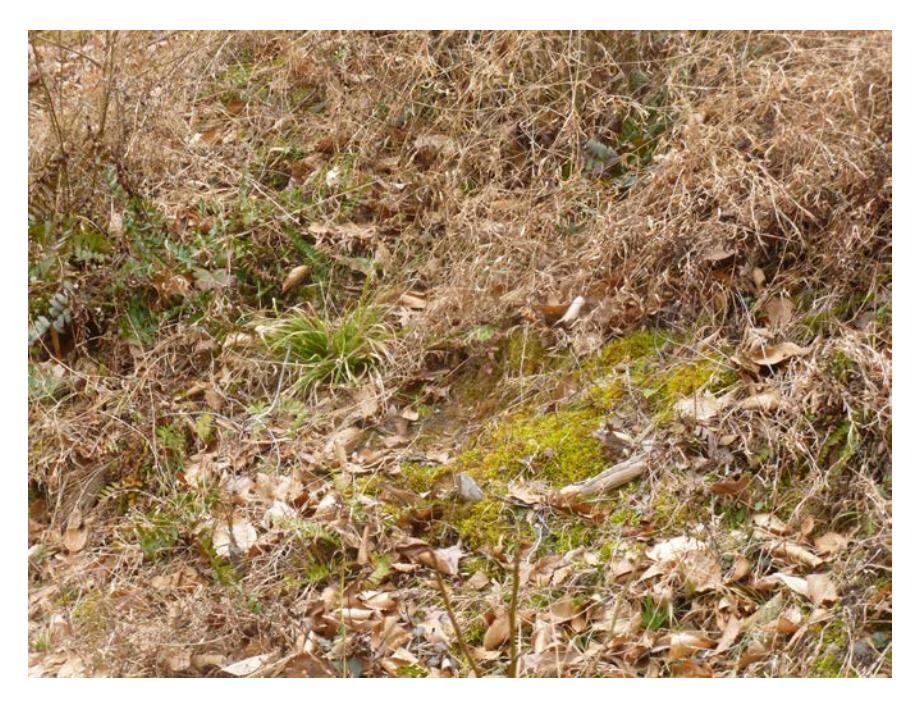
Moss and bare spots on embankment.

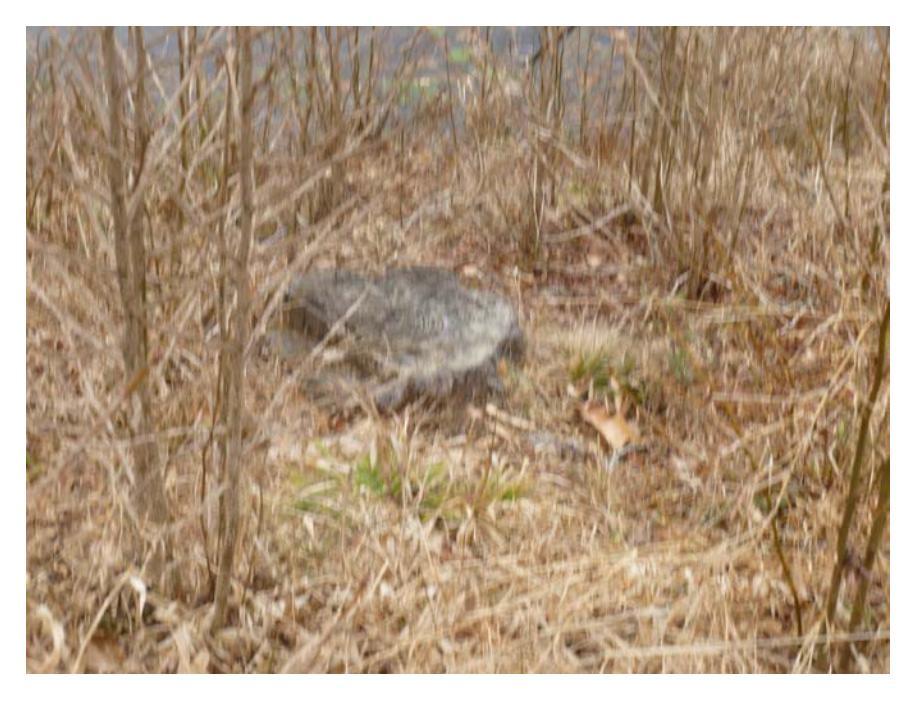
Tree stump that should be removed.

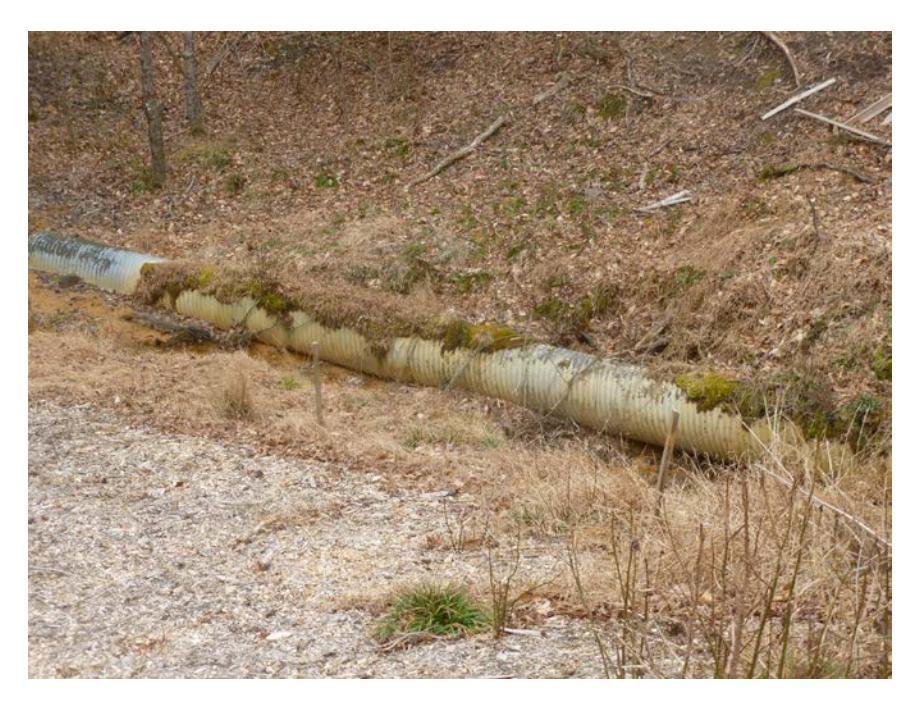
Downstream part of separated outfall barrel, corrugated metal pipe (CMP).

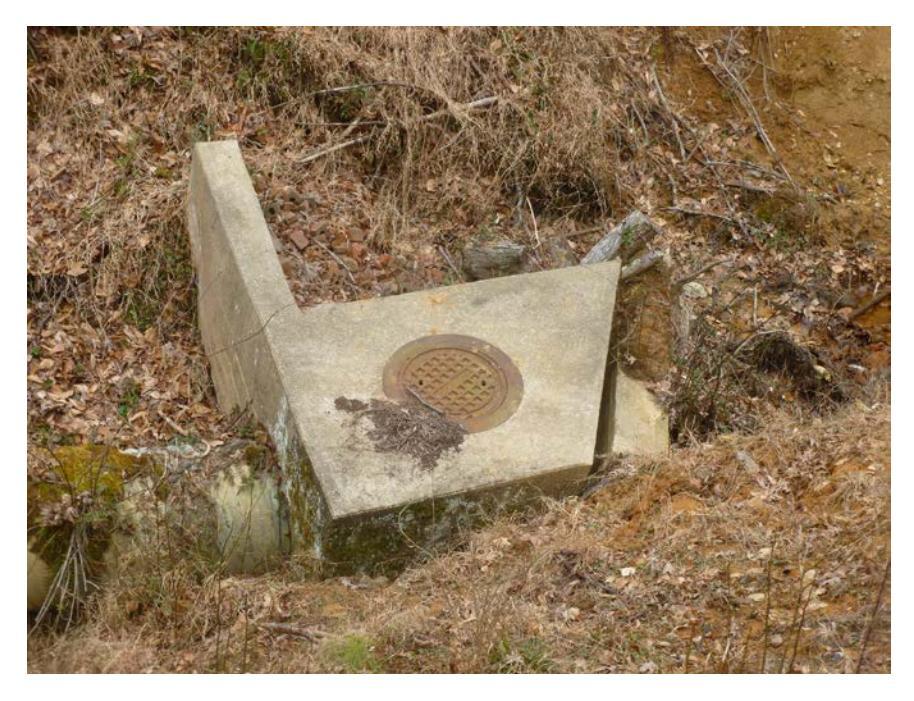
Displaced junction box within outfall barrel.

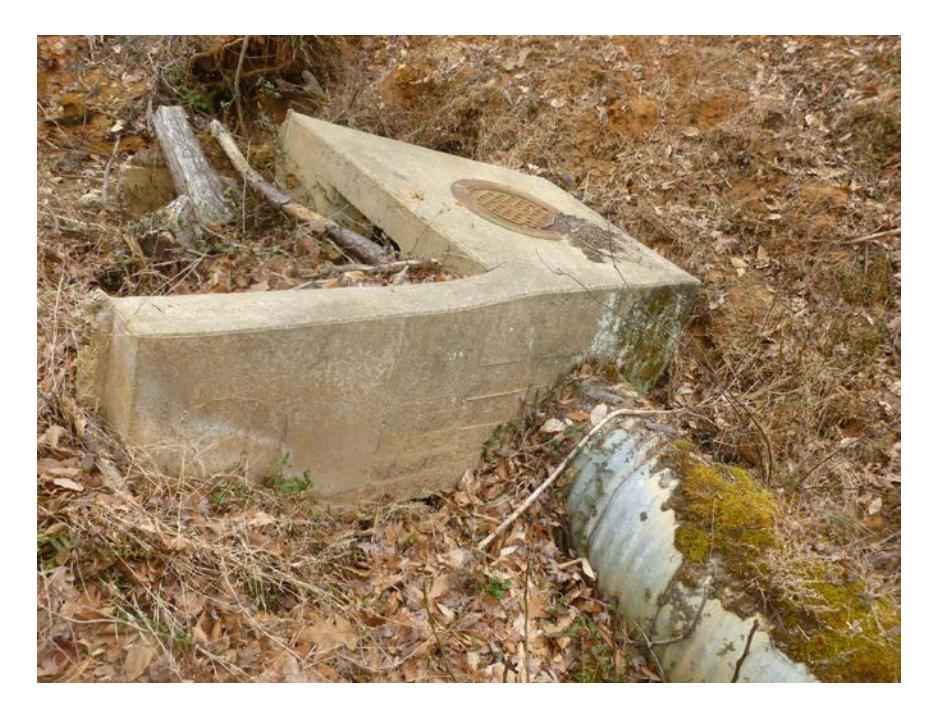
Displaced junction box.

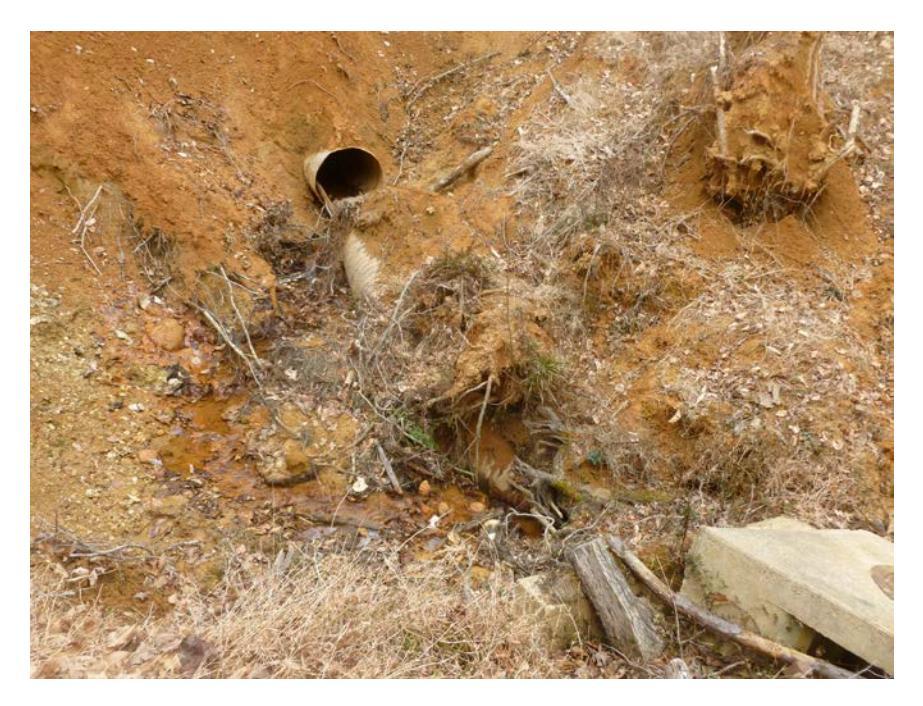
Downstream penetration of remaining outfall barrel, with displaced portion of barrel and junction box.

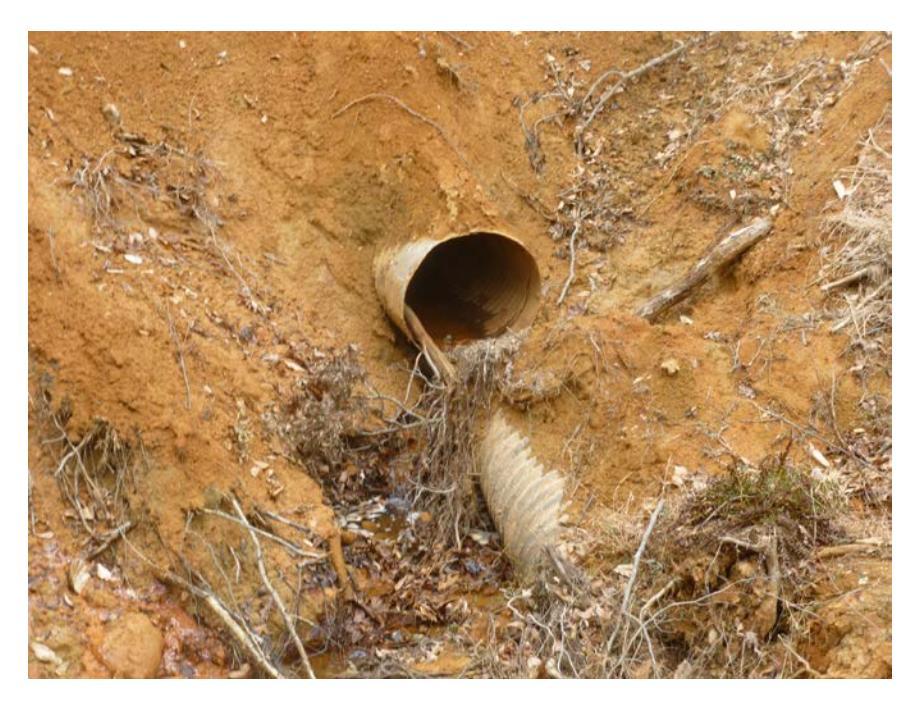
Outfall barrel, pipe separation area.

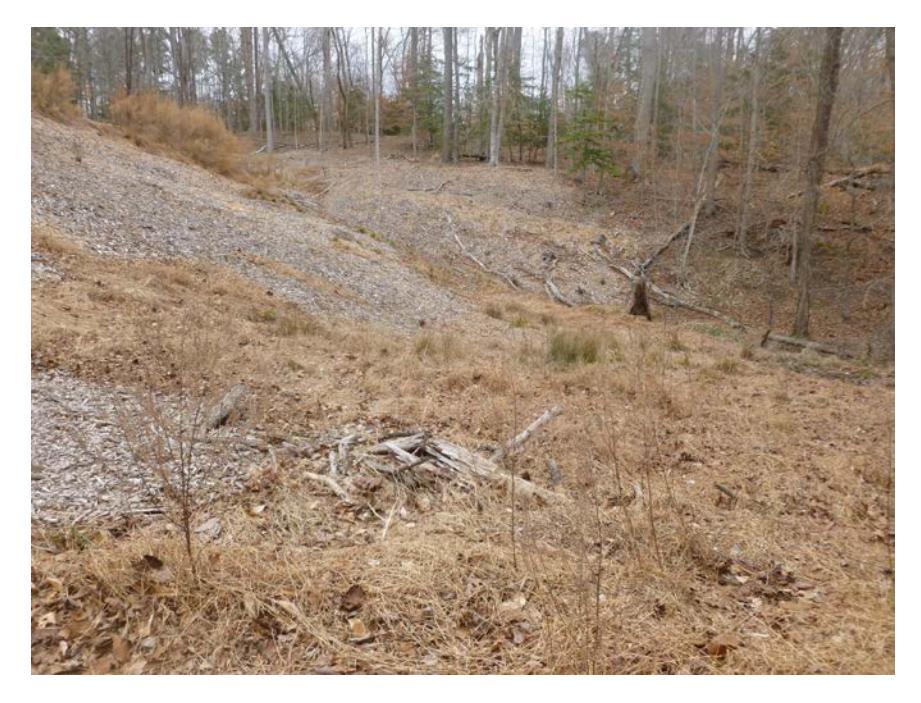
Downstream face of embankment.

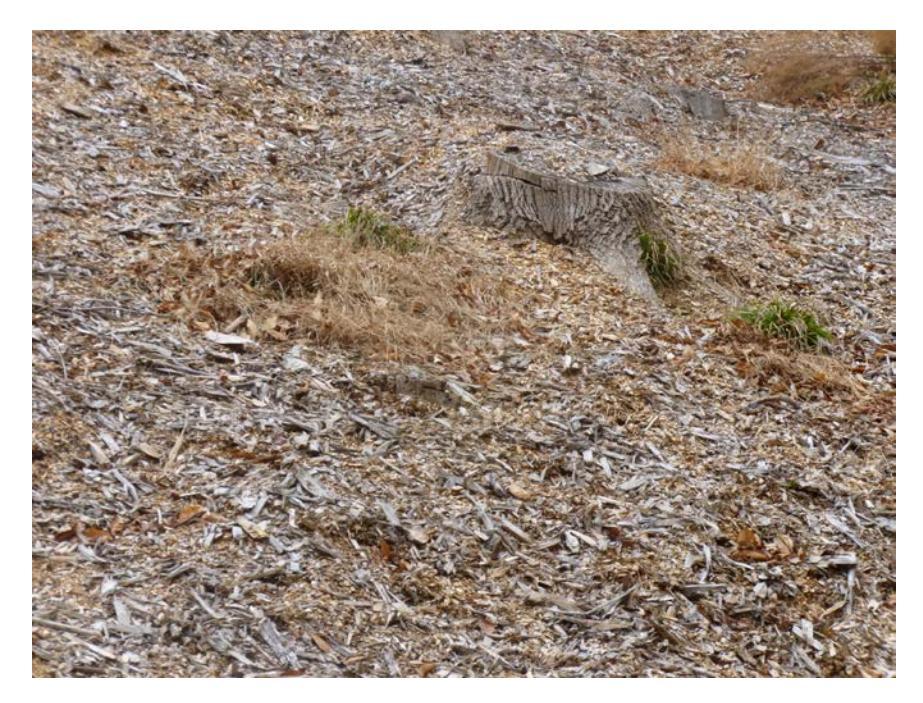
Wood chip cover and remaining tree stump.

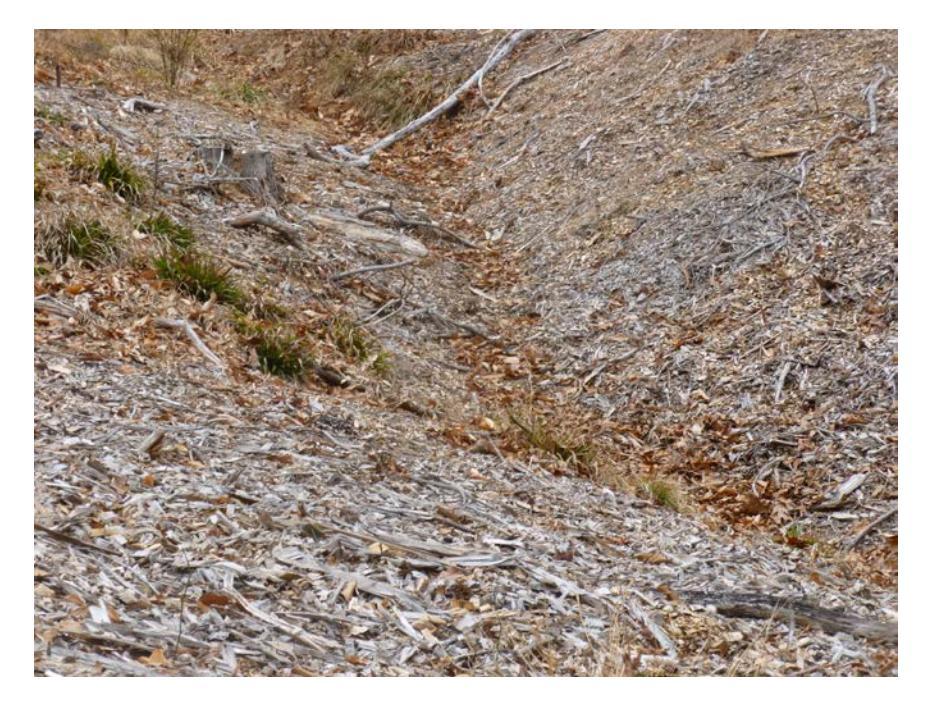
Groin swale on left abutment, downstream face.

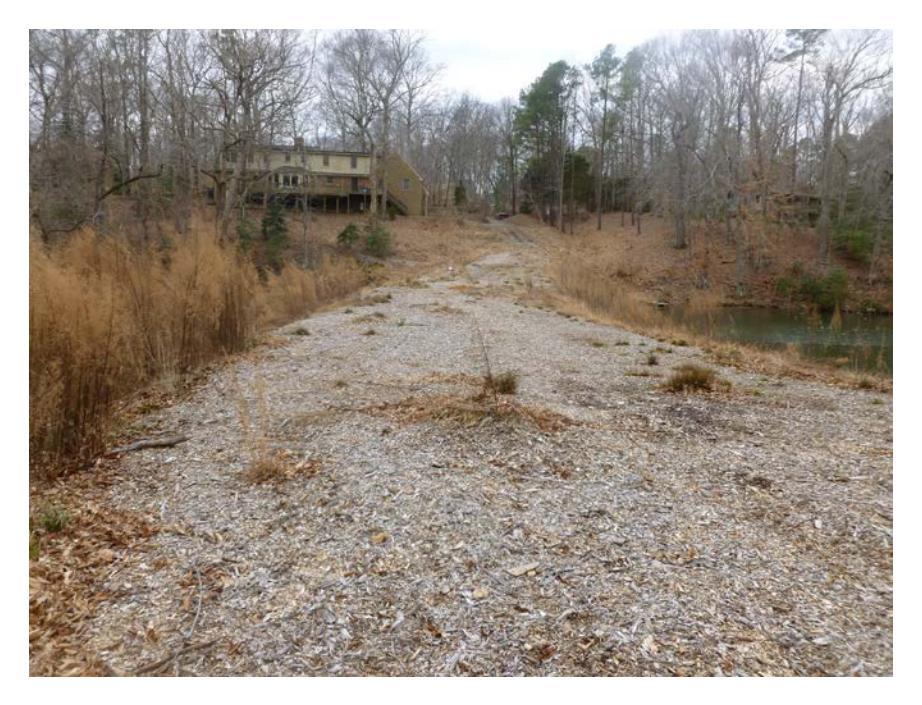
View along top of embankment, from left abutment.

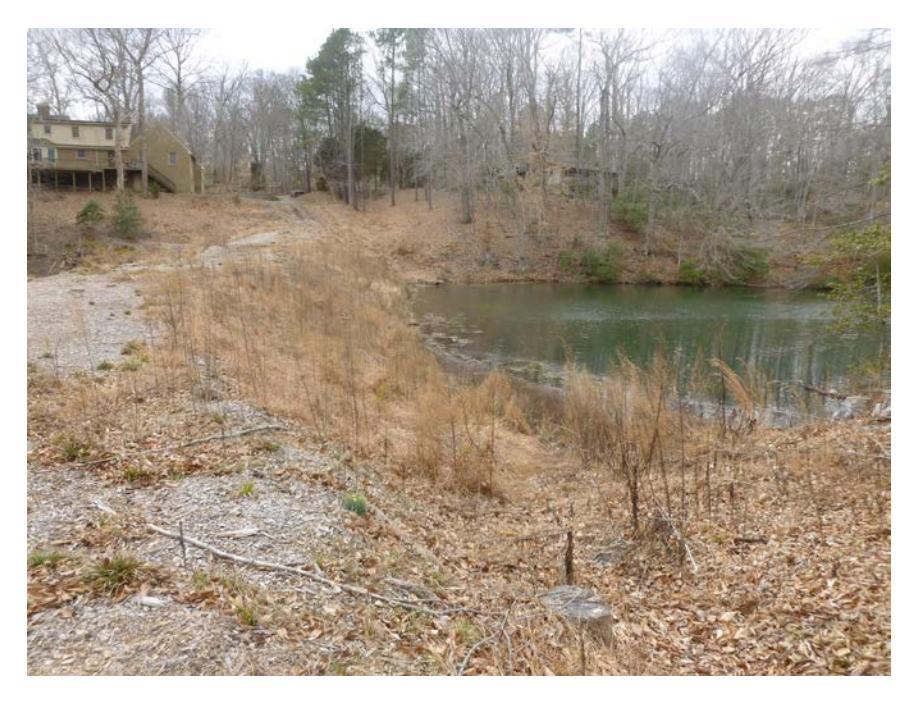
View along upstream face of embankment, from left abutment.

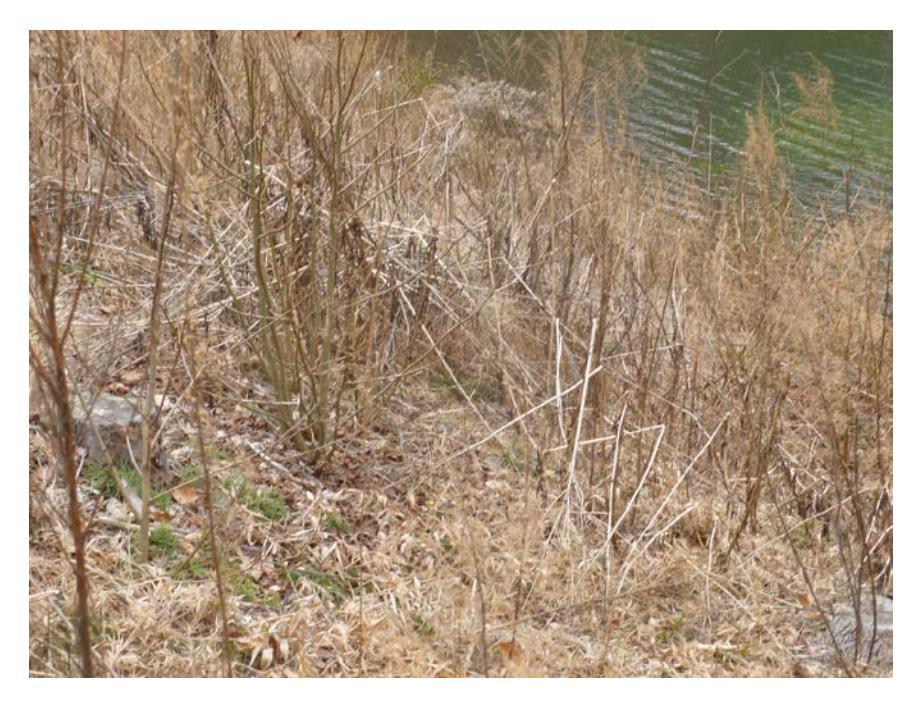
Herbaceous vegetation on upstream face of abutment.

The upstream face of the dam embankment is covered with remnants of herbaceous vegetation to a degree that makes it impossible to inspect the dam properly. This vegetation should be removed and the embankment re-seeded, with soil amendments determined by soils tests, so that a healthy stand of grass can be established. The grass should be mowed at least twice per growing season to prevent the re-establishment of woody vegetation.

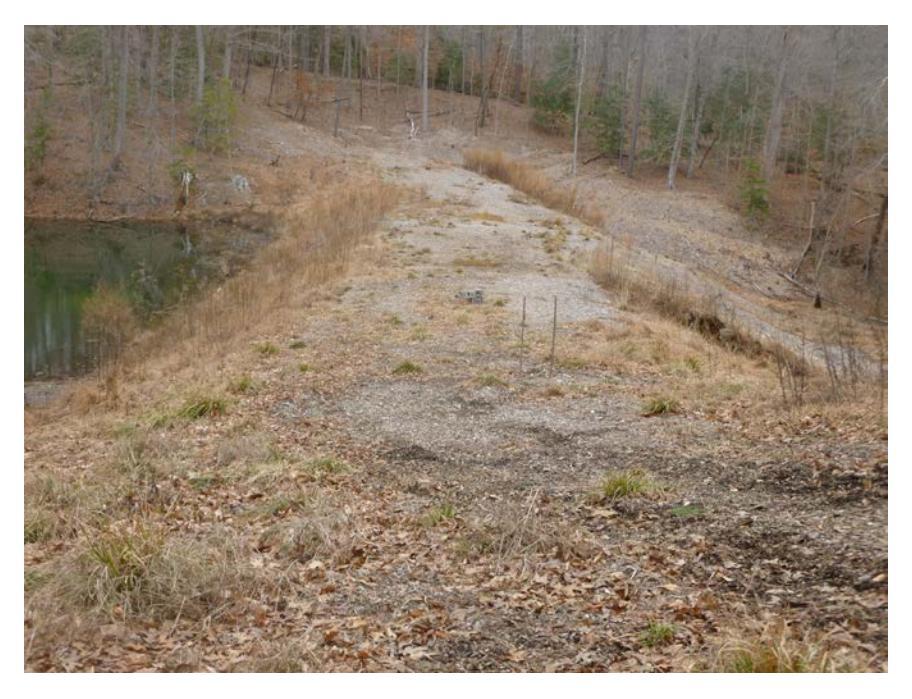
View along top of dam, from right abutment.

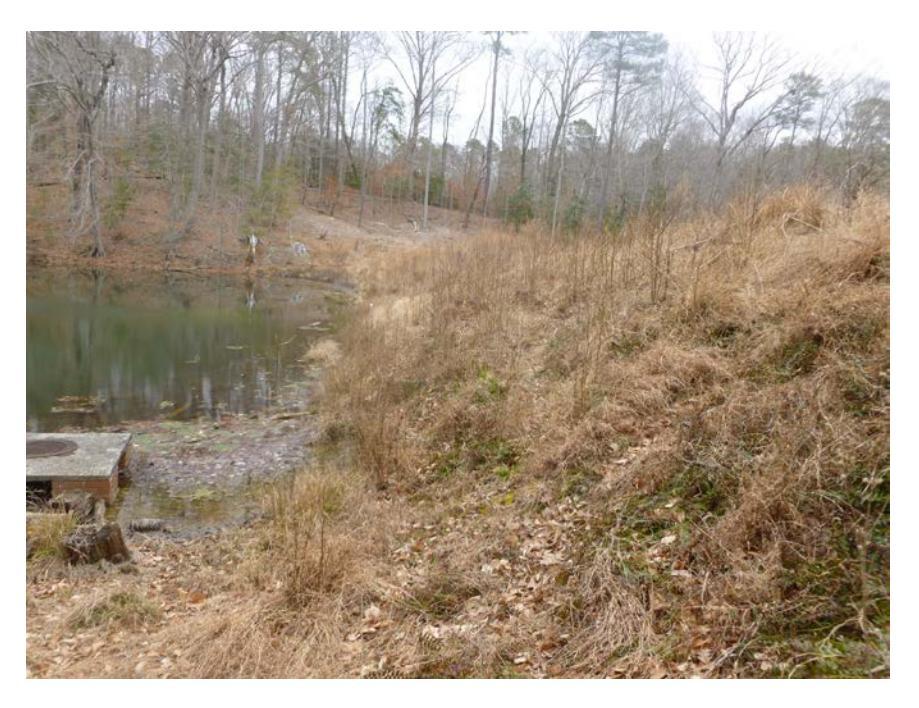
View along upstream face of dam, from right abutment.

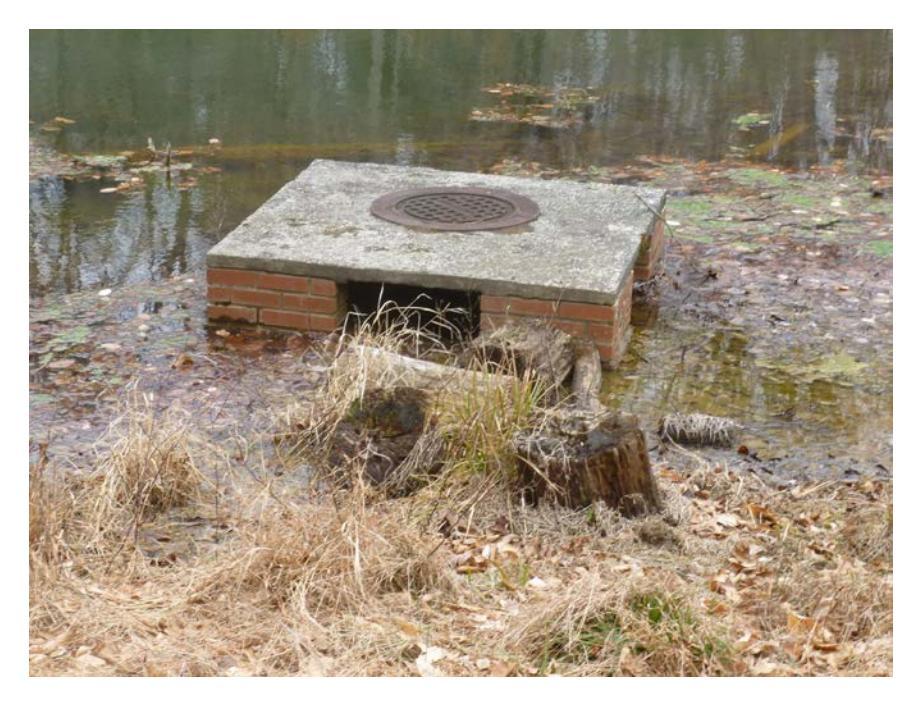
Brick principal spillway with four (4) control orifices.

In keeping with the general lack of maintenance of this impoundment, debris, including tree trunks and branches, has accumulated along the shoreline and to a smaller degree at the inlet to the principal spillway. Such debris accumulation will reduce the capacity and reliability of the spillway. In the extreme the debris can clog the spillway to a degree that will block the spillway and raise the water level in the reservoir. Such debris should be removed on a regular basis.

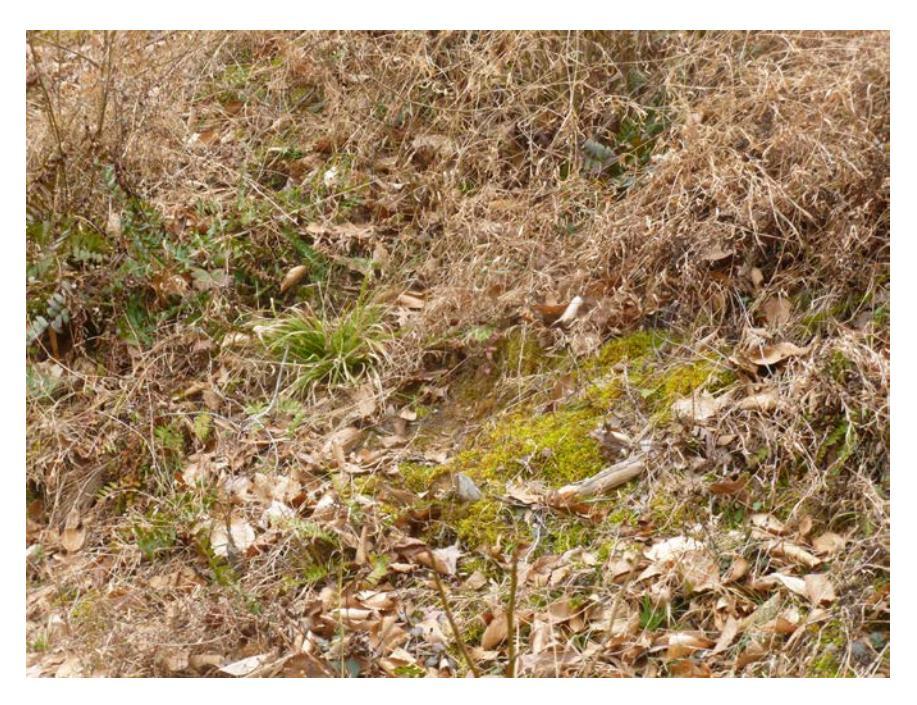
Moss and bare spots on embankment.

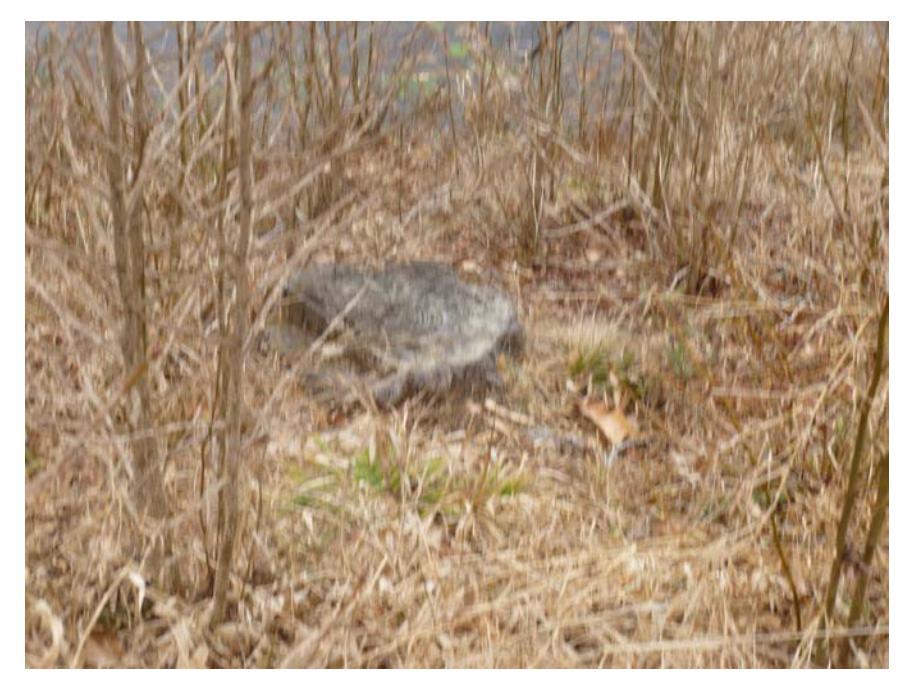
Tree stump that should be removed.

Several tree roots were noted in the geotechnical report. The root balls will be removed, backfilled, and compacted.

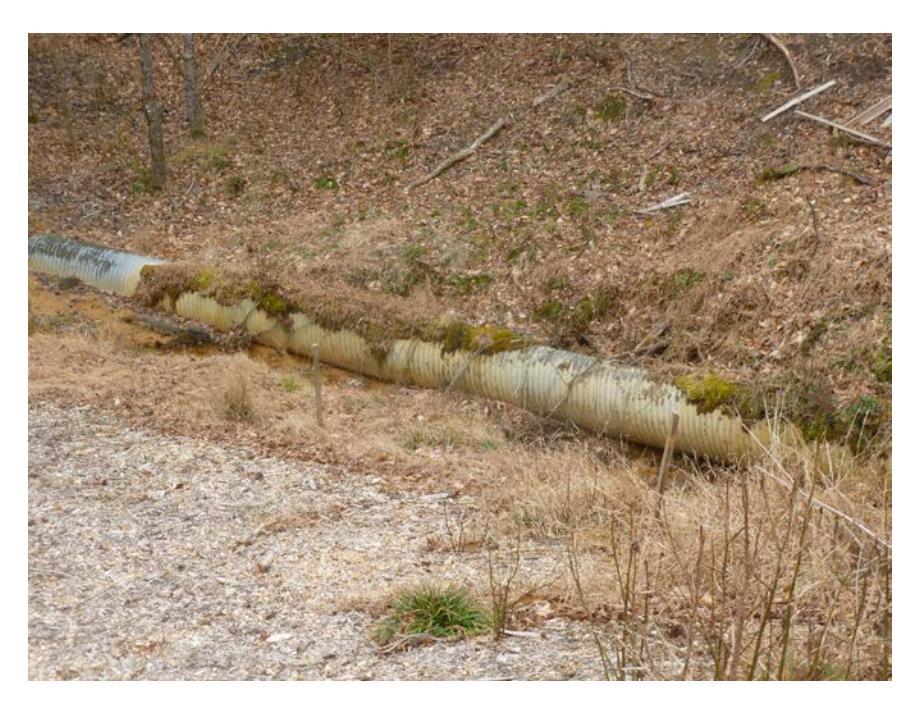
Downstream part of separated outfall barrel, corrugated metal pipe (CMP).

The existing failed corrugated metal outfall pipe will be removed to stable CMP. Care needs to be taken when working around the failed embankment and a trench box may be required.

Bander Smith, LLC proposes to line the existing CMP outfall with either an 18 inch DR26 or DR21 HDPE pipe. From the pictures, the existing CMP appears to be 24 inches. The pipe dimensions can be found in the chart below.

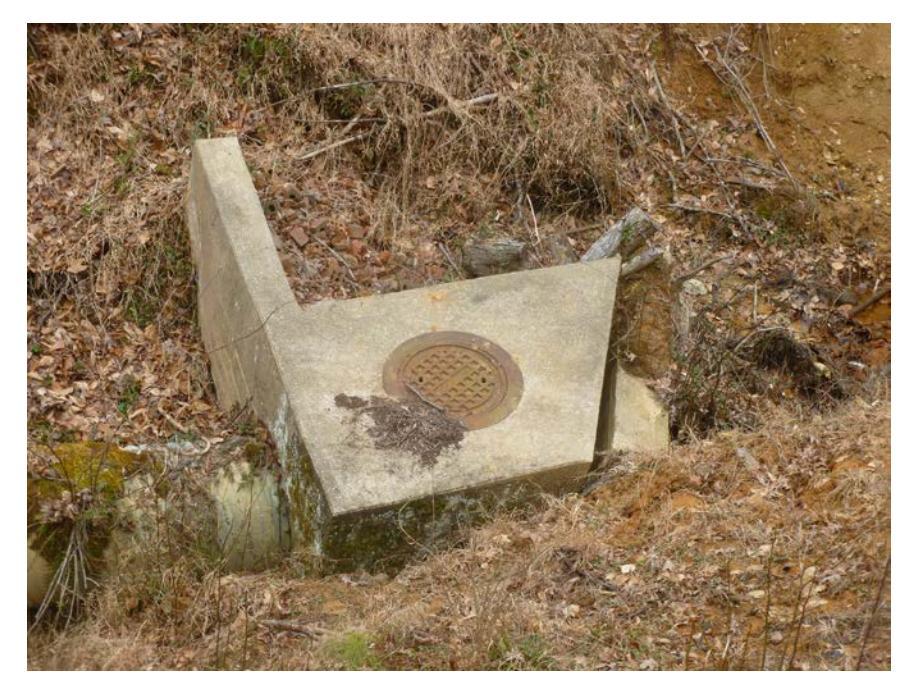
Displaced junction box within outfall barrel.

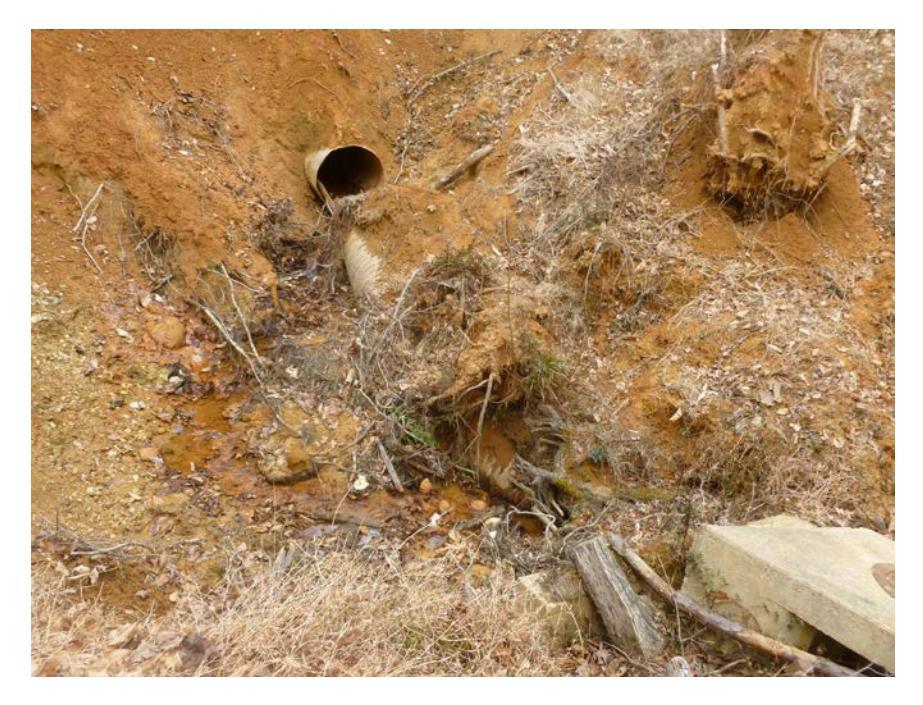
Downstream penetration of remaining outfall barrel, with displaced portion of barrel and junction box.

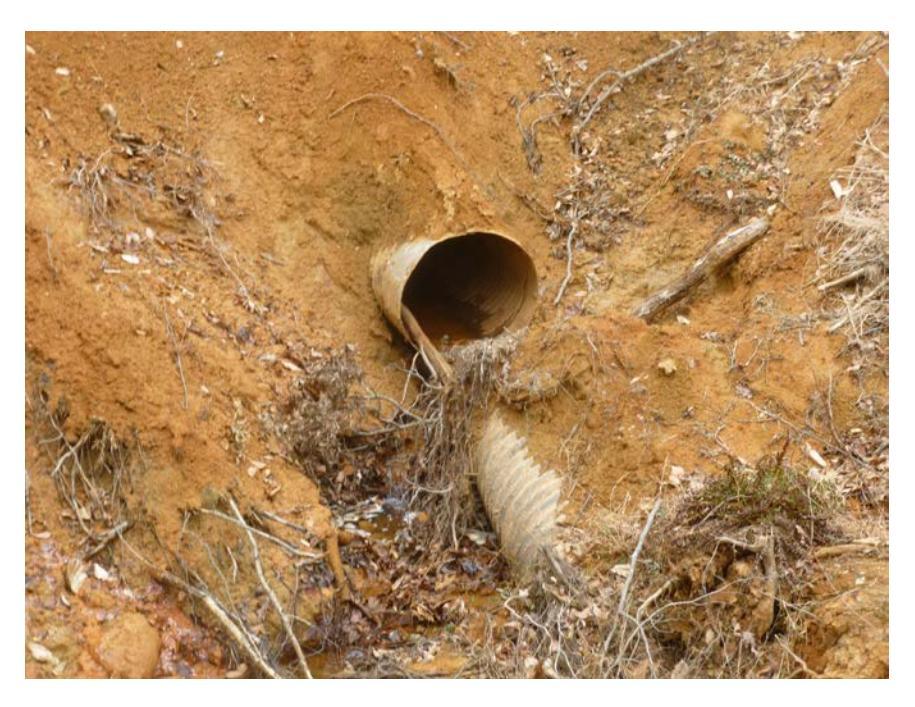
Outfall barrel, pipe separation area.

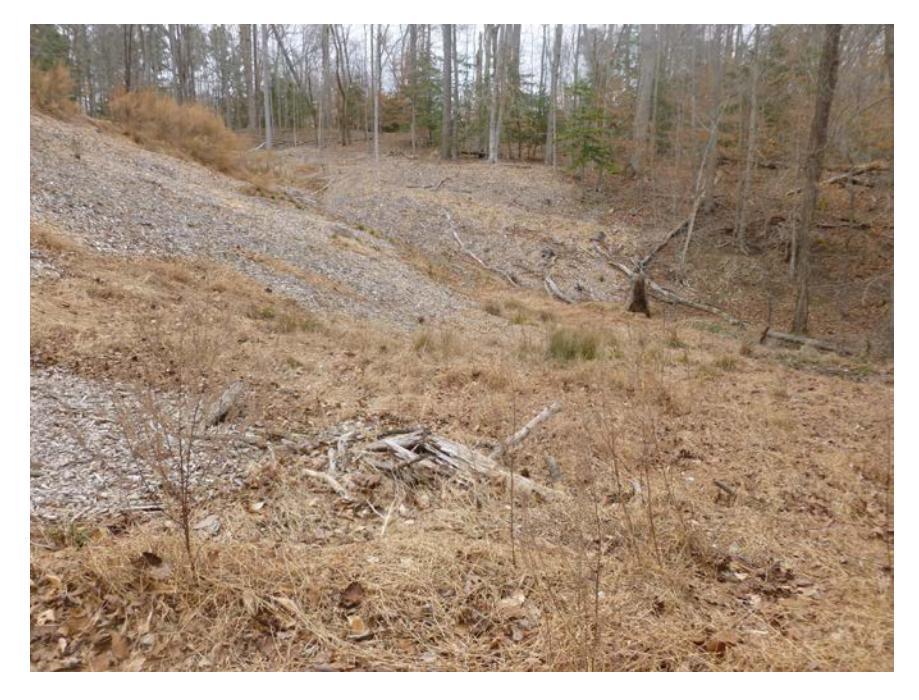
Downstream face of embankment.

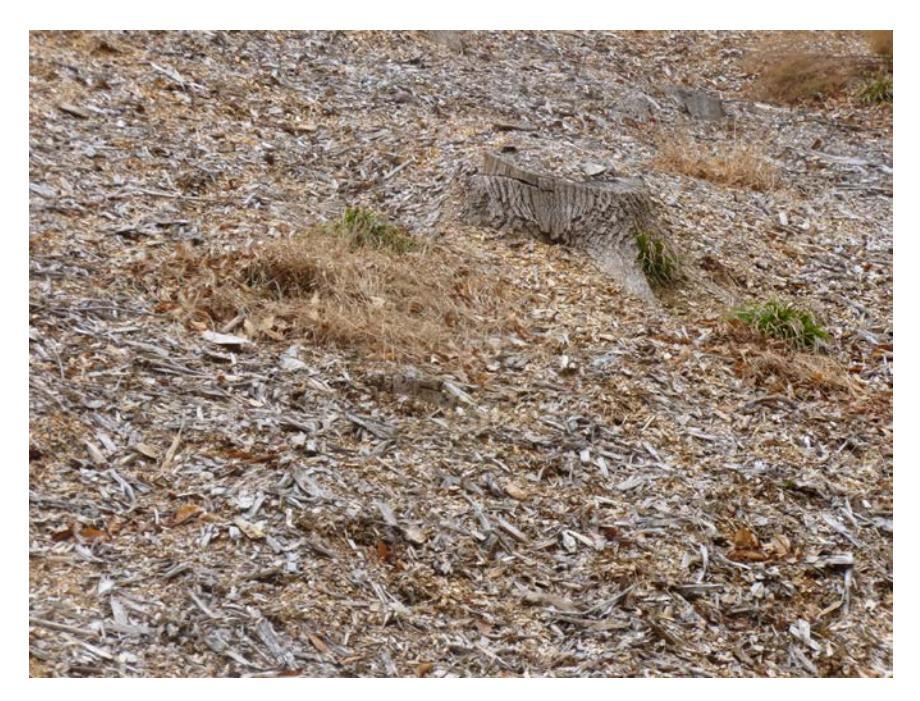
Wood chip cover and remaining tree stump.

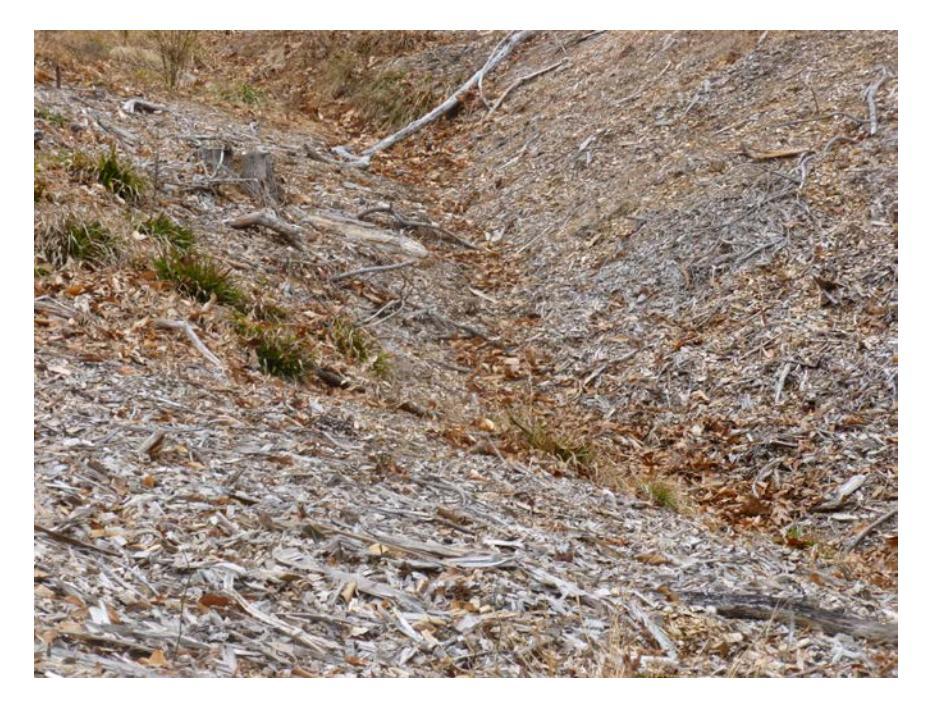
Groin swale on left abutment, downstream face.

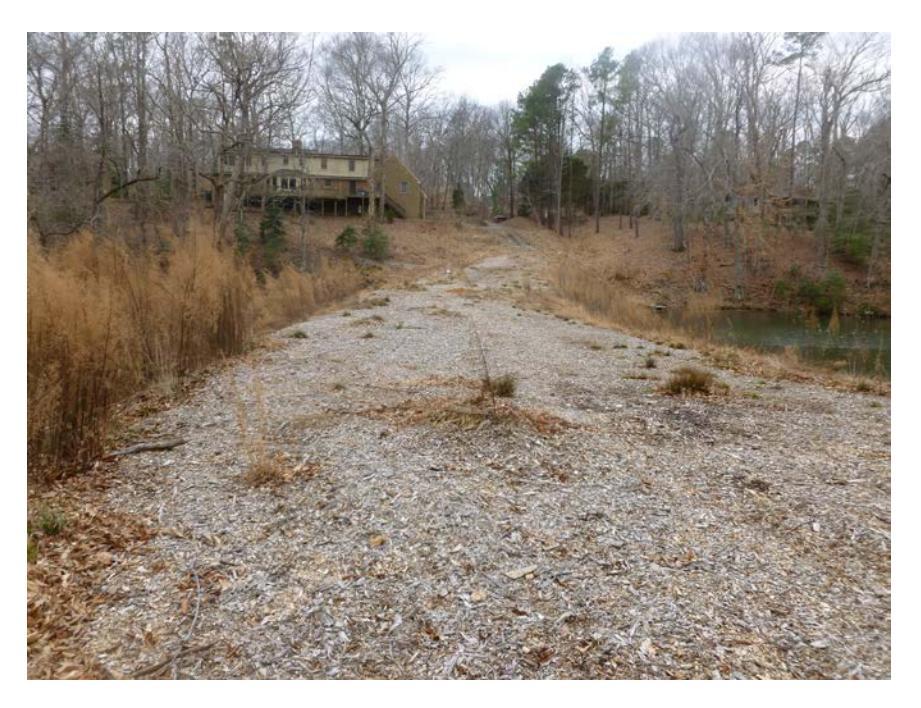
View along top of embankment, from left abutment.

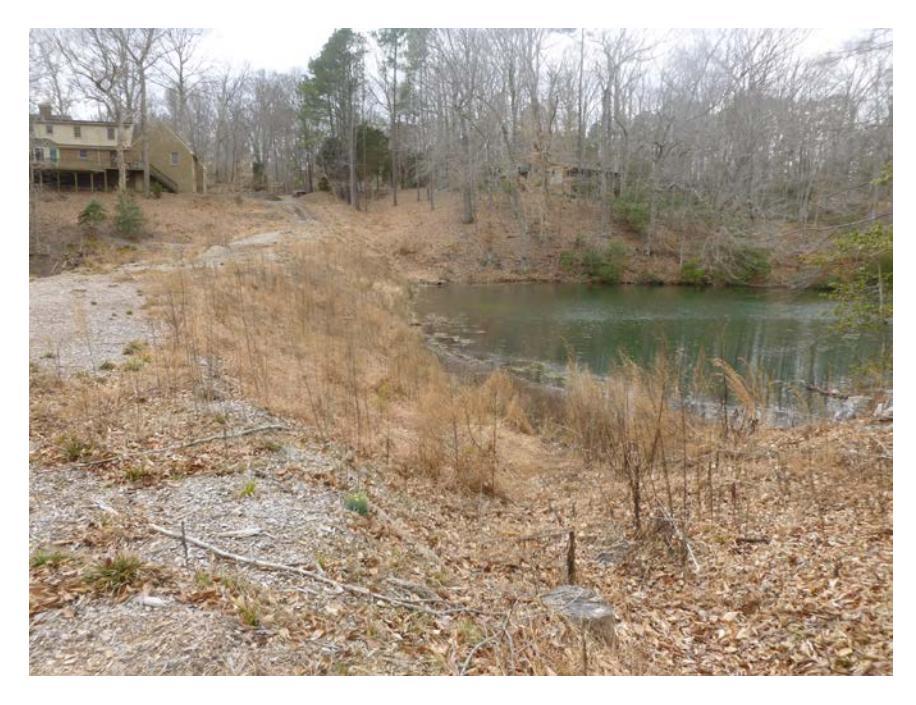
View along upstream face of embankment, from left abutment.

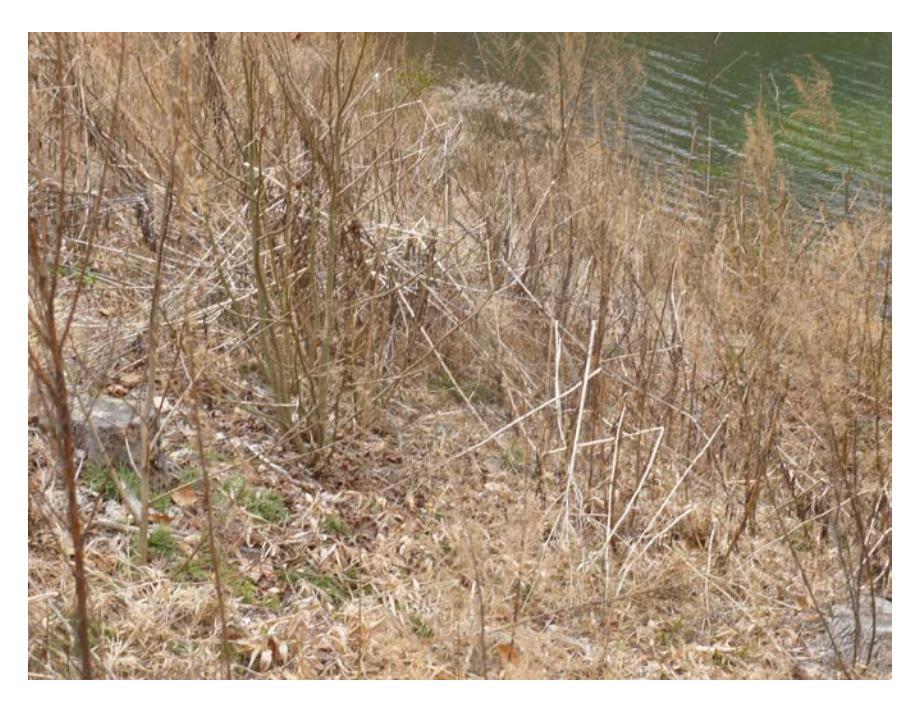
Herbaceous vegetation on upstream face of abutment.

The upstream face of the dam embankment is covered with remnants of herbaceous vegetation to a degree that makes it impossible to inspect the dam properly. This vegetation should be removed and the embankment re-seeded, with soil amendments determined by soils tests, so that a healthy stand of grass can be established. The grass should be mowed at least twice per growing season to prevent the re-establishment of woody vegetation.

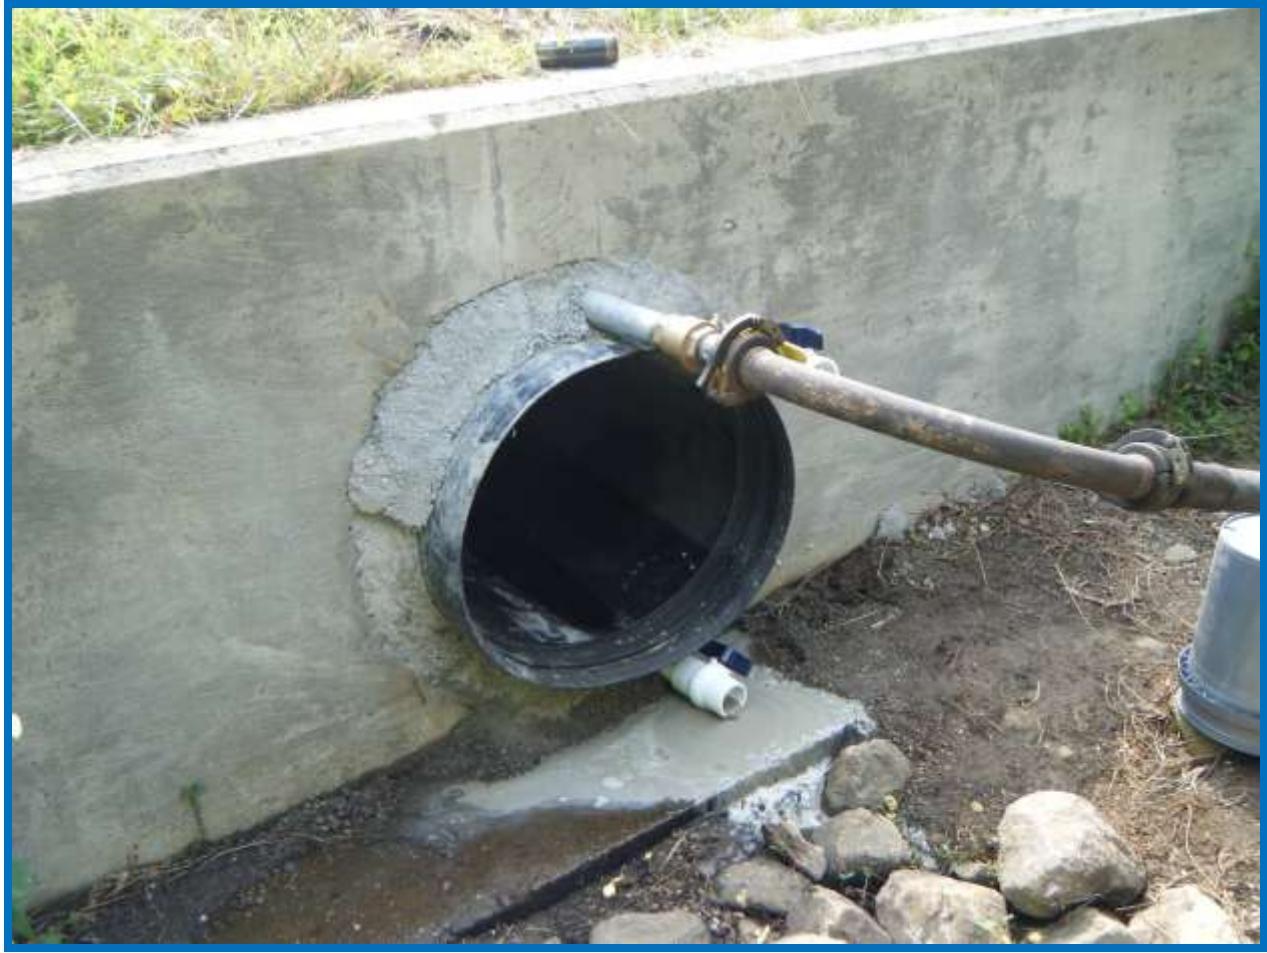
Figure 1 – Typical Grout injection port and vent ports

Bulkheads will be installed on the upstream and downstream side of the outfall pipe. The bulkhead will consist of anti-shrink concrete packed approximately 2 to 3 feet into the annular space between the old and new pipes. Vent ports will be installed on the bottom, middle, and top of the bulkhead to insure a complete grouting has occurred. A 2 inch diameter steel injection port will be installed at the top of the downstream bulkhead. Once all vent ports have passed grout and closed, the grouting operation is complete.

Careful grouting of the annular space between the existing conduit and the HDPE slipliner is essential. This can be a complex process, requiring the experience of a qualified contractor. The HDPE slipliner is typically designed to withstand all internal and external loadings independently from exterior conditions. A lightweight, low density grout containing no aggregate will ensure the best result. Usually the material used is a Fine grout ("flowable fill") amended with Tetraguard AS20 (anti-shrink) & super plasticizer. Depending on the conditions, additional admixtures may be required to obtain desired performance such as cellular grout.
